| <b>DATE:</b> | 7/27/2026 - 7/30/2026 |
| <b>REPORT NUMBER:</b> | 12 |
| <b>PROJECT NUMBER:</b> | 20260236 |
| <b>PROJECT:</b> | Tyrone Water System Improvements Construction |

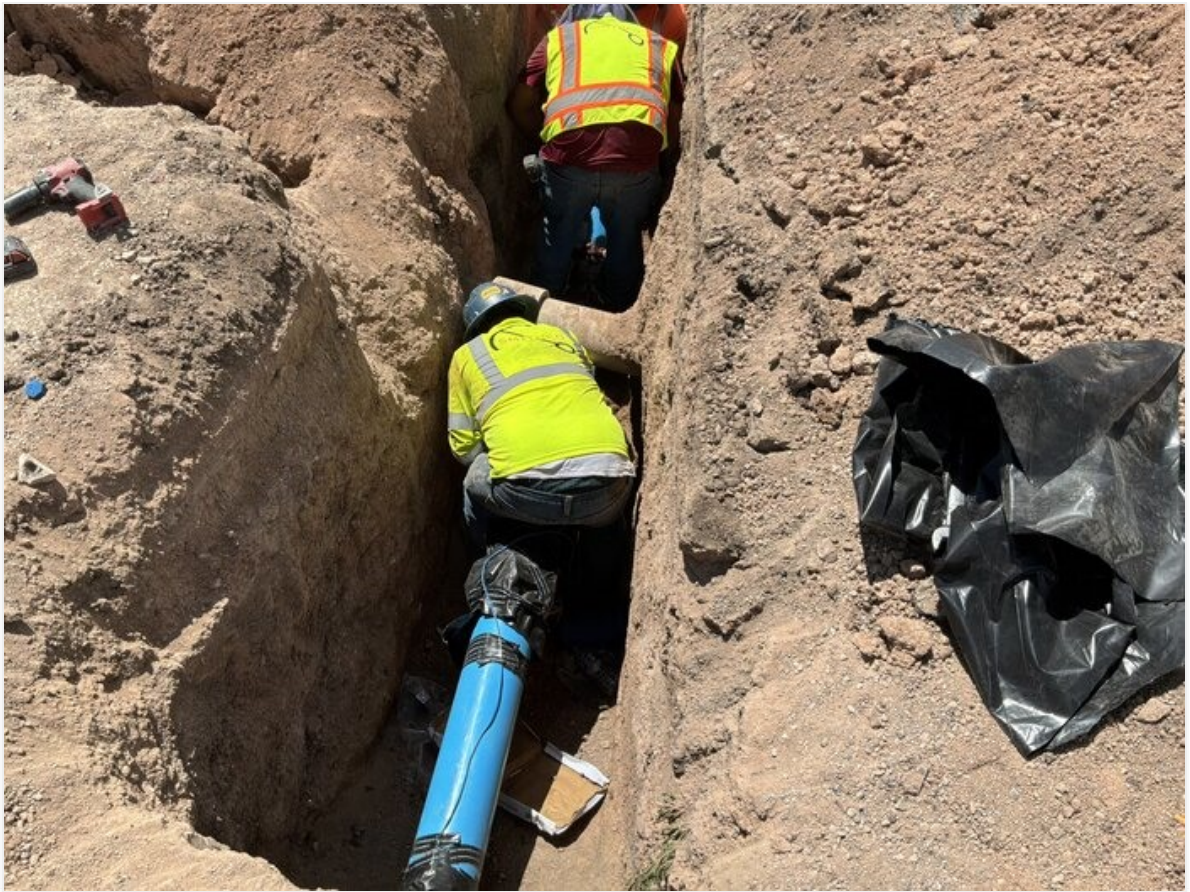
*45 DI bends at sta 13+96, under hydrant line.*

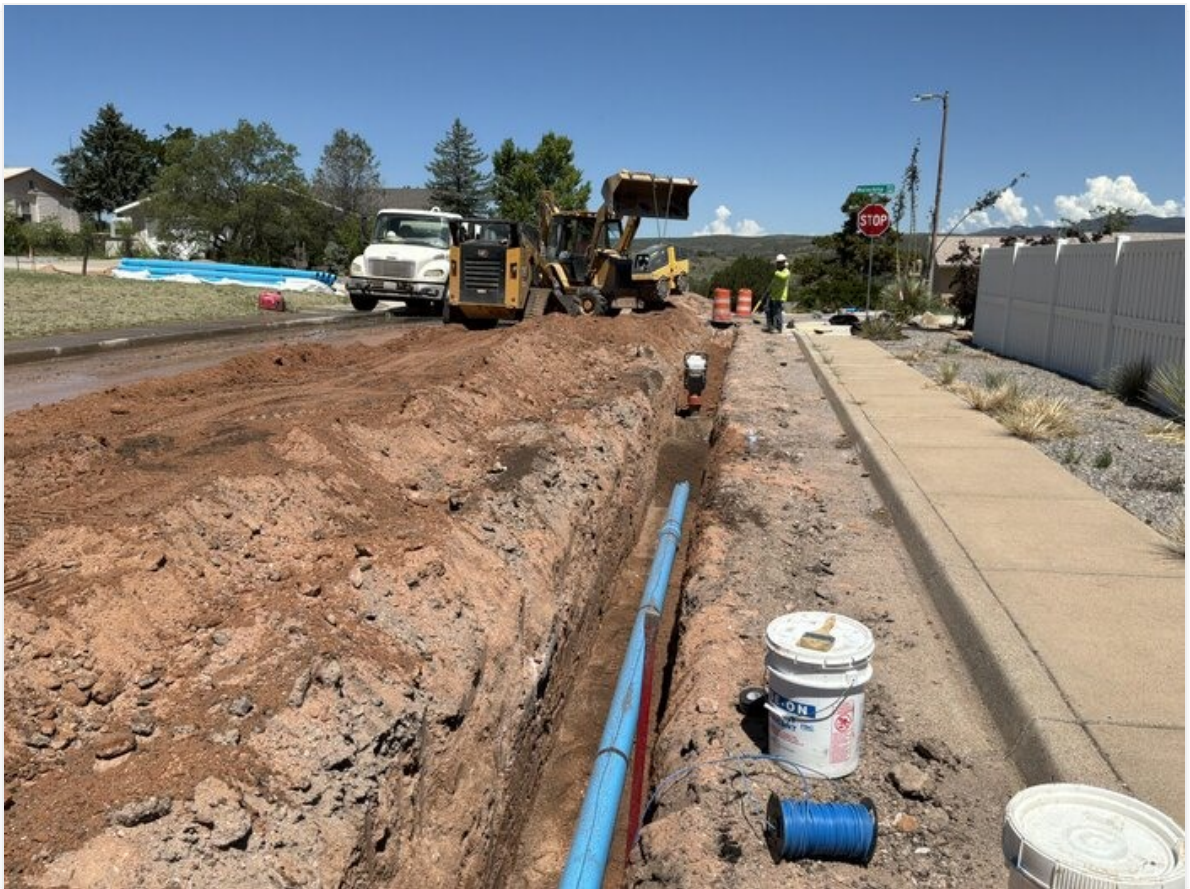
*6" C-900 on Chalcopryite Ave.*

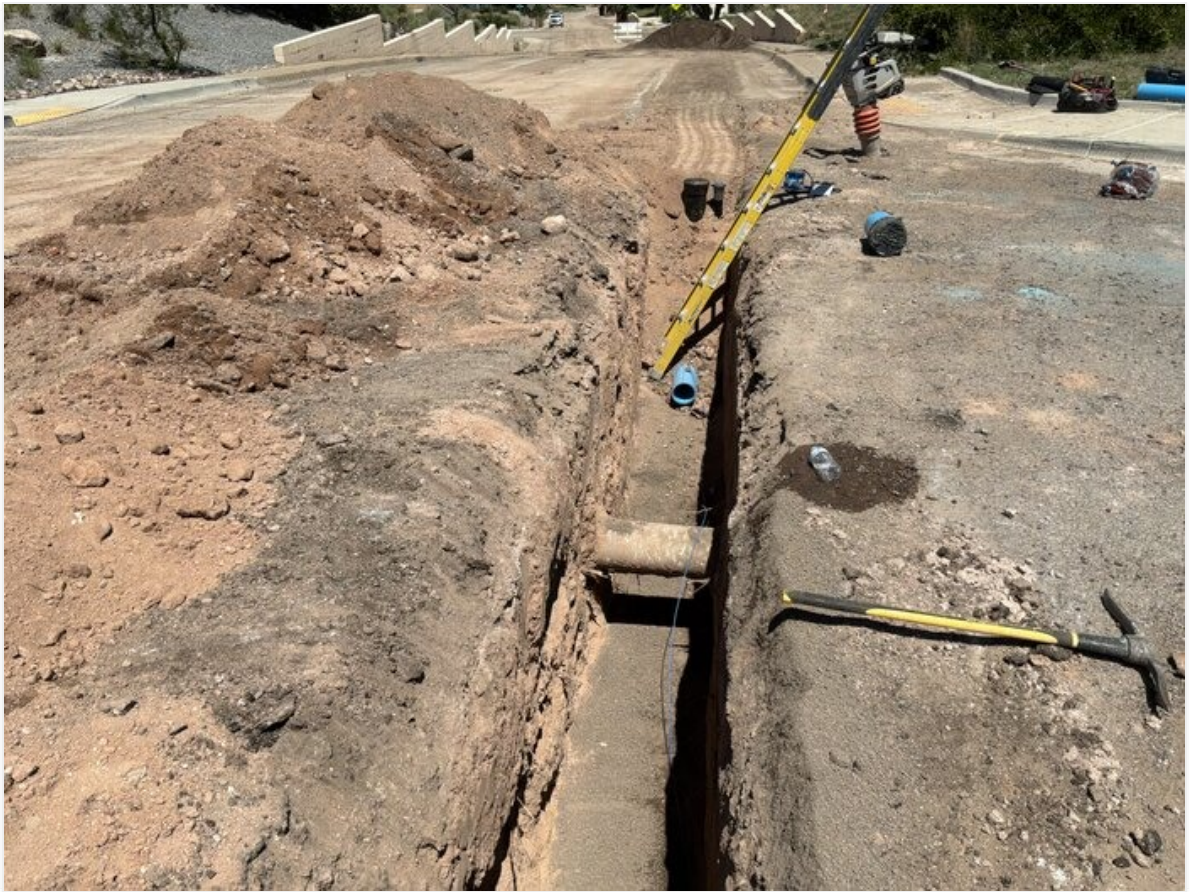
| WORK DESCRIPTION |
|---|
| <p><b>Crew#1</b>– The contractor continued to place 6” C-900 on Chalcopyrite Ave. At the intersection of Malachite Ave. and Chalcopyrite Ave. The contractor will be eliminating the DI 45 bends at sta. 27+40 to 27+60 due to the existing sewer being 6’ below grade and it will interfere with the water bend. Also the existing water line will have 18” of clearance from the new water line. The new line will pass under the existing with at least 18” of separation.</p> <p><b>Crew #1</b>– The contractor continued to pothole ahead of the excavation looking for existing utilities on Chalcopyrite Ave. (north) The contractor did not need the DI 45 bends at sta. 13+94 to 13+73 due to the existing water line not crossing the new line in this area. however the contractual did need 45 DI bends to go under the existing 6” fire line at approx sta. 13+96.</p> <p>Summit testing was onsite to take backfill densities for crew #2. All tests taken passed.</p> |

*Existing 8" on Chalcopyrite Ave and Malachite Ave. new 6" to go under with min. 18" separation.*

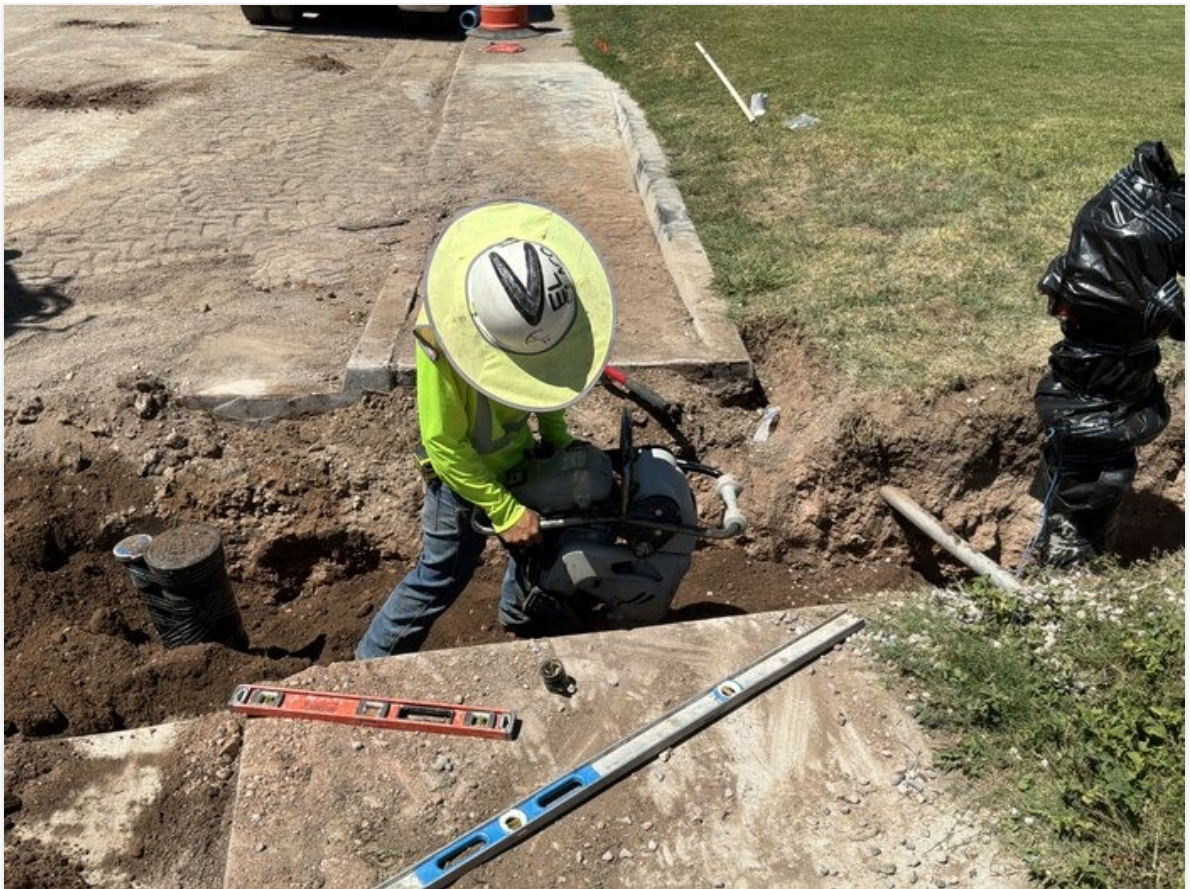
*Compaction on backfill of fire hydrant on Copper Ave. and Chalcopyrite Ave.*

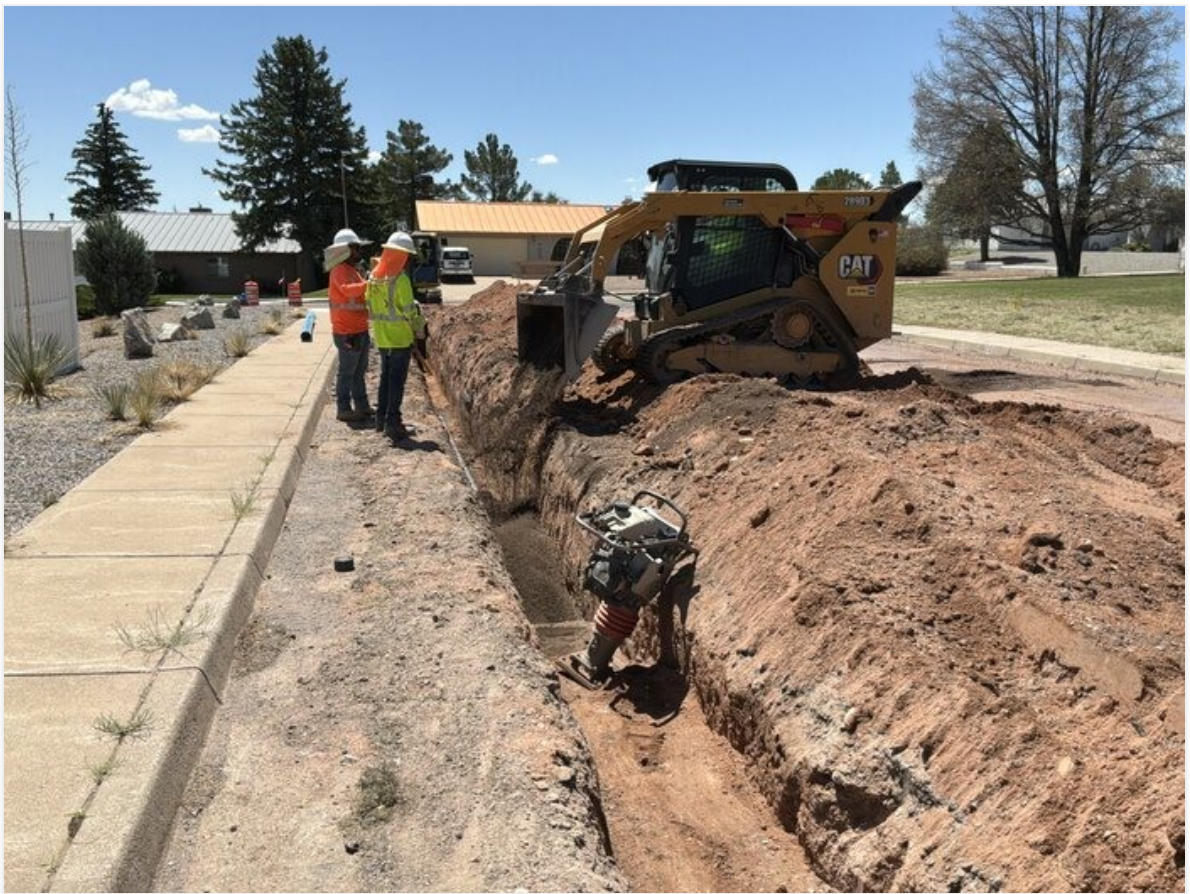
*Placing backfill over 6" C-900 on Chalcopyrite Ave.*

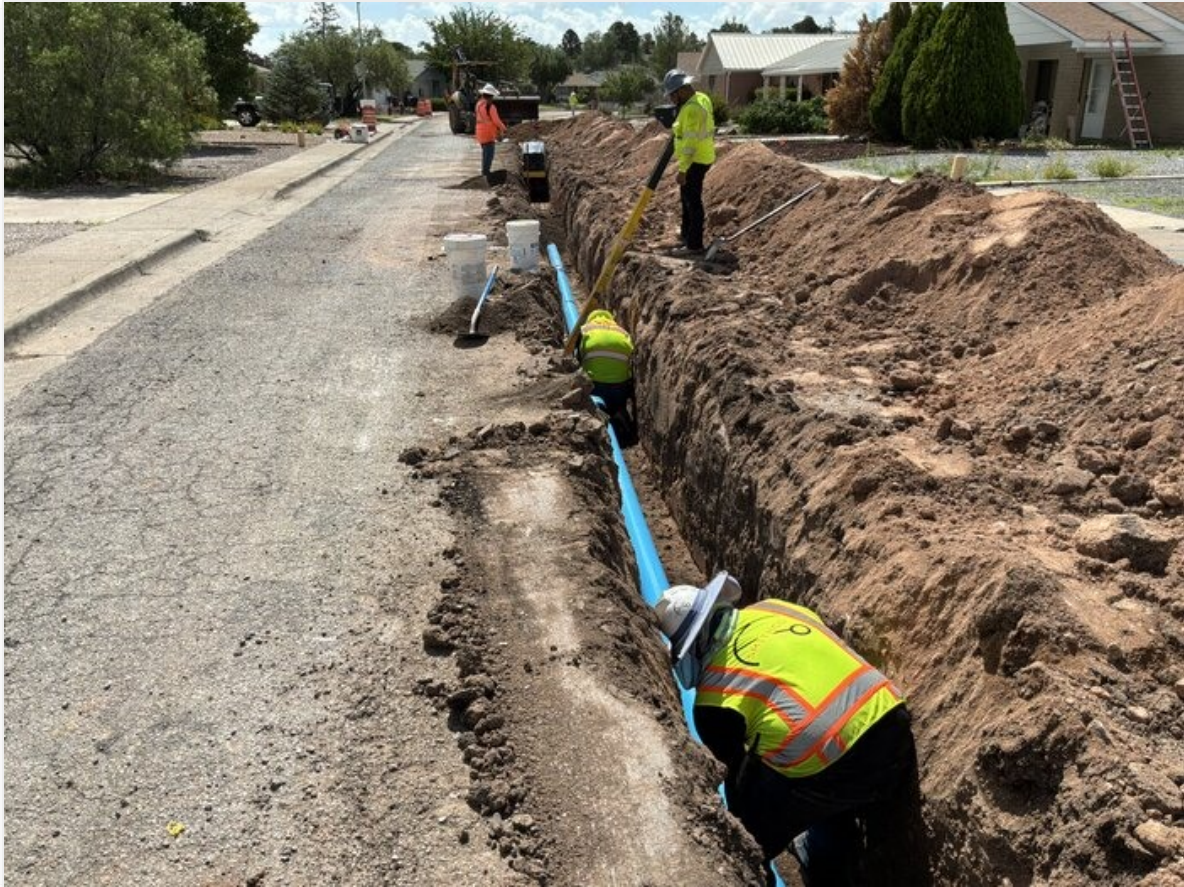
*Placing 6" C-900 on Chalcopyrite Ave.*

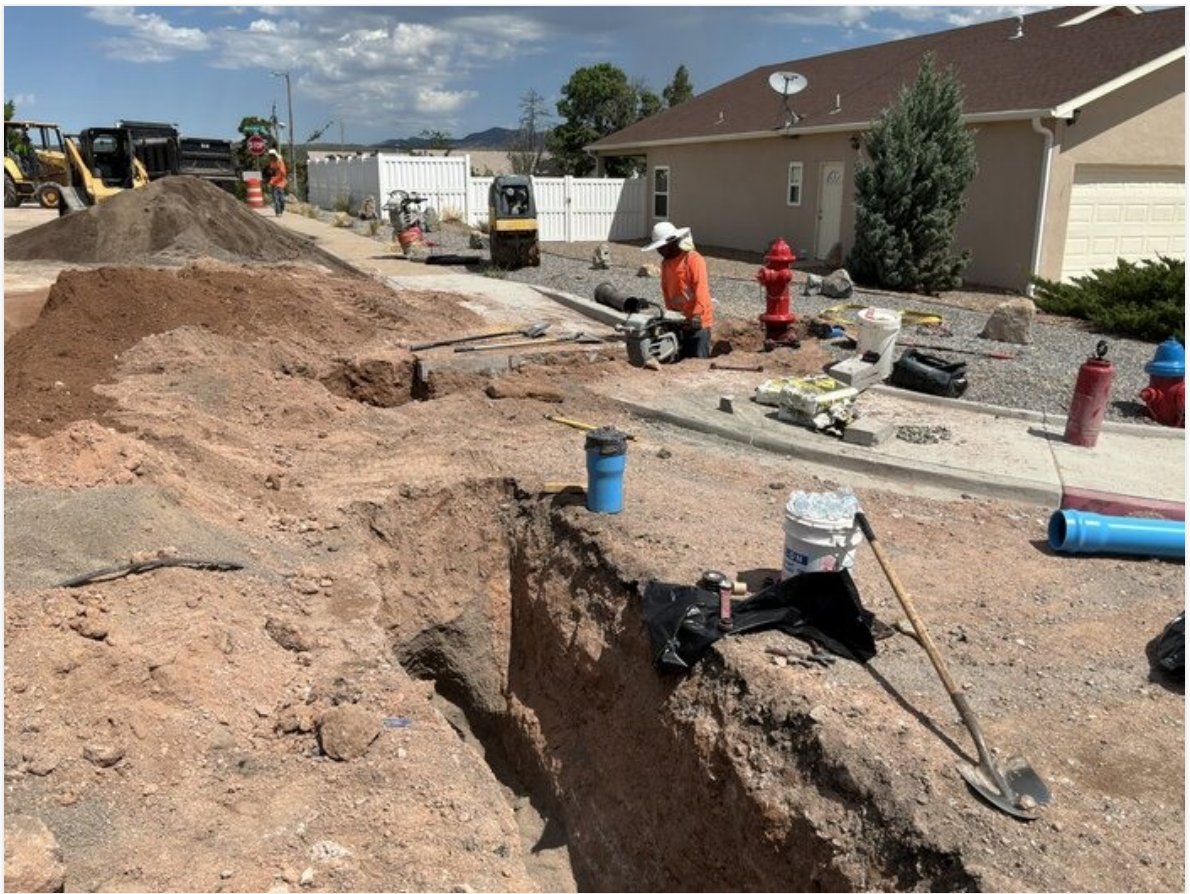
**Crew #2—** The crew continued placing 6” C-900 on Malachite Ave. as per plan. The contractor placed the DI 45 bends at sta. 42+00- sta. 42+13. Fire hydrant #26 was placed as per the new hydrant plan.

*Hydrant #26 compaction*

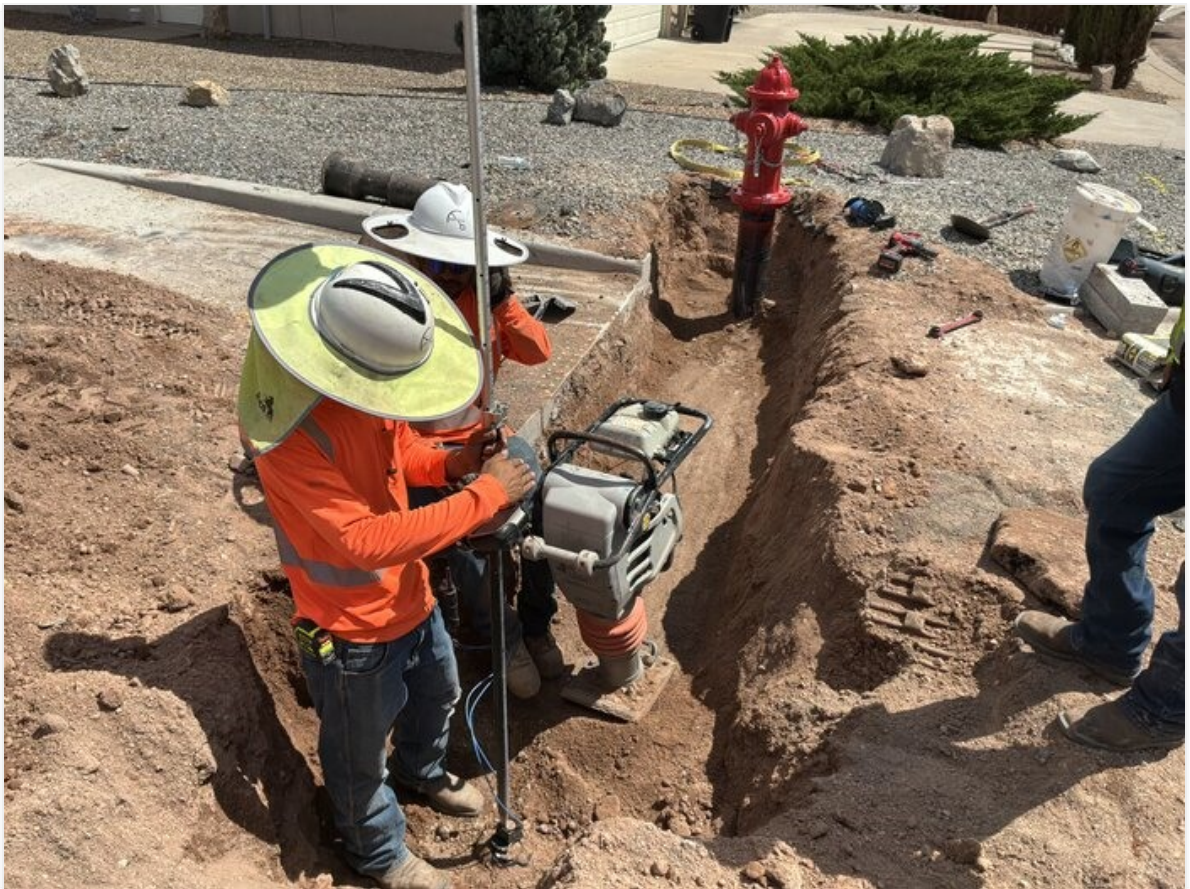
Survey as-built shots were taken on all fittings and every 100’ of C-900 placed.

*Survey as-built shot on GV for Hydrant #26*

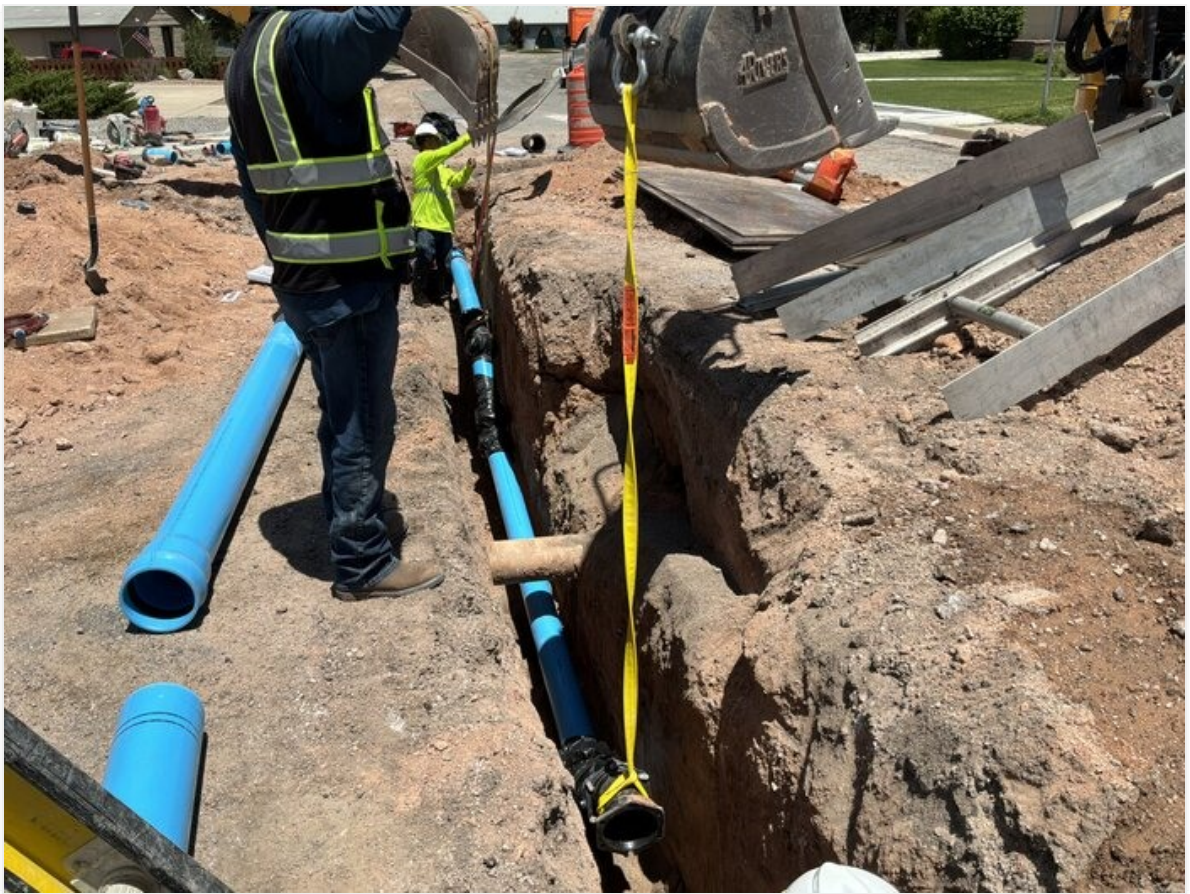
*Placing DI 45 bends under existing water on Malachite Ave. sta. 42+00-42+13*

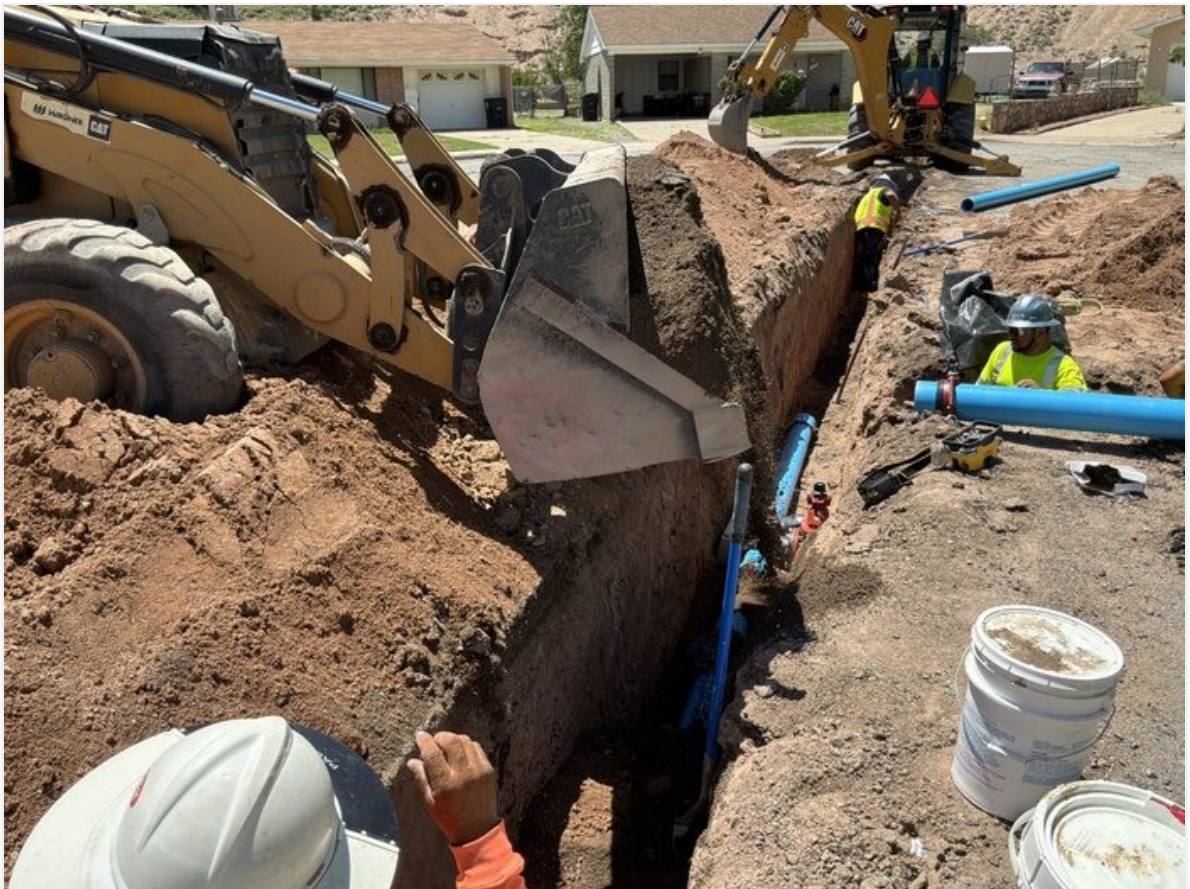
*Placing processed bedding over 6"C-900*
