425 South Telshor Blvd  
Suite C-103  
Las Cruces, NM 88011  
www.bhinc.com  
voice: 575.532.8670  
facsimile: 575.532.8680

| <b>REPORT NUMBER:</b> | 17 |
| <b>PROJECT NUMBER:</b> | 20260236 |
| <b>PROJECT:</b> | Tyrone Water System Improvements Construction |

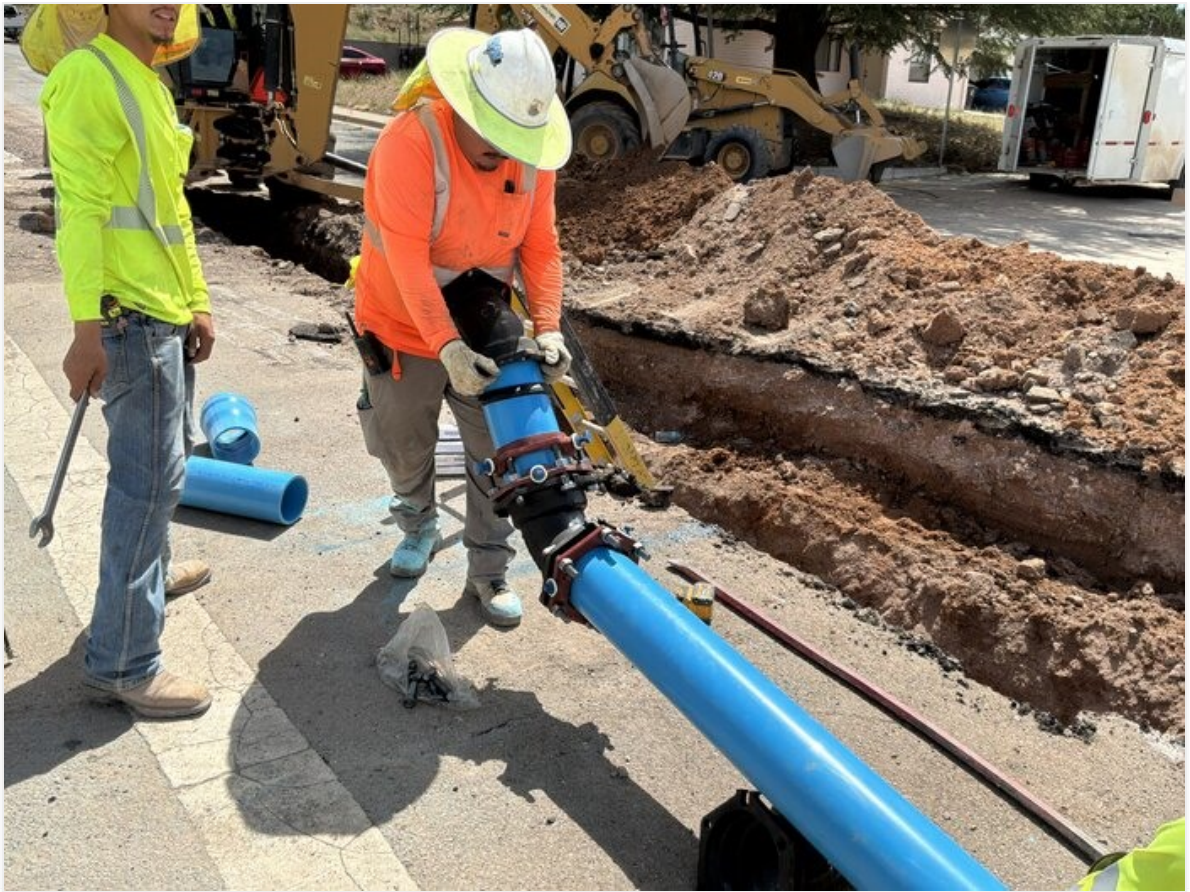
*Connecting DI 45 outside of trench.*

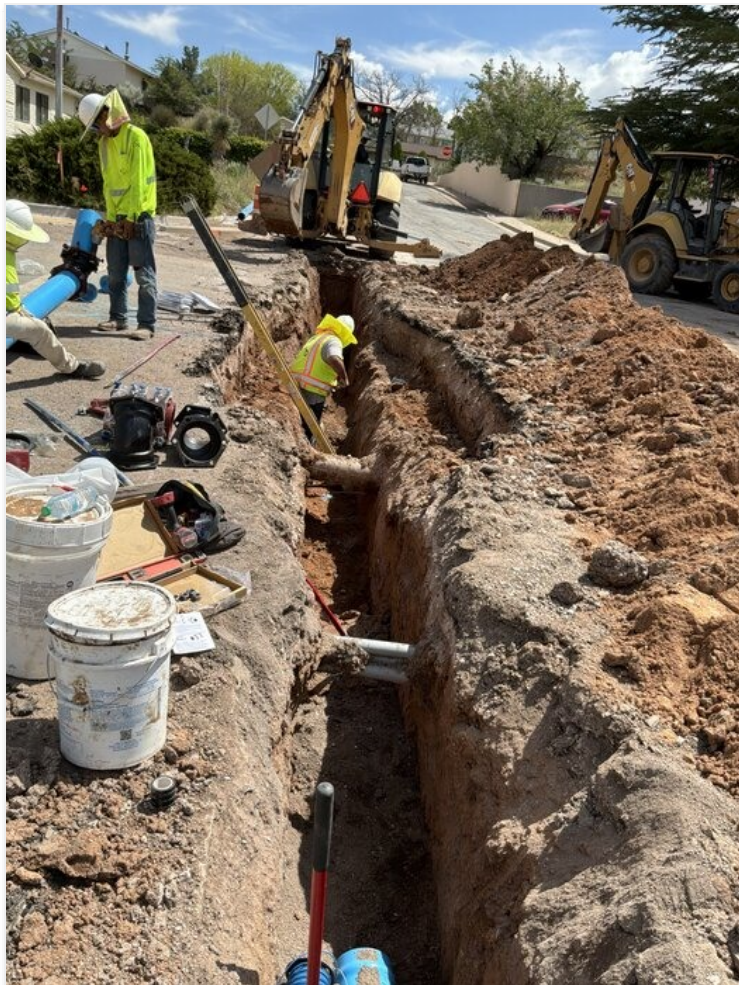
The contractor continued to place 6” C-900 on Chrysocolla Ave. as per plan. DI 45 bends were needed at sta. 13+07 to sta. 13+24 to go under existing water line. Potholing continued ahead of the excavation for existing underground utilities. Summit testing was onsite to take backfill densities. All tests taken passed.

*Existing utilities on Chrysocolla Ave. DI 45 bends will go under existing water line.*

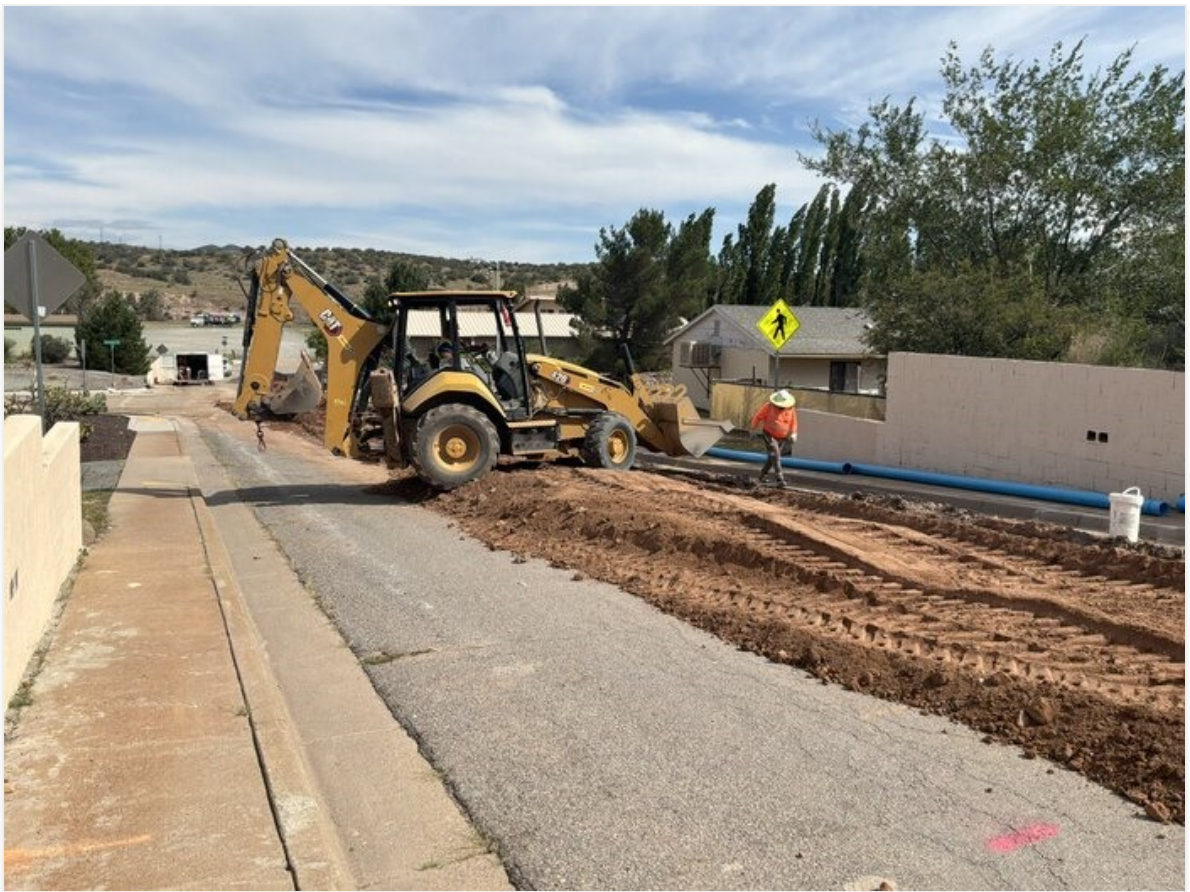
*Backfill process on Chrysocolla Ave.*

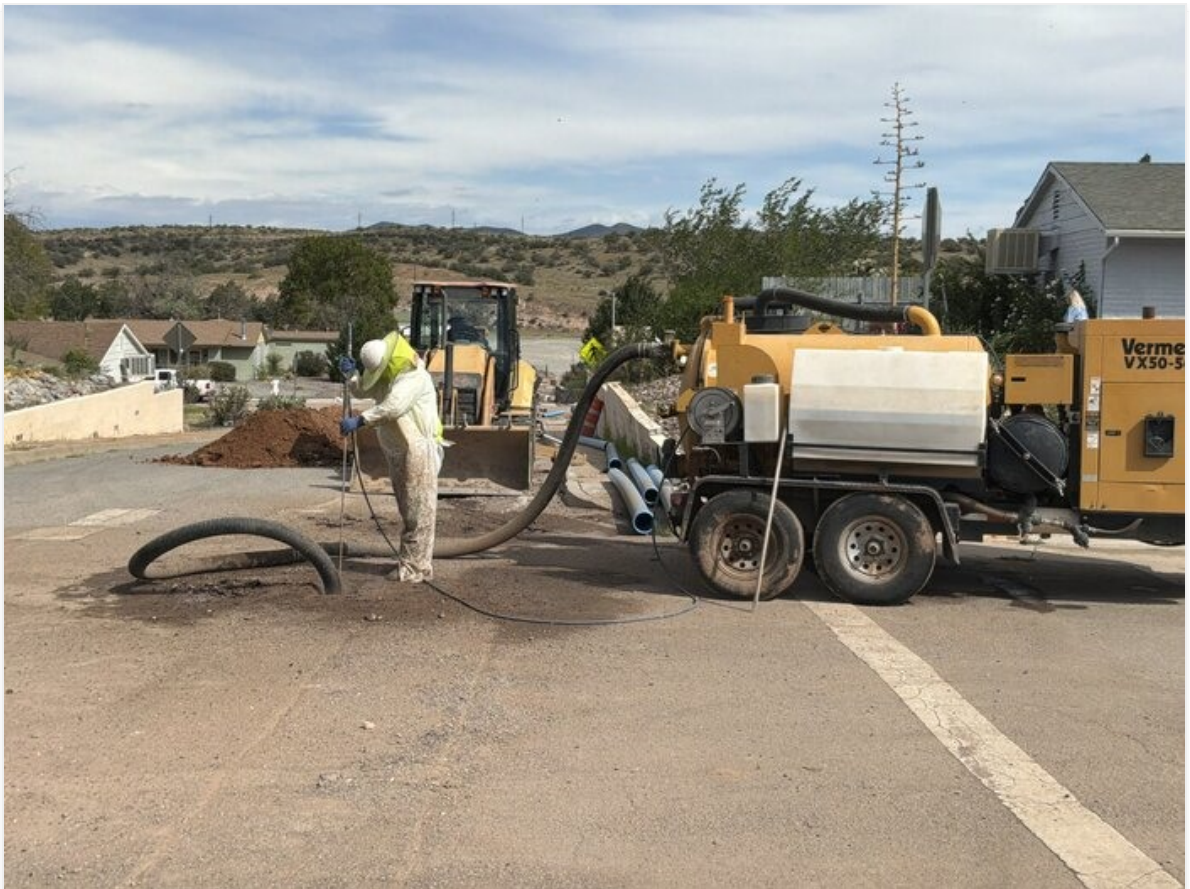
*Potholing for existing utilities on Chrysocolla Ave.*

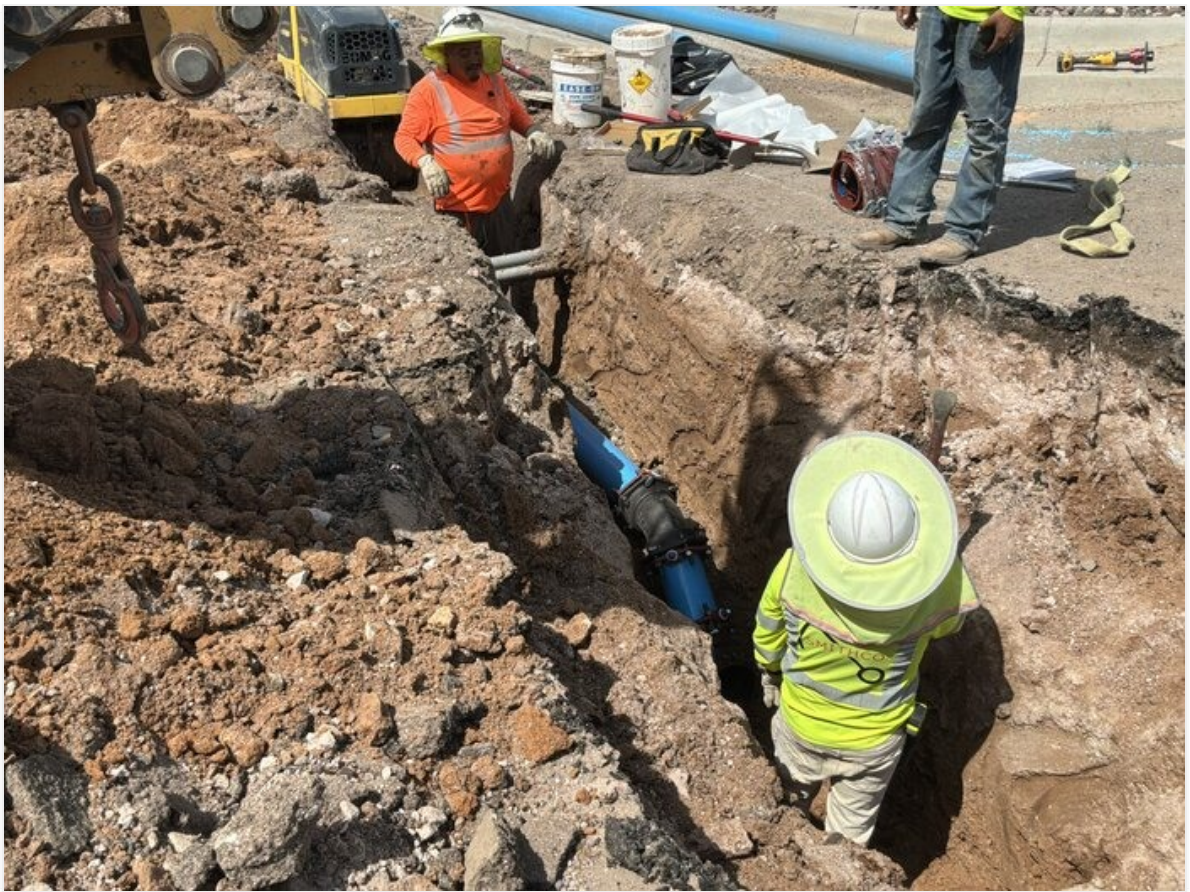
*45 DI bend on Chrysocolla Ave.*

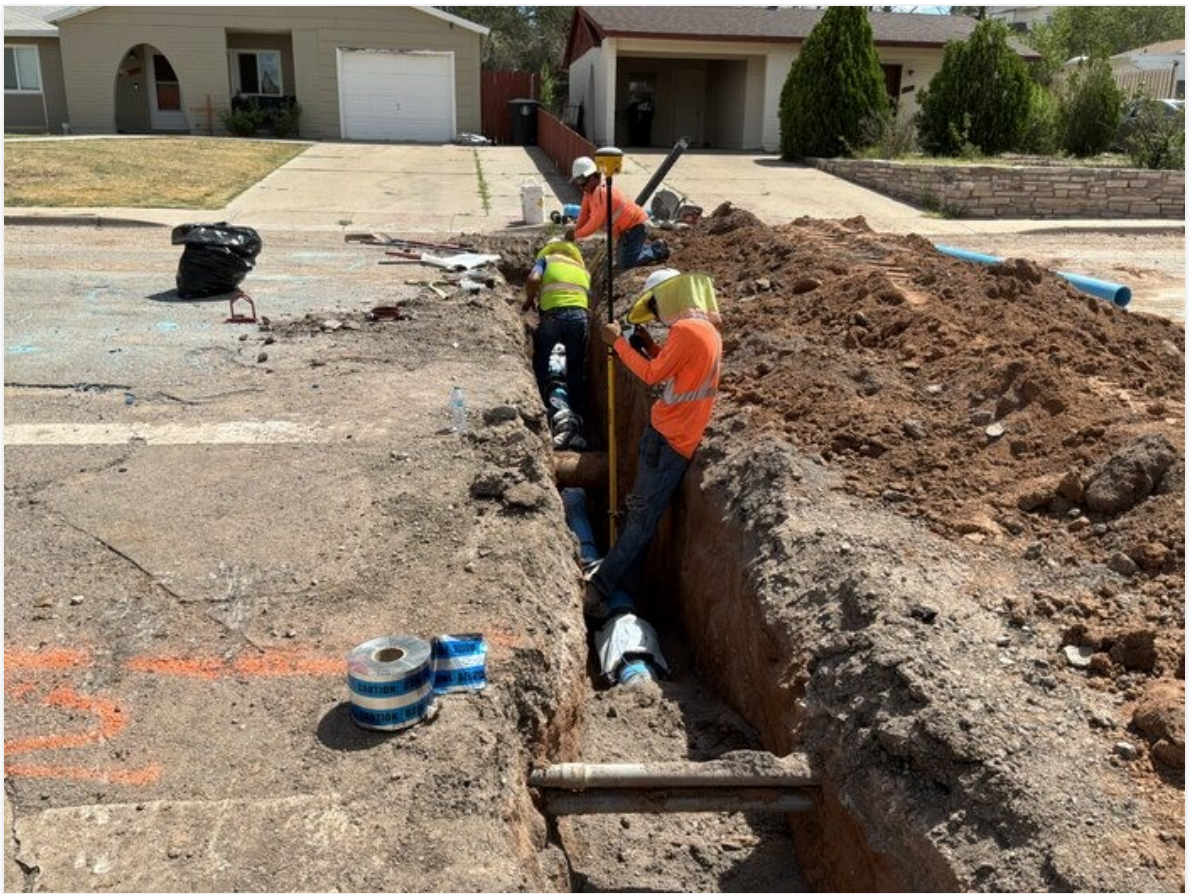
*Survey as-build shot being taken on DI fittings on Chrysocola Ave.*

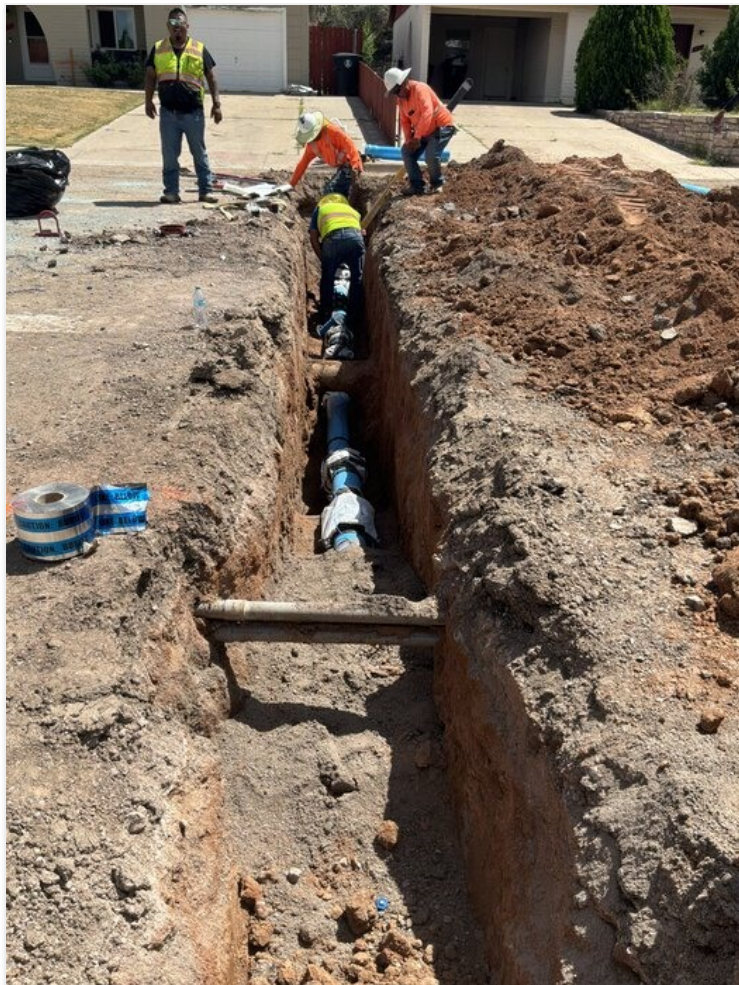
*Di 45 fittings wrapped with anti corrosion plastic, under the existing water line on Chrysocola Ave.*

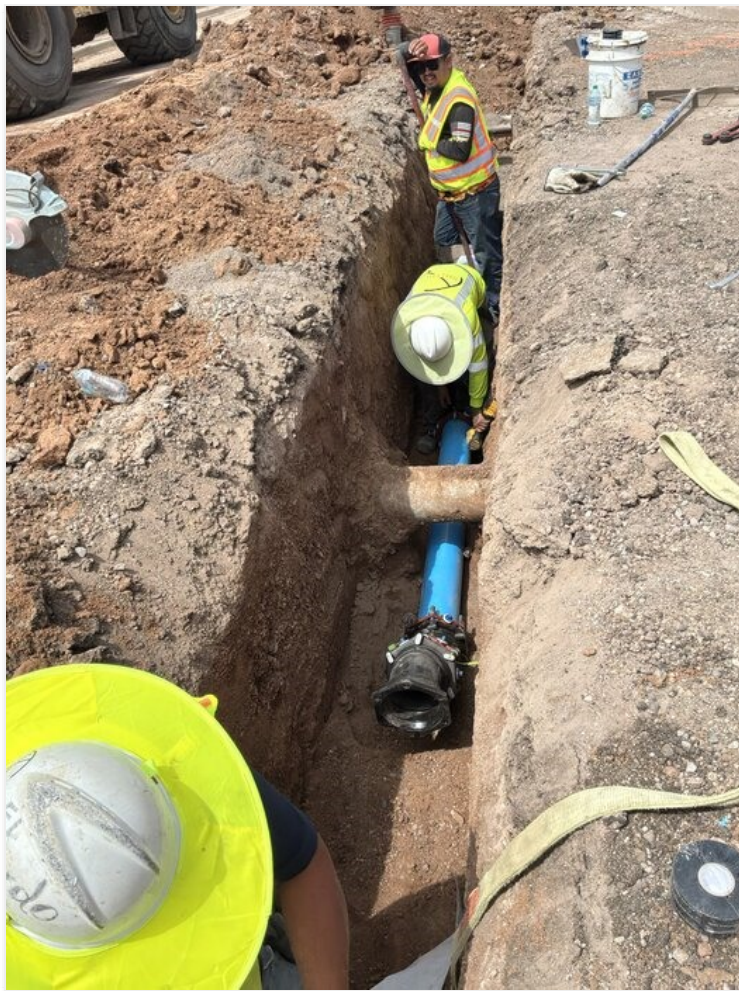
*Going under existing water line Chrysocola Ave.*

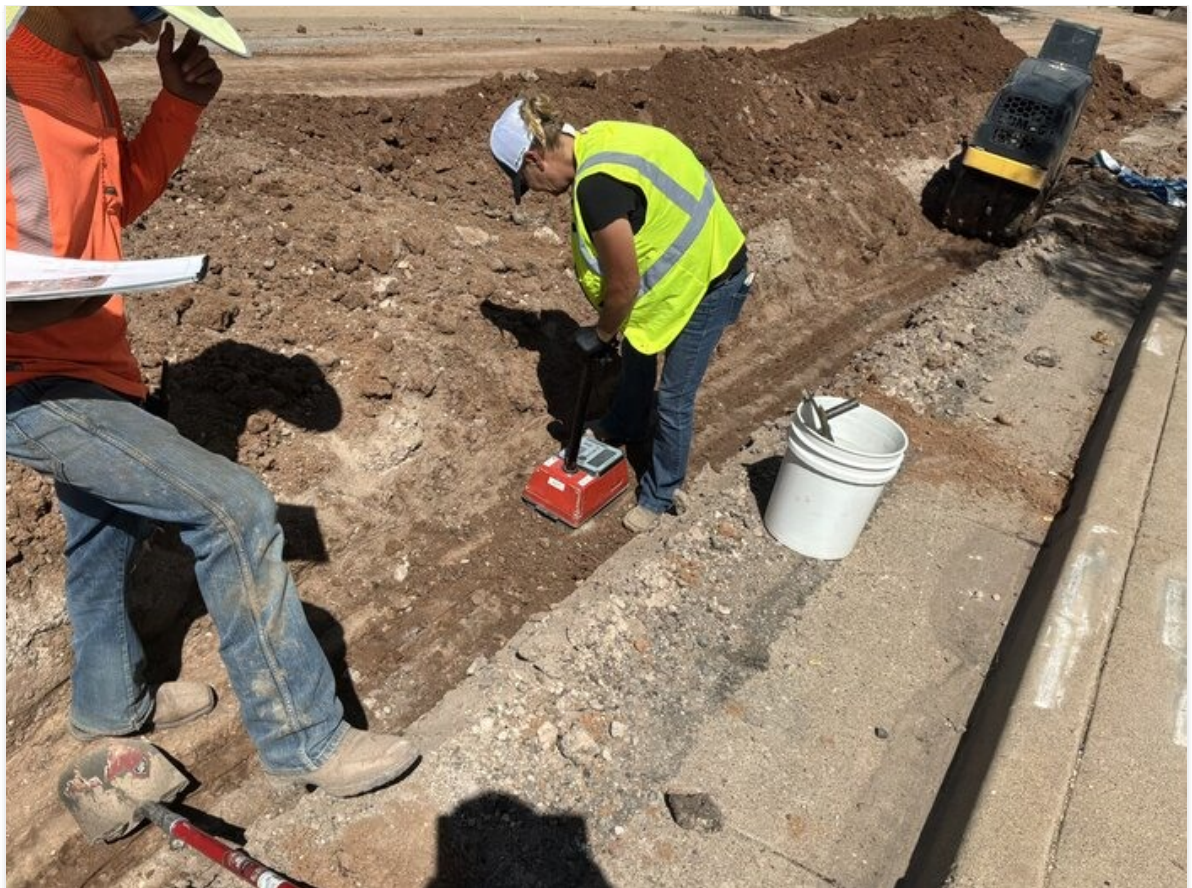
The contractor continued placing 6" C-900 on Chrysocolla Ave as per plan. 45 DI bends were needed at sta. 18+09 to sta. 18+24 to go under shallow existing water line. Survey as-build was taken on all fitting. Summit testing was called onsite to take backfill densities. All tests taken passed.

*Summit Testing taking backfill densities.*

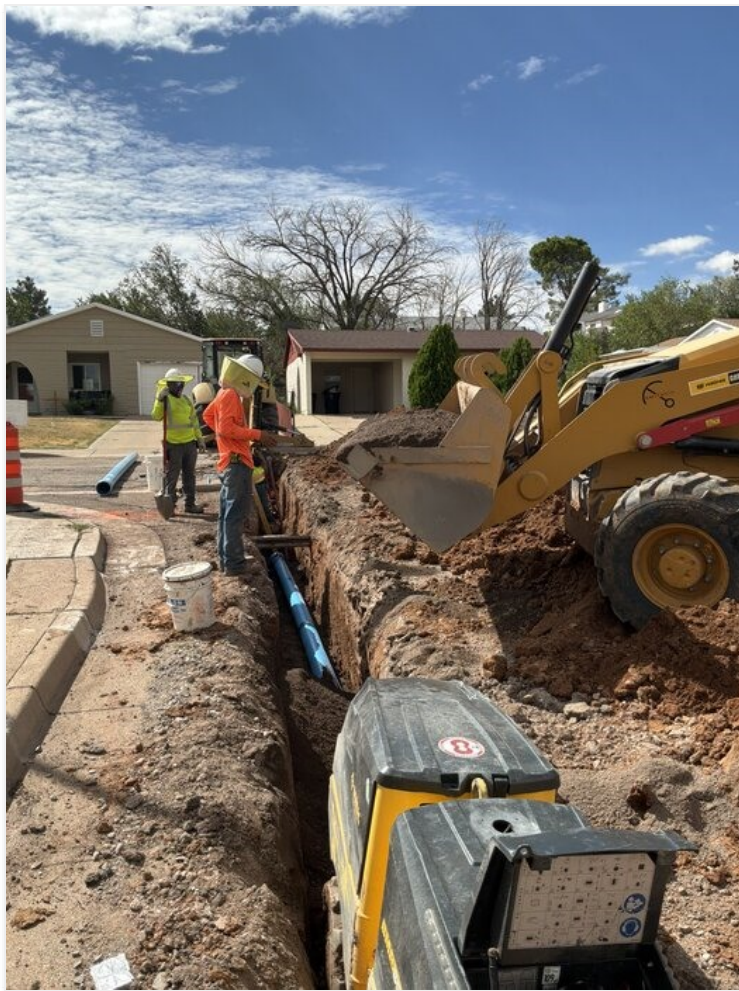
*Placing backfill over 6" C-900 on Chrysocolla Ave.*

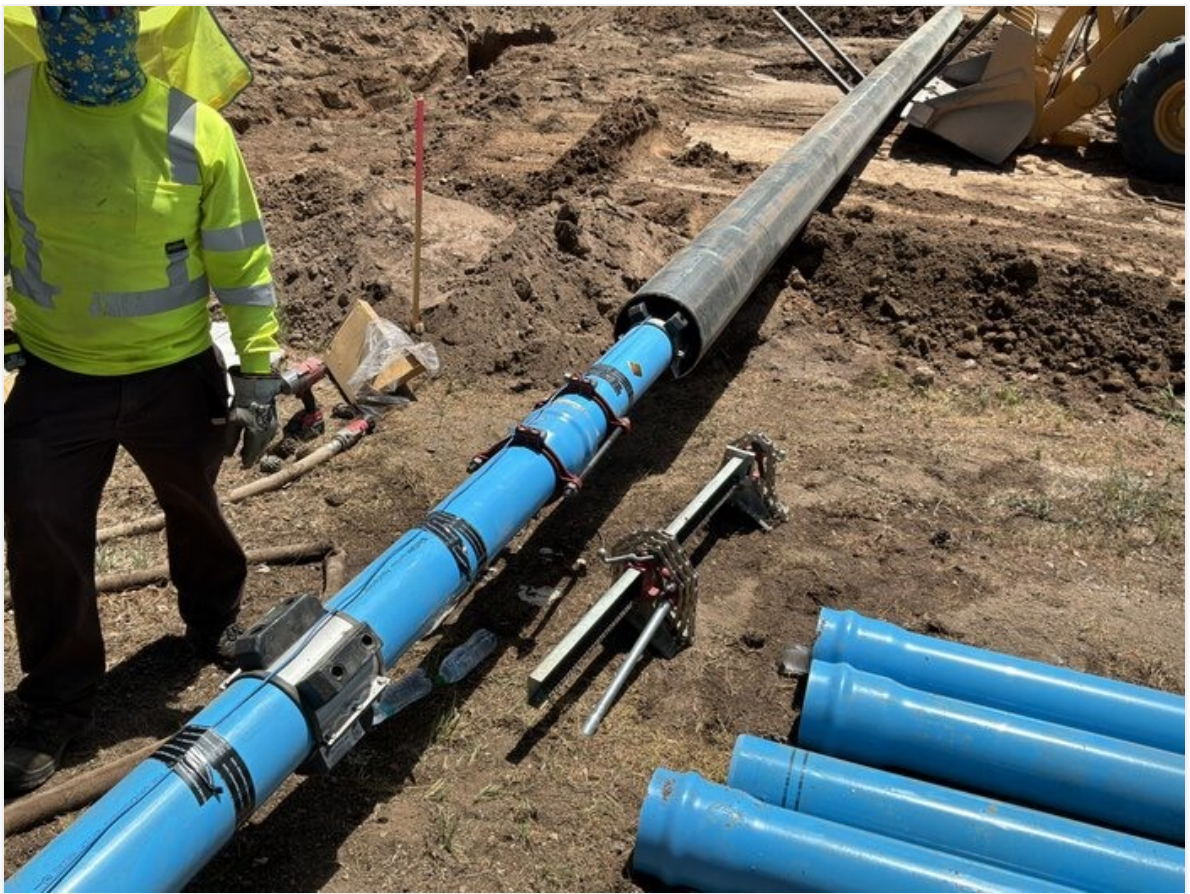
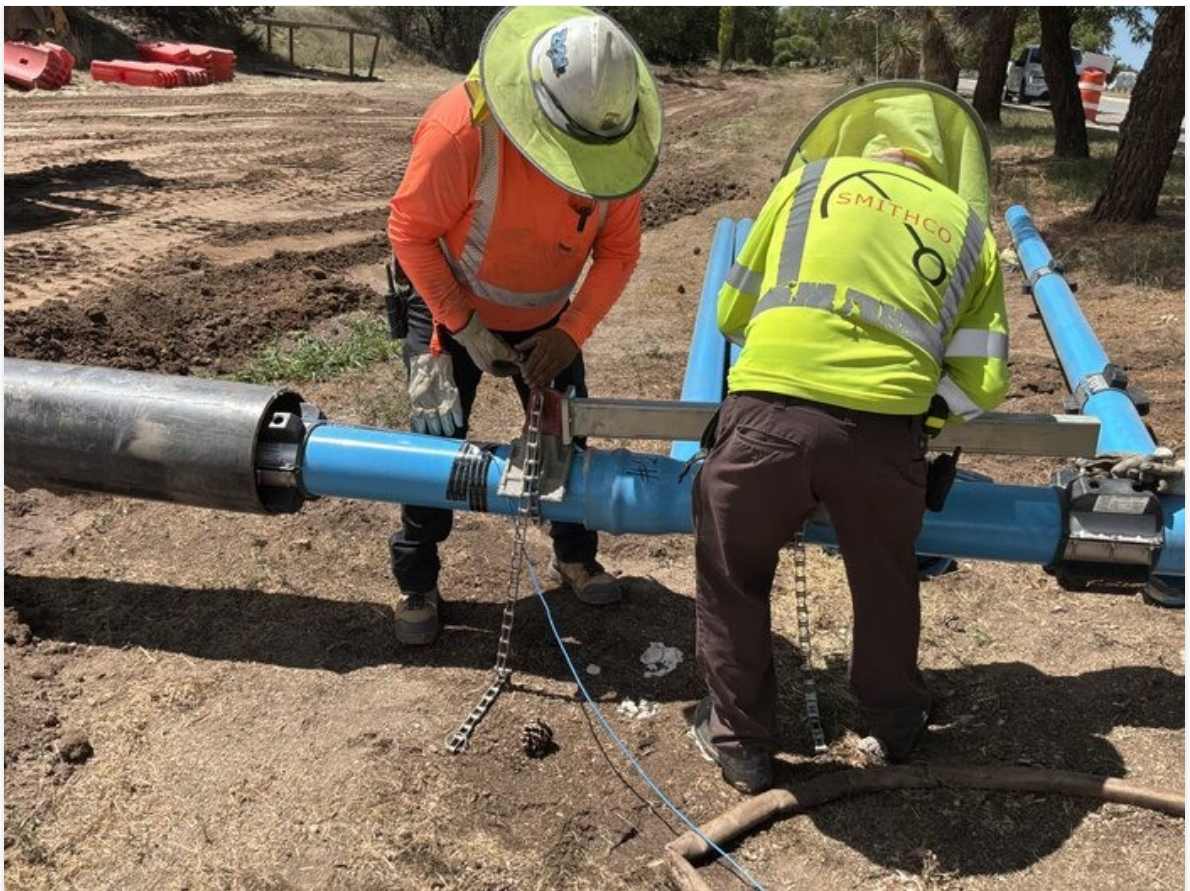
*Pushing 6" C-900 together with tool.*

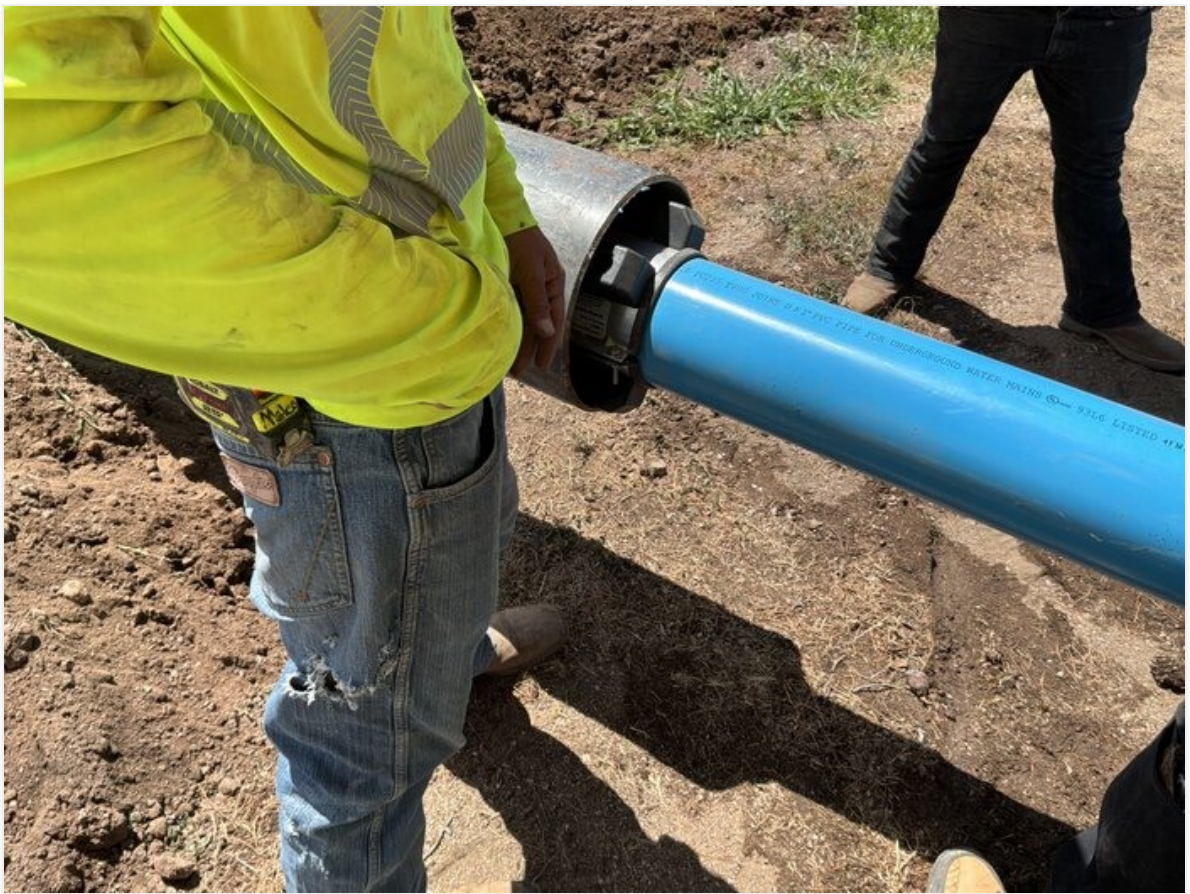
The contractor Began exacting for the 12” steel casing for the arroyo next to Malachite Ave. The contractor placed all DI 45 bends as per plan and placed casing spacers around the 6” C-900. The casing was placed and casing end seals were used at each end of the 42’ steel casing. The casing was backfilled and compacted over it.

*6" C-900 being pushed into 12" steel casing.*

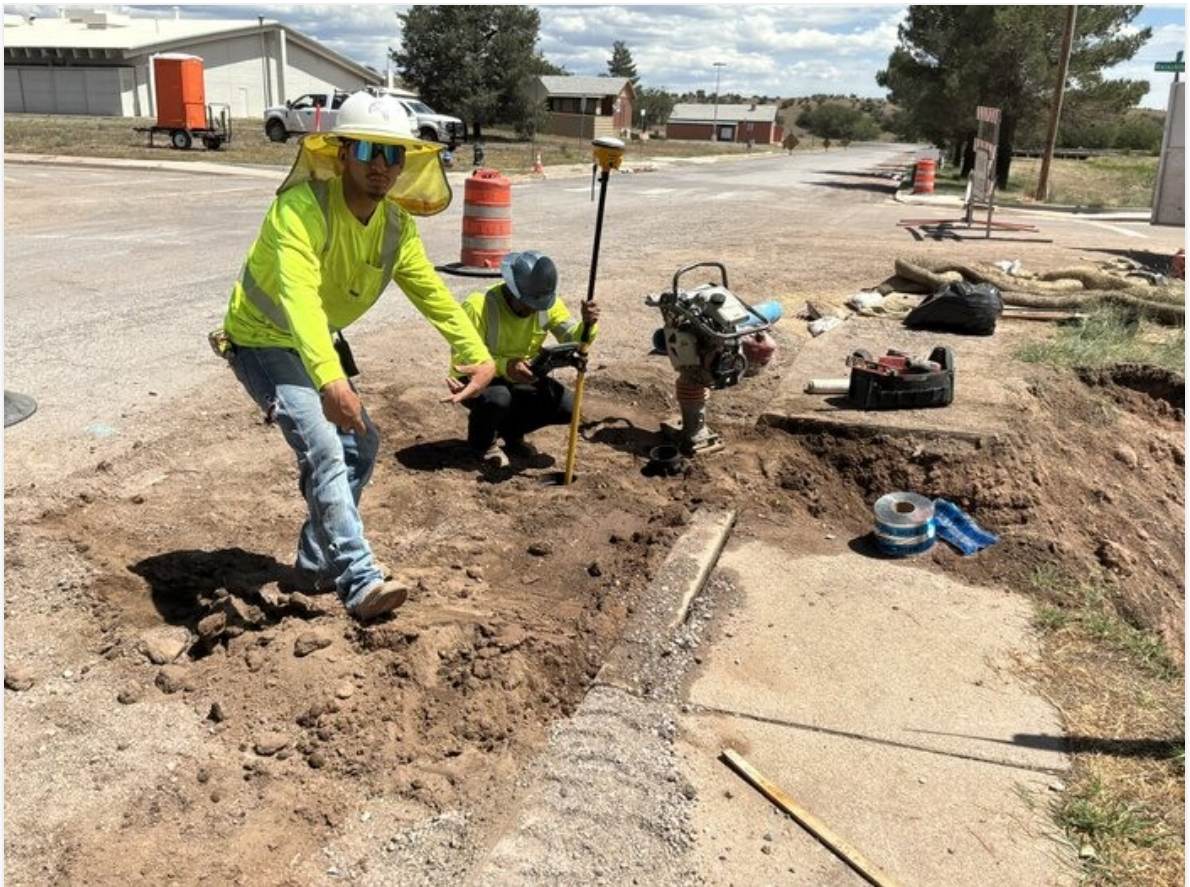
*Survey as-built shot on DI fittings.*

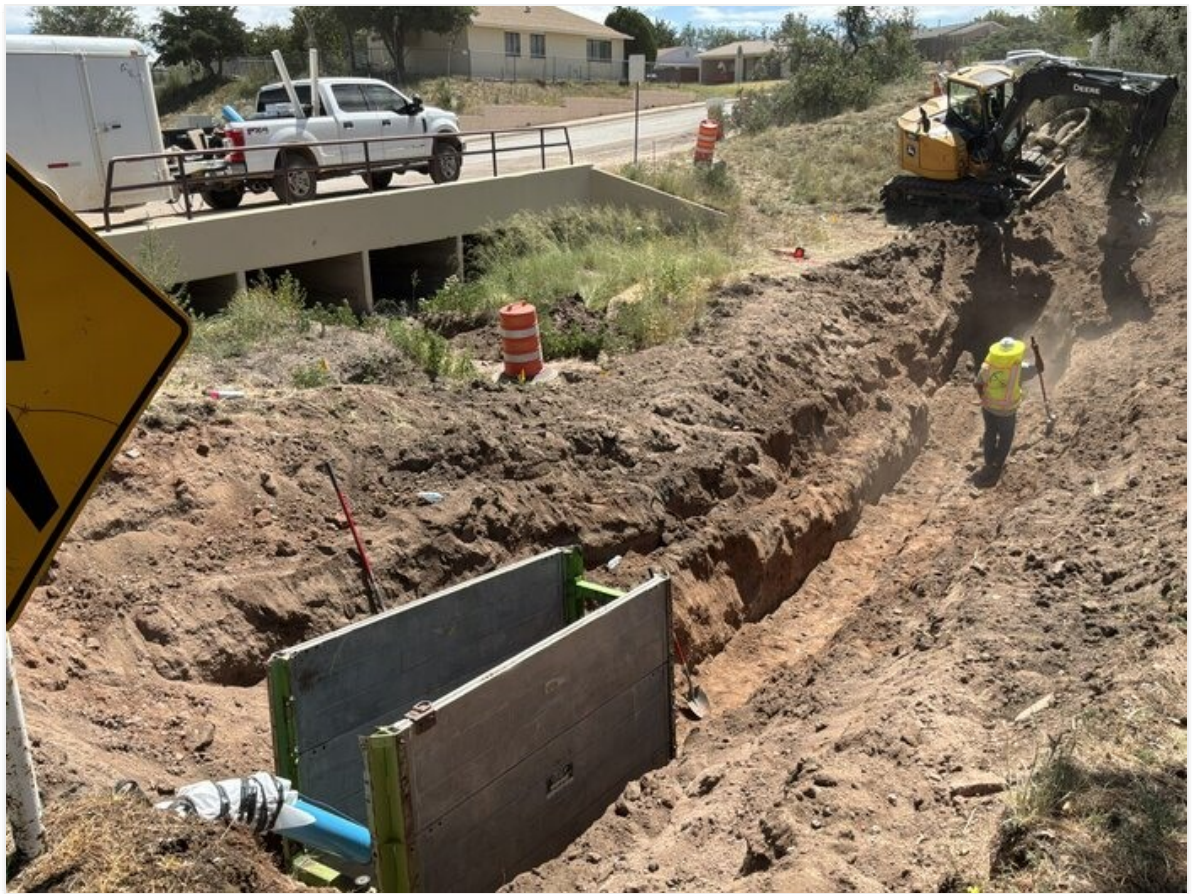
*Excavation for 12" steel casing with trench box.*

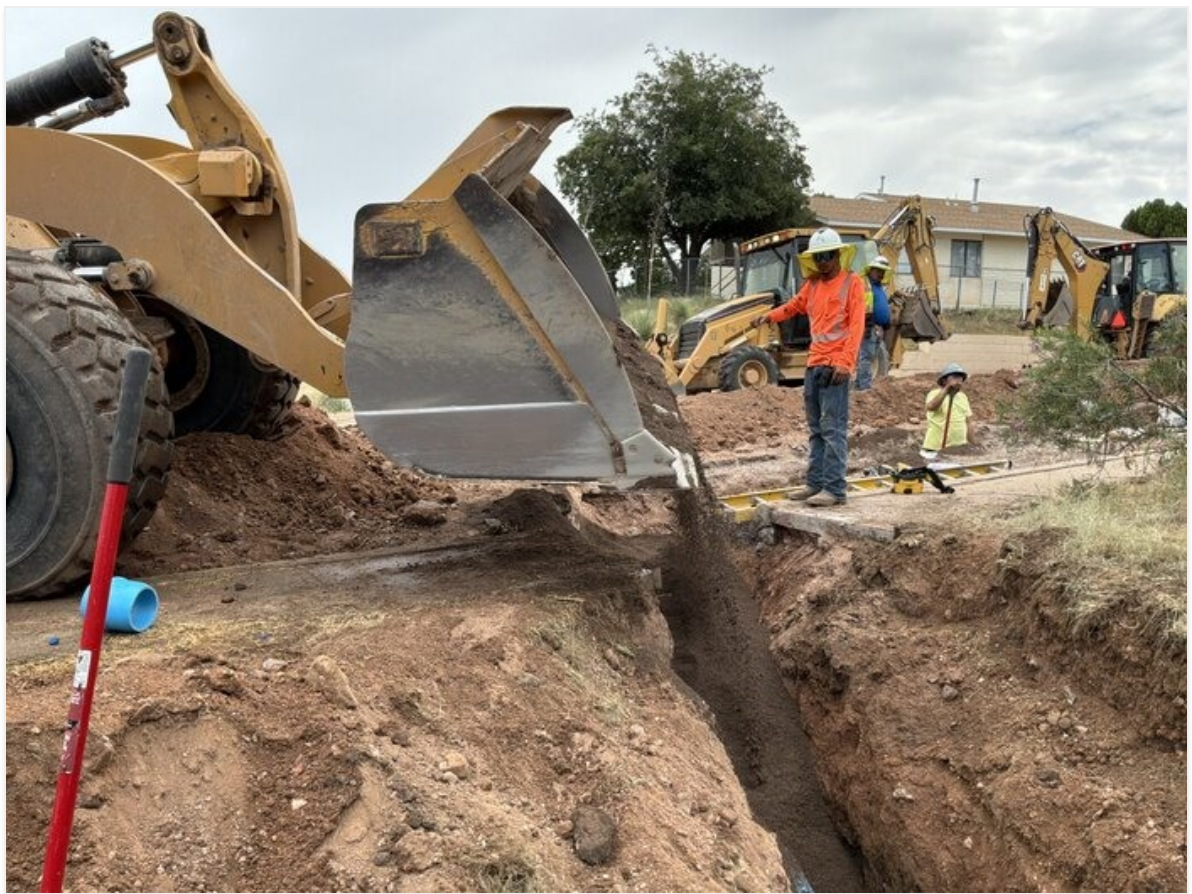
*Pipe bedding being placed into trench.*

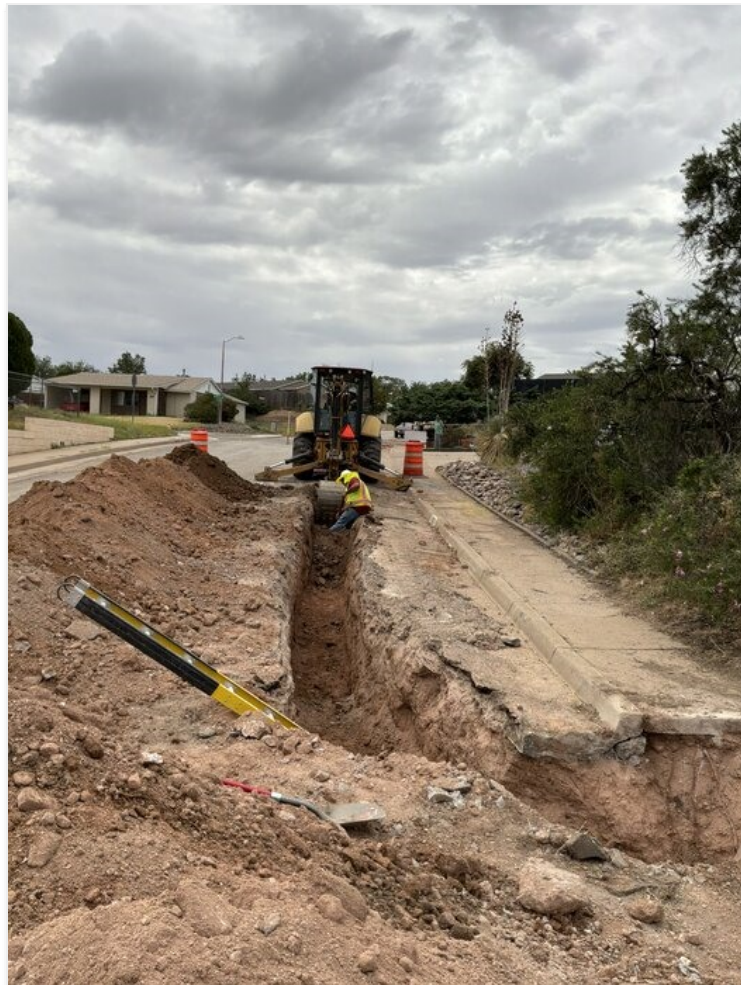
*Excavating for 6" C-900 placement on Malachite Ave.*

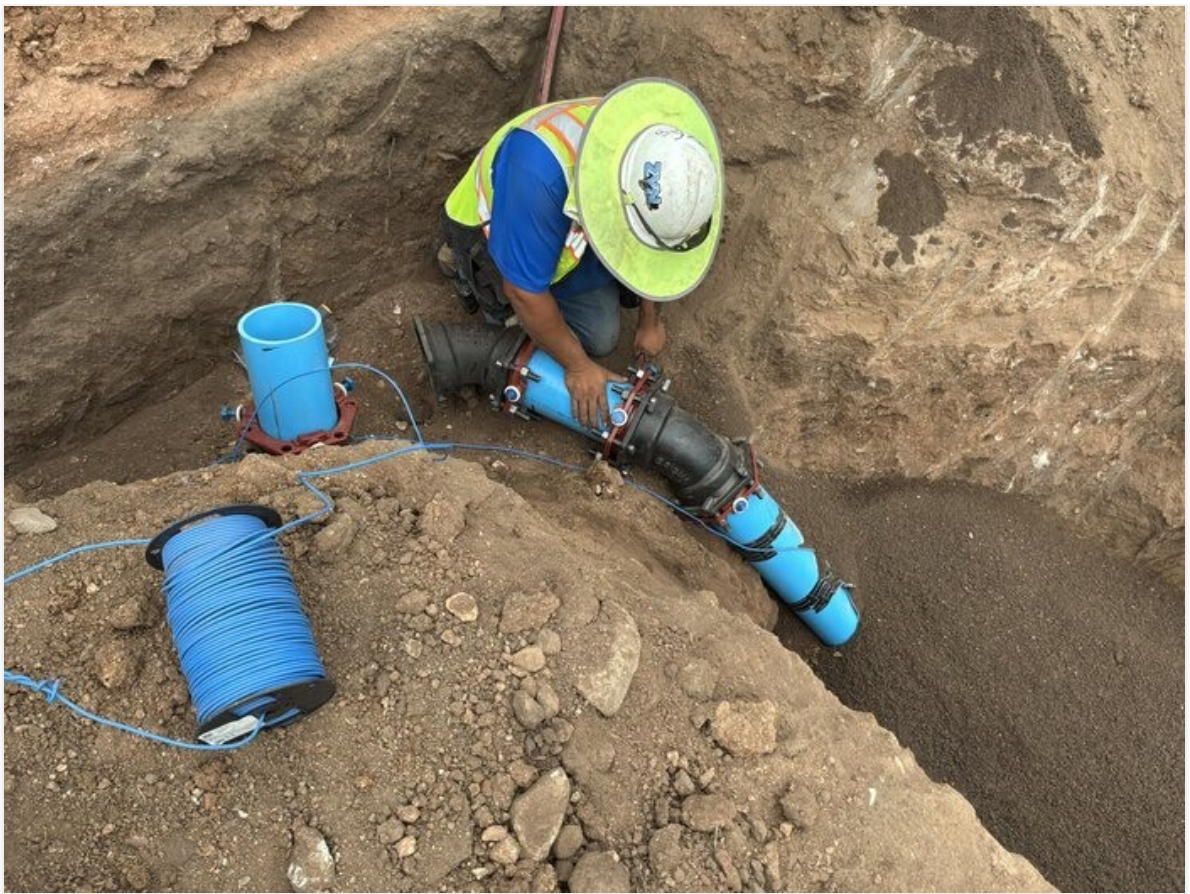
*45 DI fittings coming out of the arroyo next to Malachite aAve.*

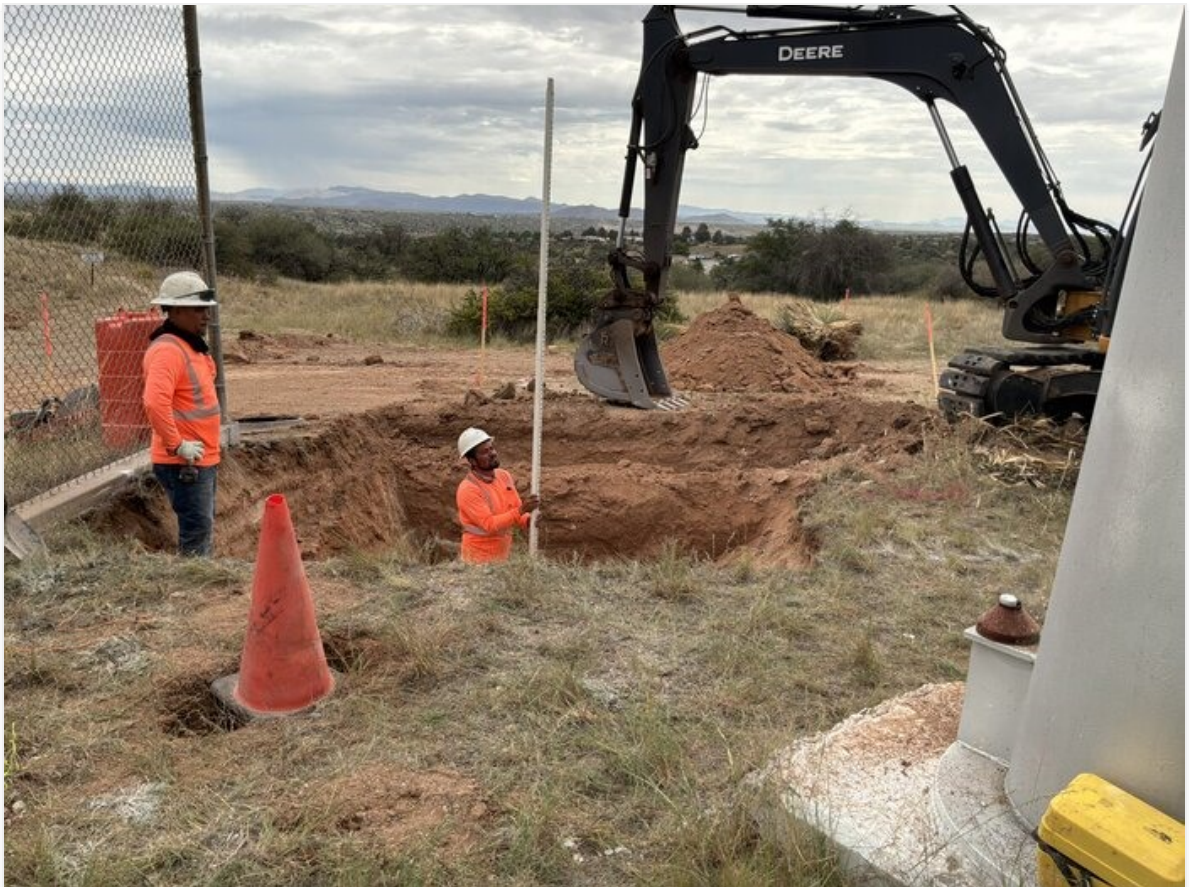
*Checking depth for the valve vault pit at the tank site.*

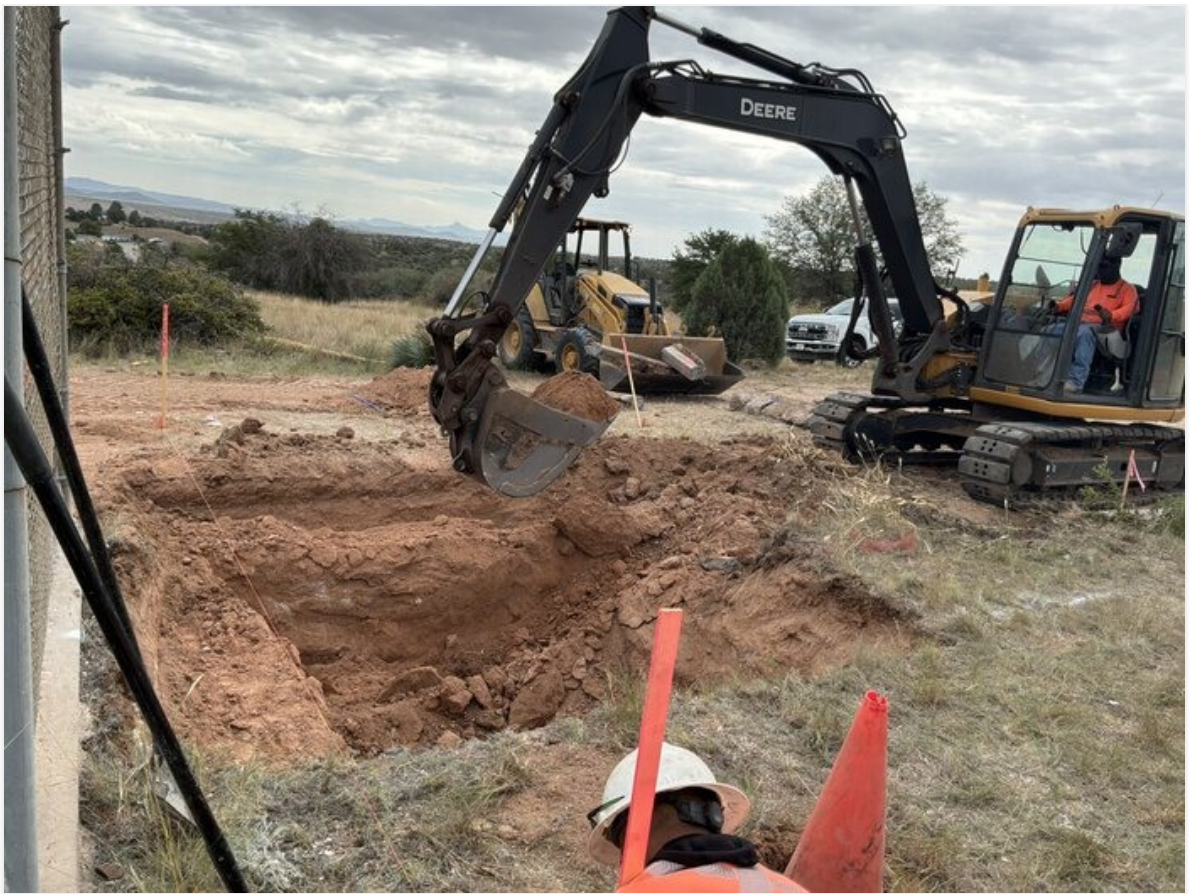
*Excavation for the valve vault pit.*
