| <b>DATE:</b> | 7/13/2026 - 7/16/2026 |
| <b>REPORT NUMBER:</b> | 10 |
| <b>PROJECT NUMBER:</b> | 20260236 |
| <b>PROJECT:</b> | Tyrone Water System Improvements Construction |

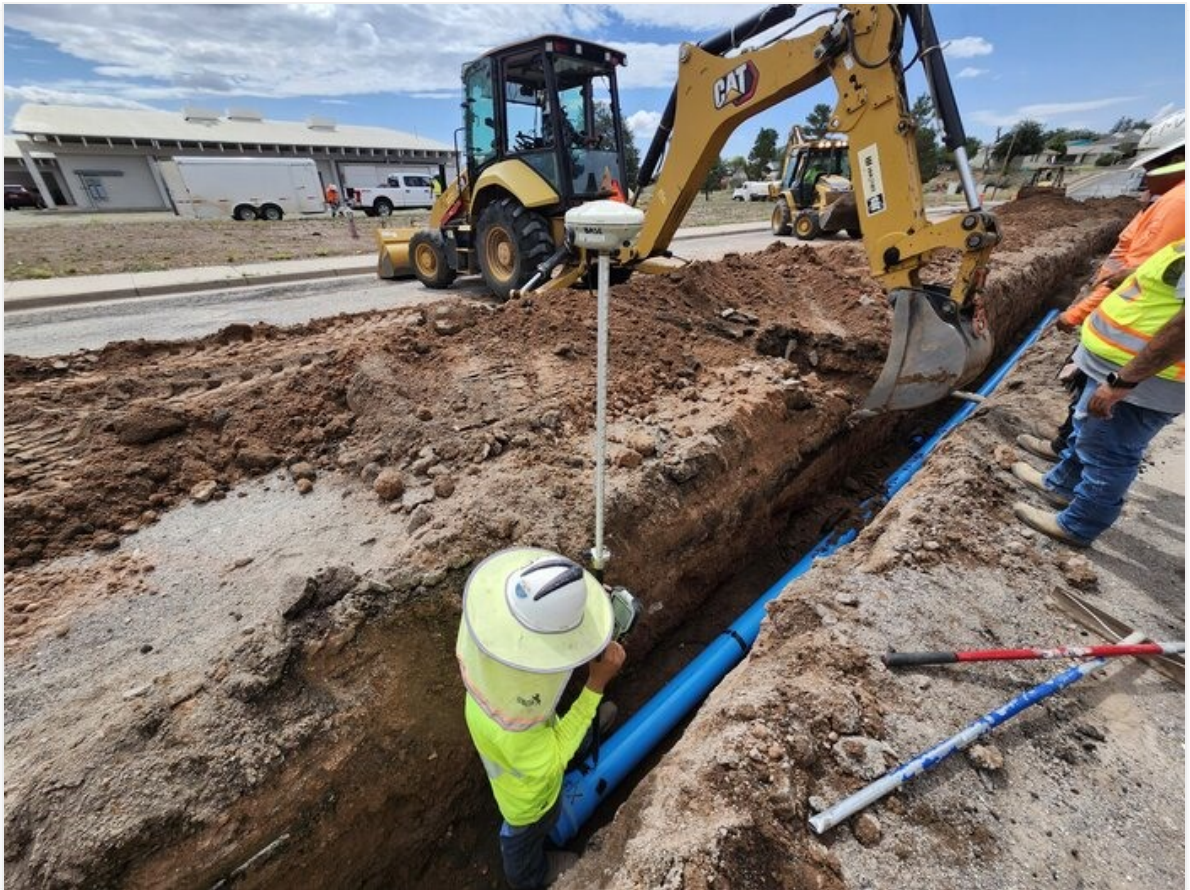
*As-built survey taken on top of pipe. 6" Malachite Ave.*

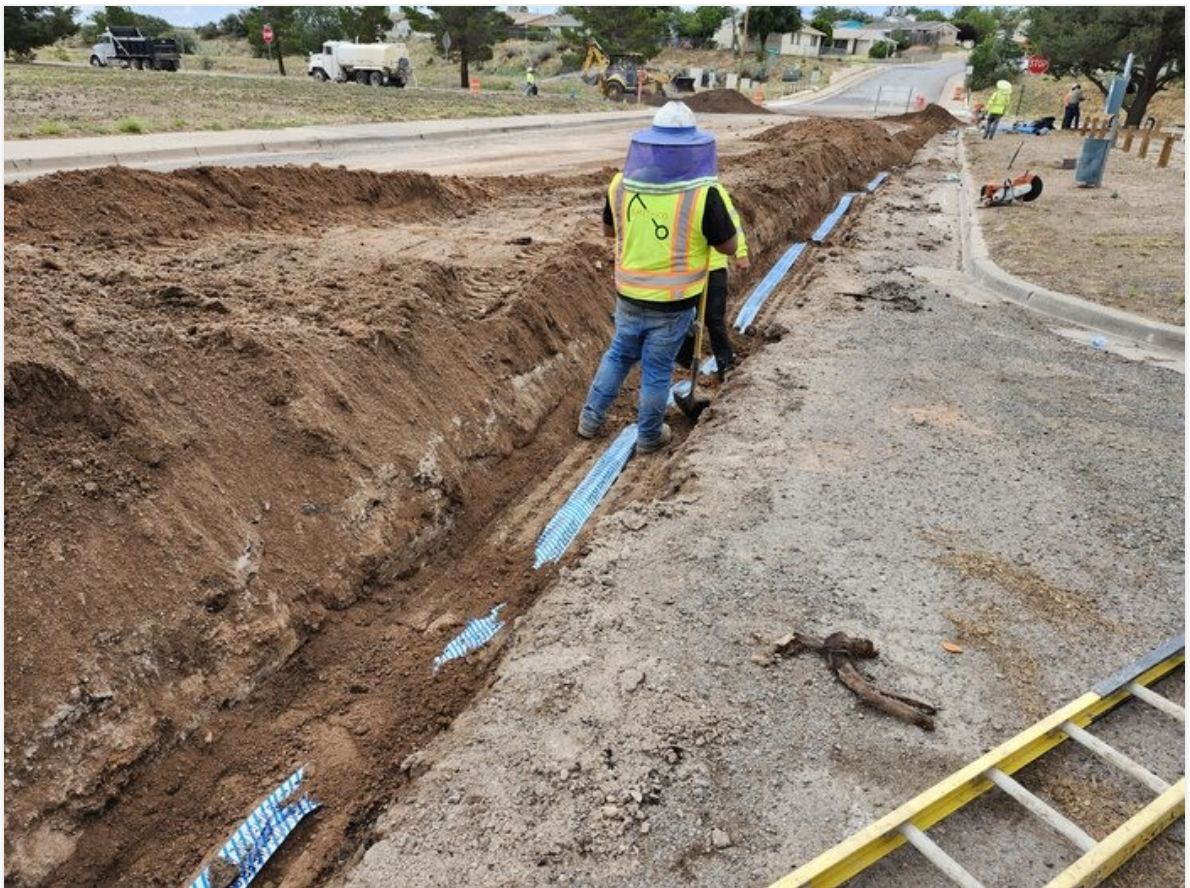
*Caution tape being placed over 6" C-900 on Malachite Ave.*

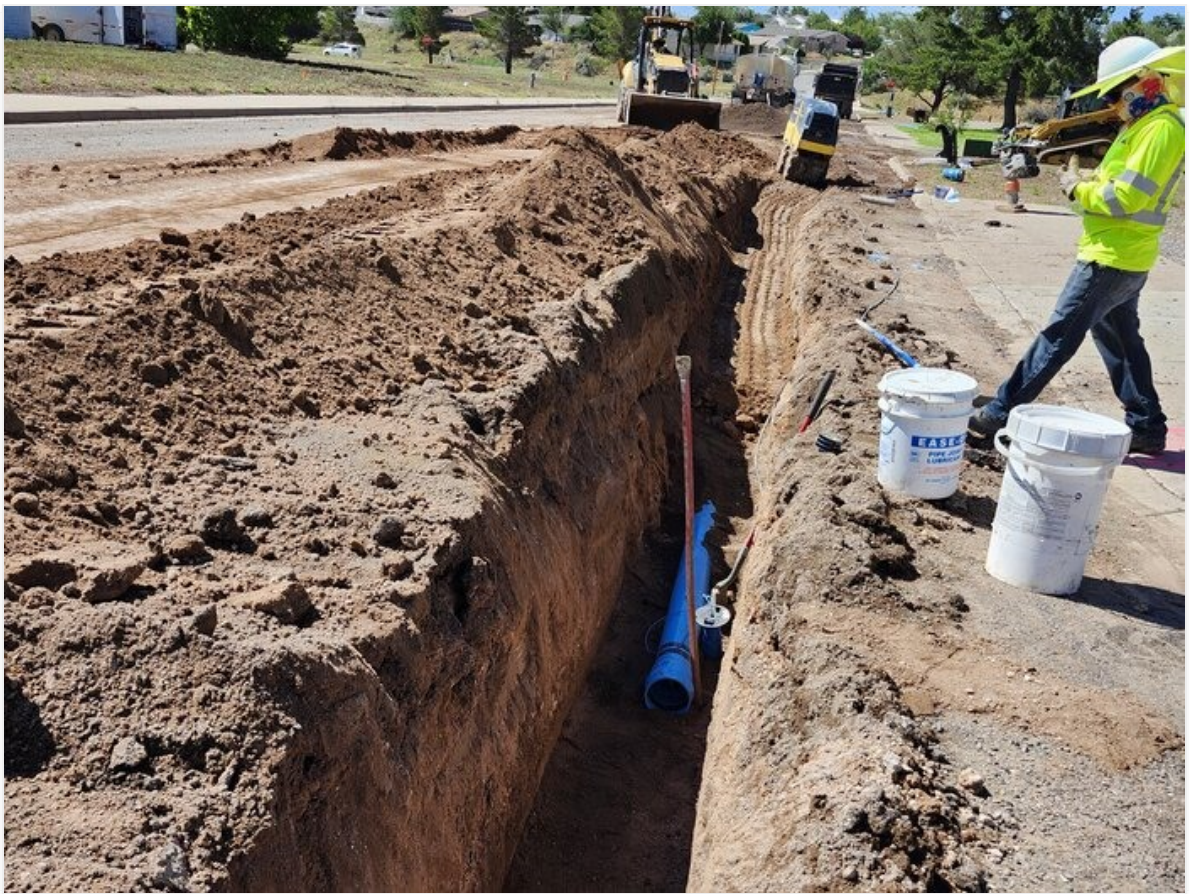
*6" C-900 operations on Malachite Ave.*

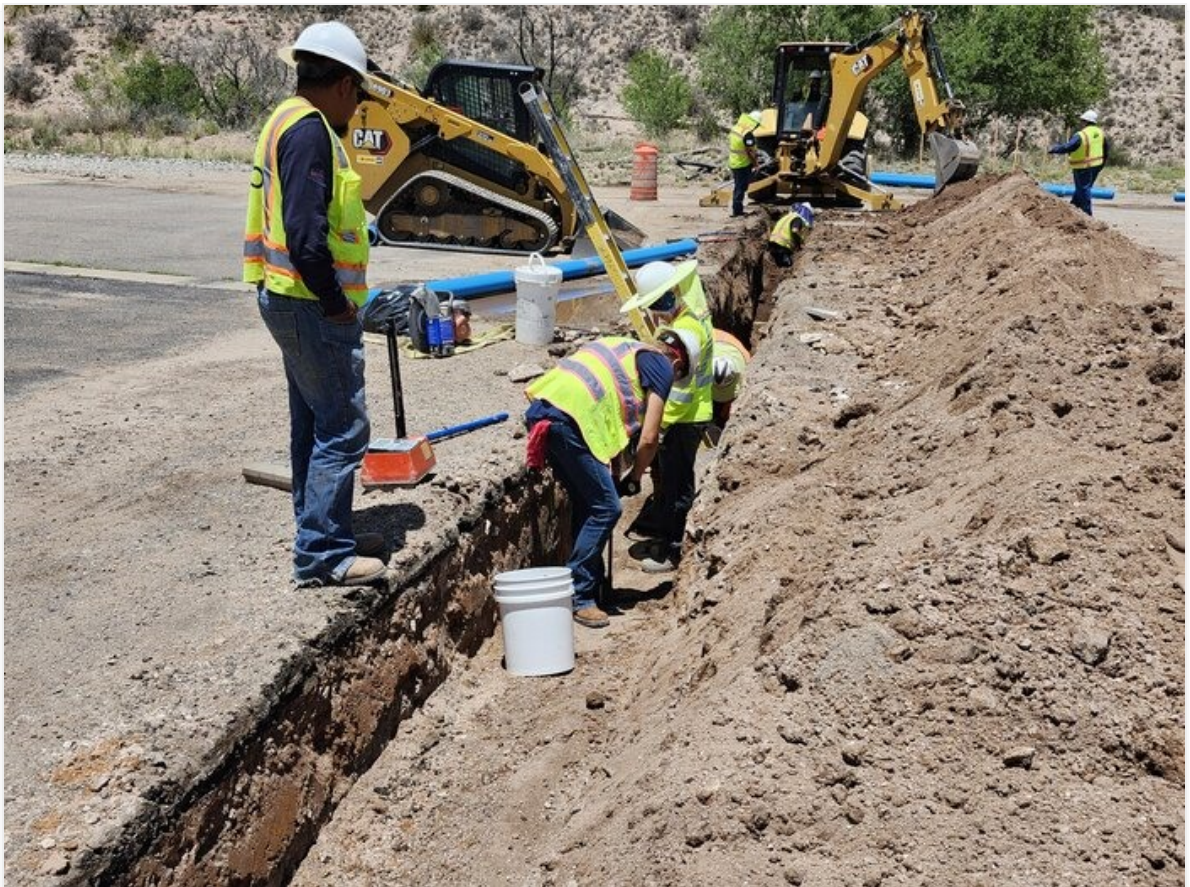
*Summit Testing taking densities on backfill over 6" C-900 on Malachite Ave.*

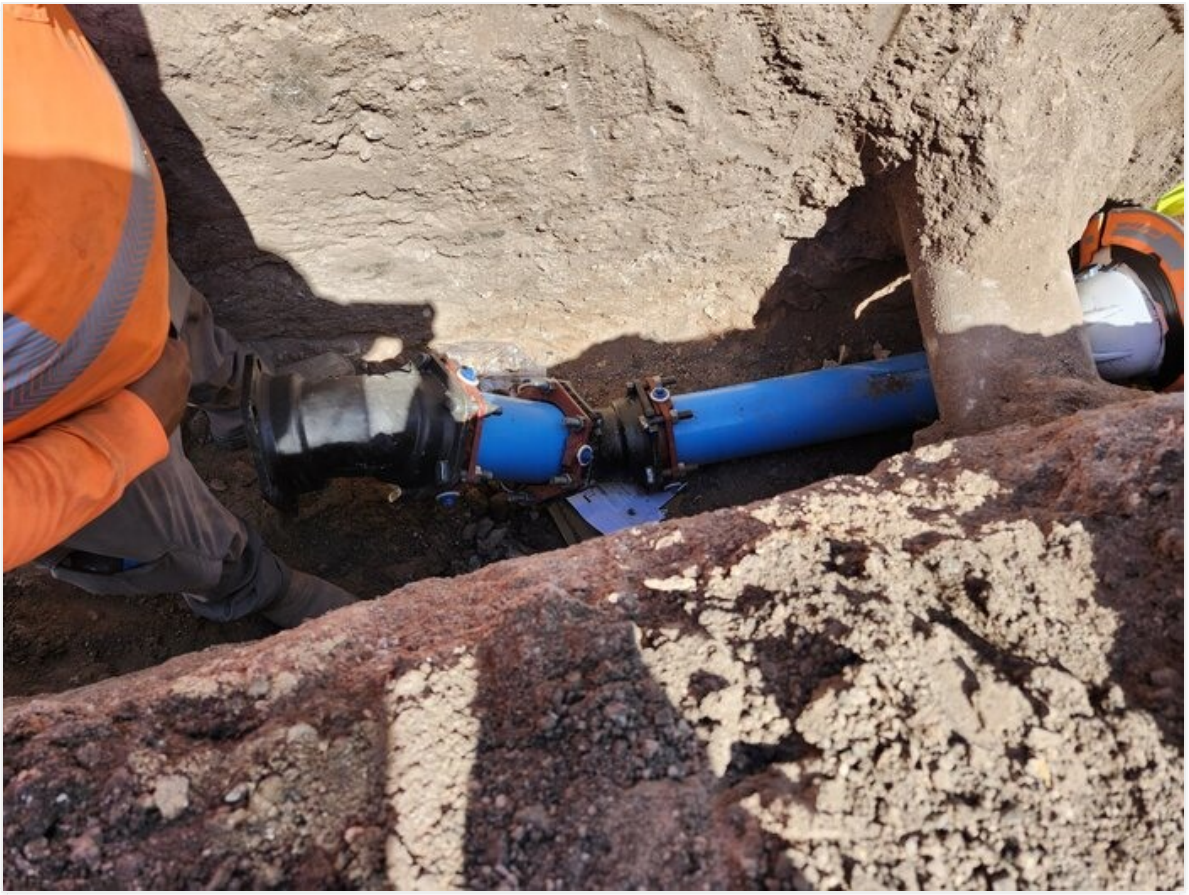
The contractor continued placing 6" C-900 on Malachite Ave as per plan. DI 45 bends were placed to go under the existing water line at sta. 10+33 to sta. 10+50. Potholing was done ahead of the excavation for verification of existing utilities.

*DI 45 bends under existing water line on Malachite Ave.*

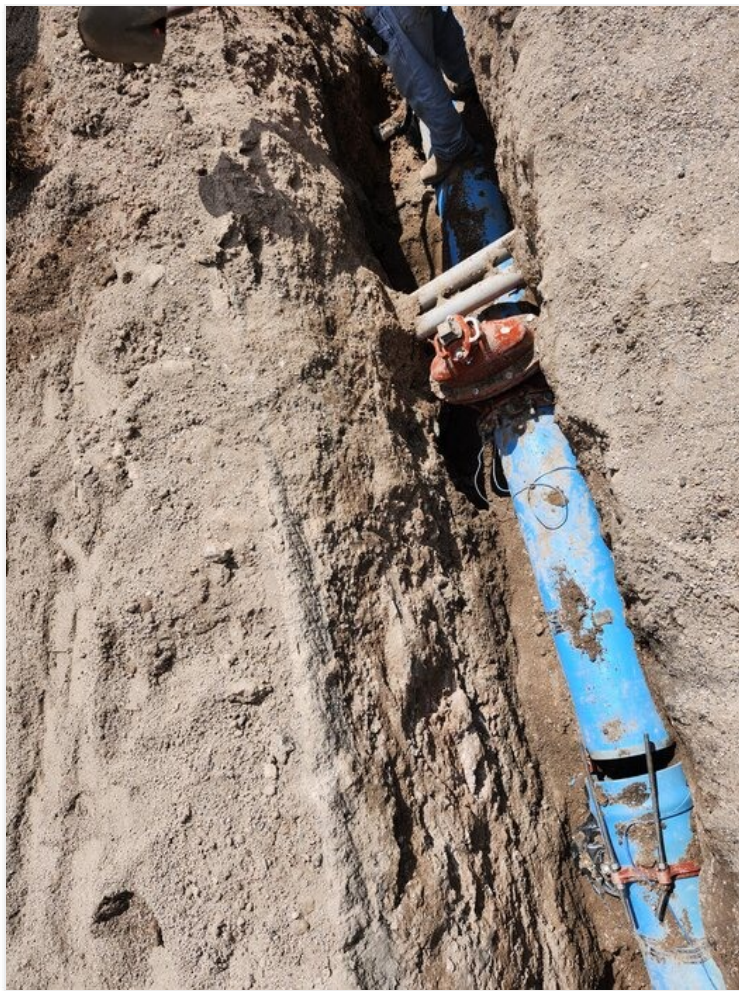
*Removing installed GV, 2" saddle and cap as per RFI #14 on Copper Dr. tie-in.*

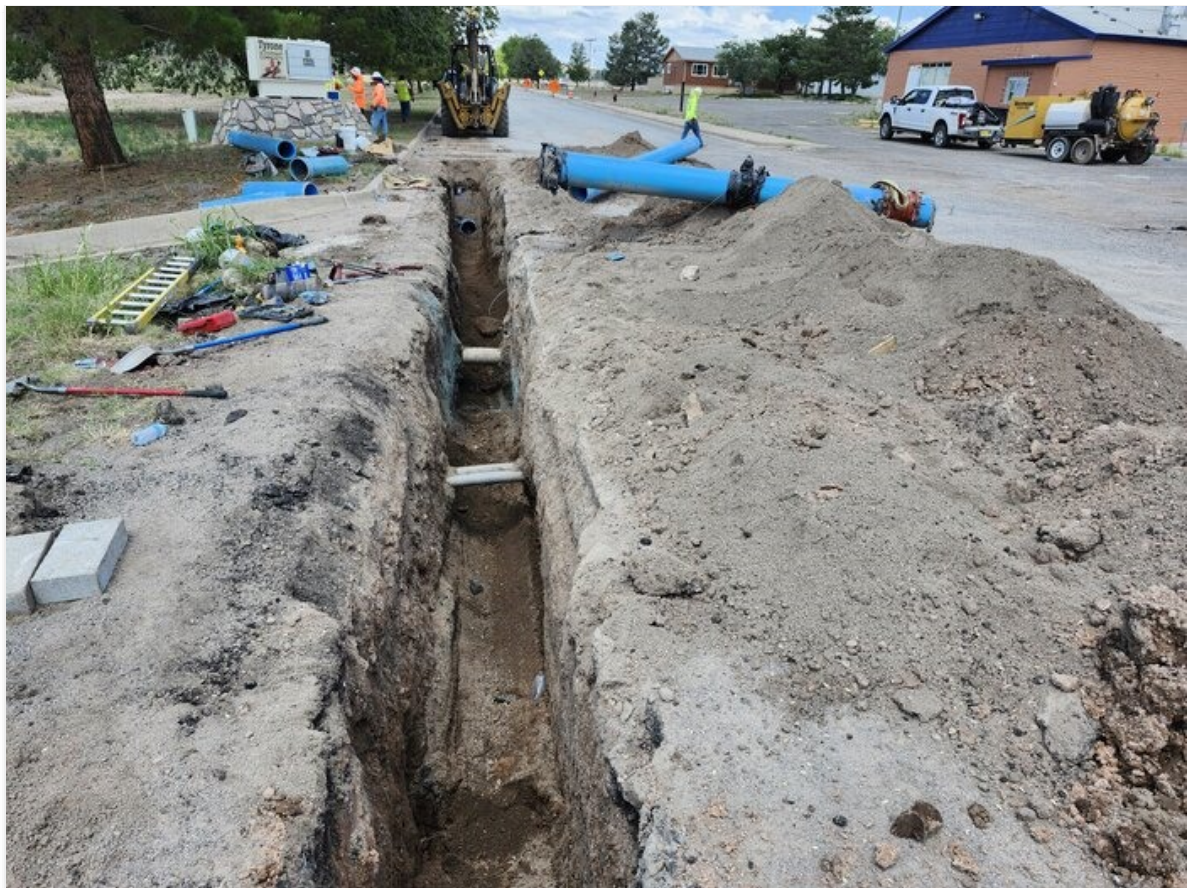
*Removed 12" C-900 on Copper Dr. tie-in as per RFI #14.*

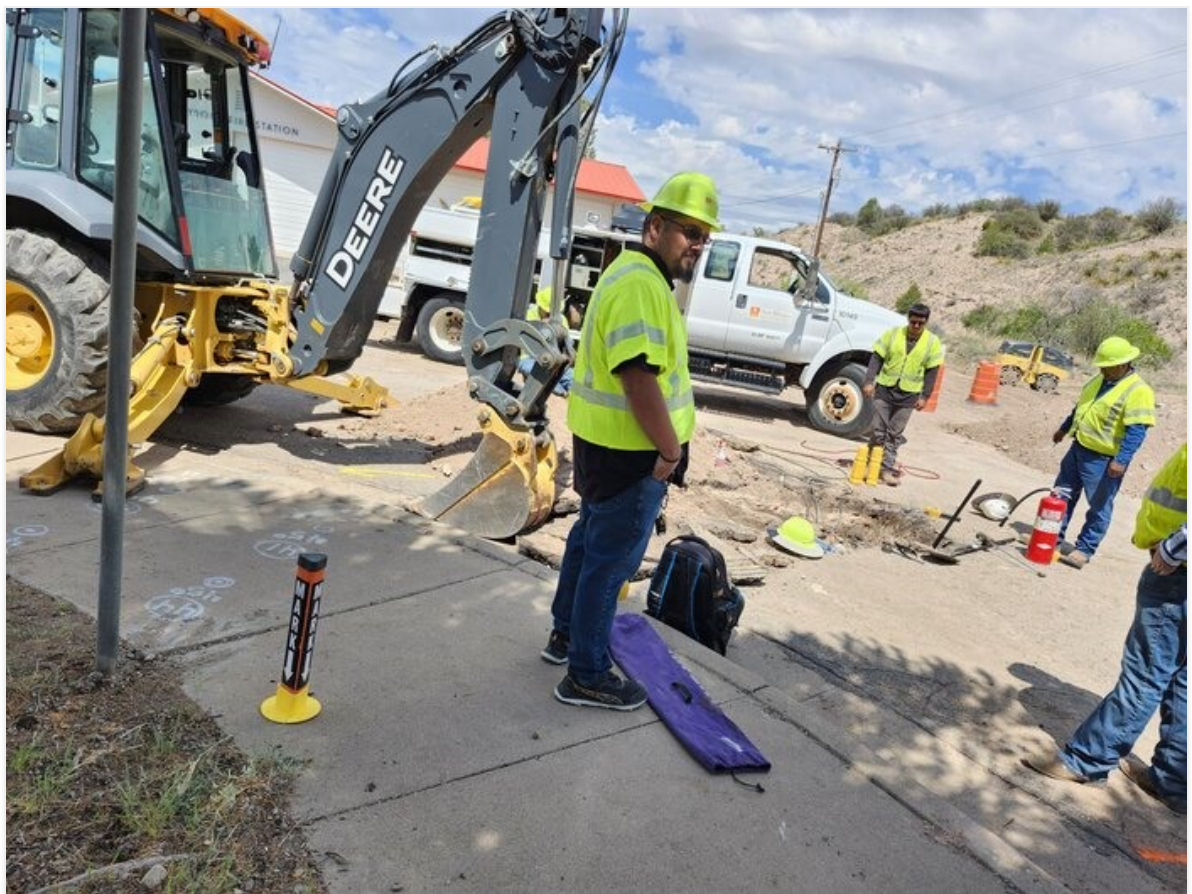
The contractor continued to place 6" C-900 on Malachite Ave as per plan. During excavation an unmarked 2" gas line was hit at approx. sta. 10+20. NM Gas and emergency personnel was called. The line was hit at 8:00AM and NM Gas had it repaired by 1:20 PM. During gas repair, Smithco moved to work on removing and replacing the already installed 12" C-900, GV and 2" saddle as per RFI #14.

*NM Gas making 2" gas repair on Malachite Ave.*

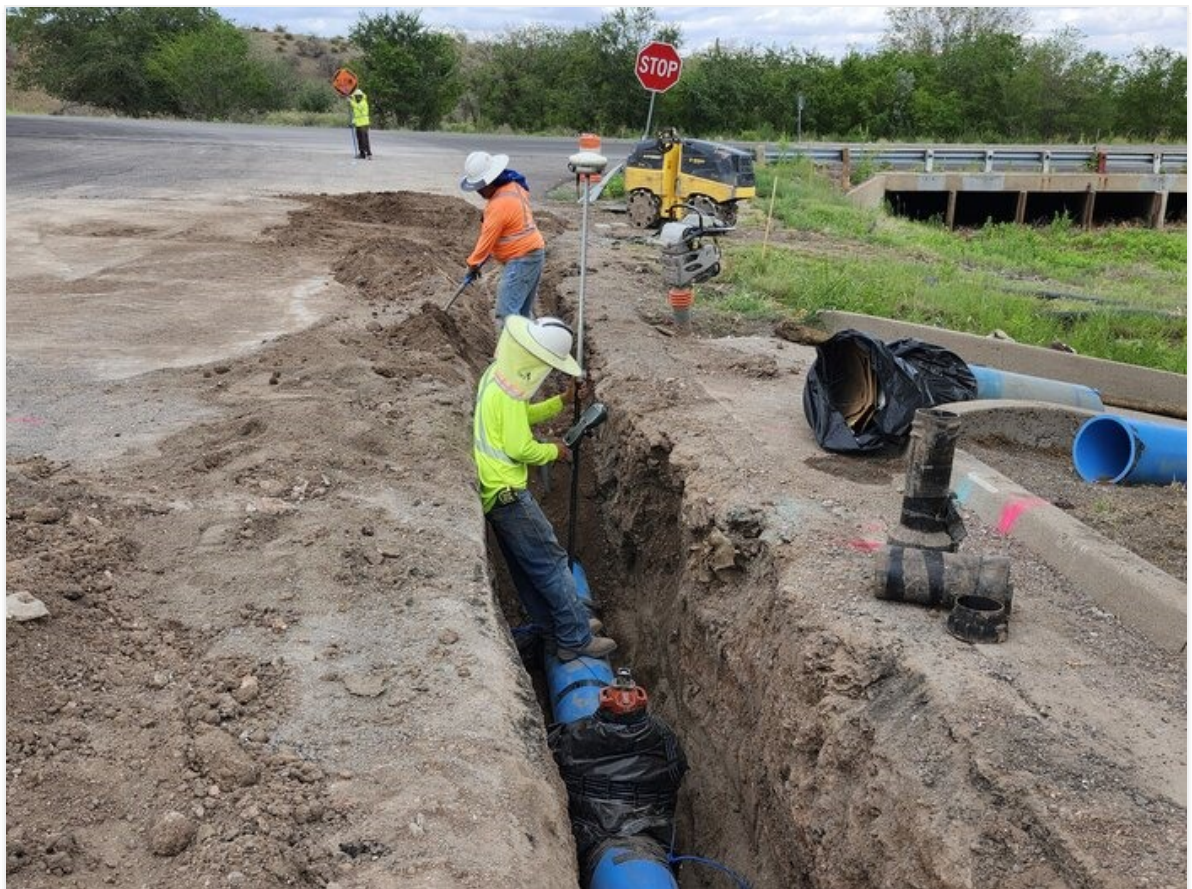
*Survey as-built on replaced fittings for tie-in on Copper Dr. as per RFI #14*

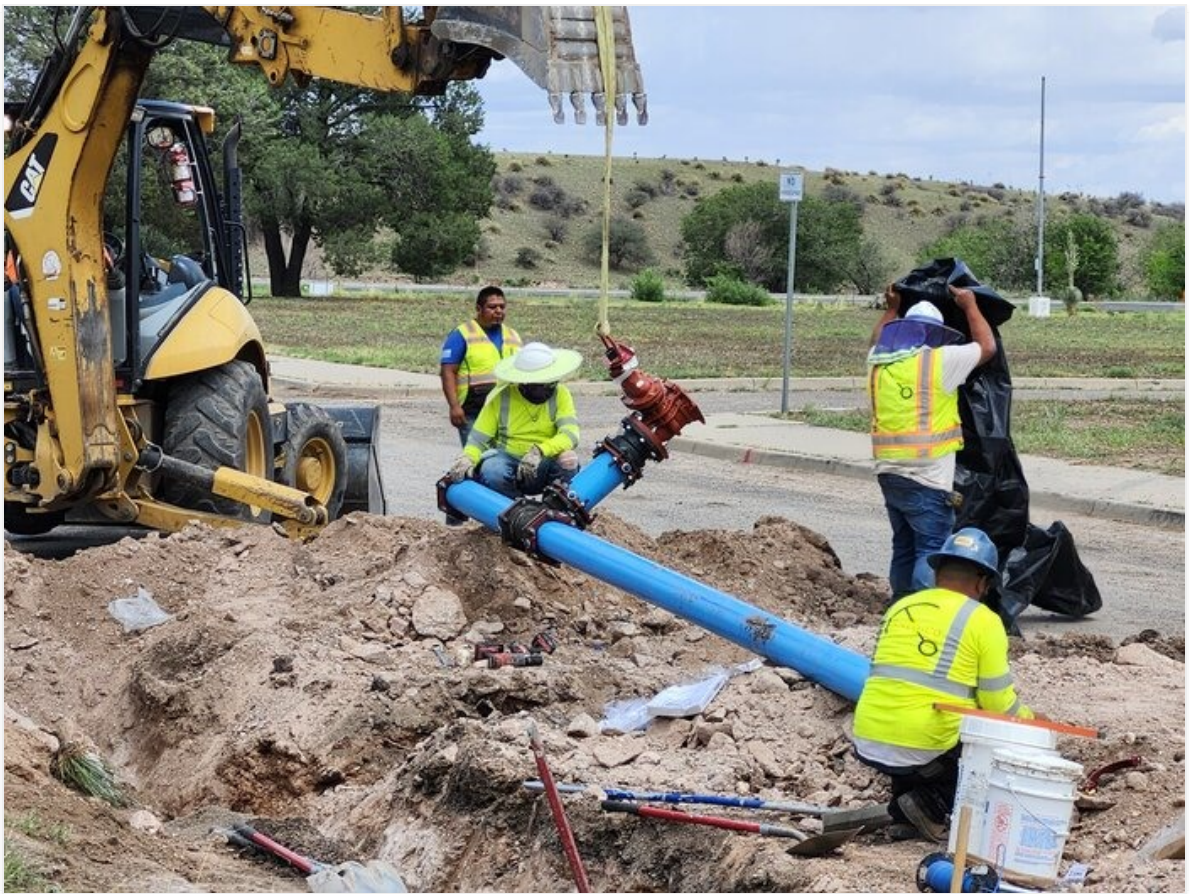
*Connecting fittings on Turquoise Dr.*

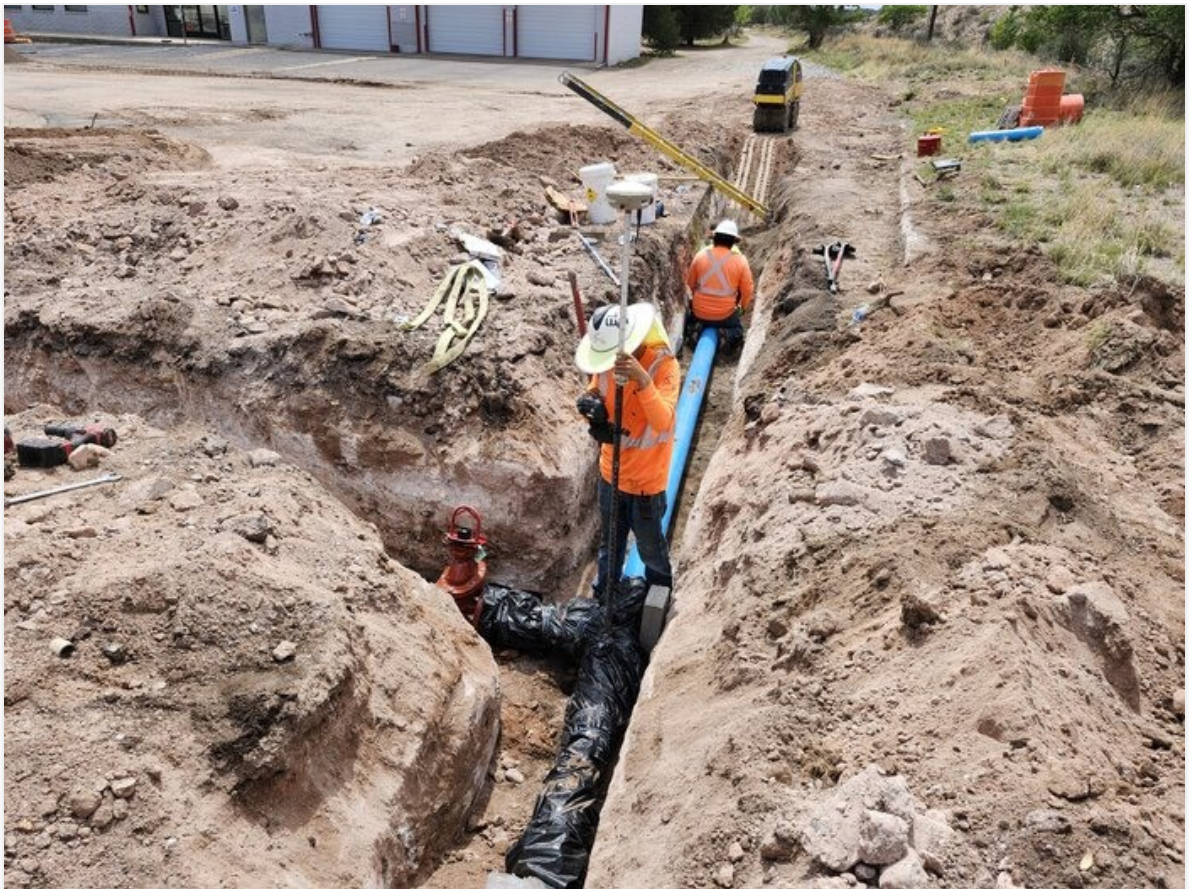
*As-built survey on fittings for Turquoise Dr.*

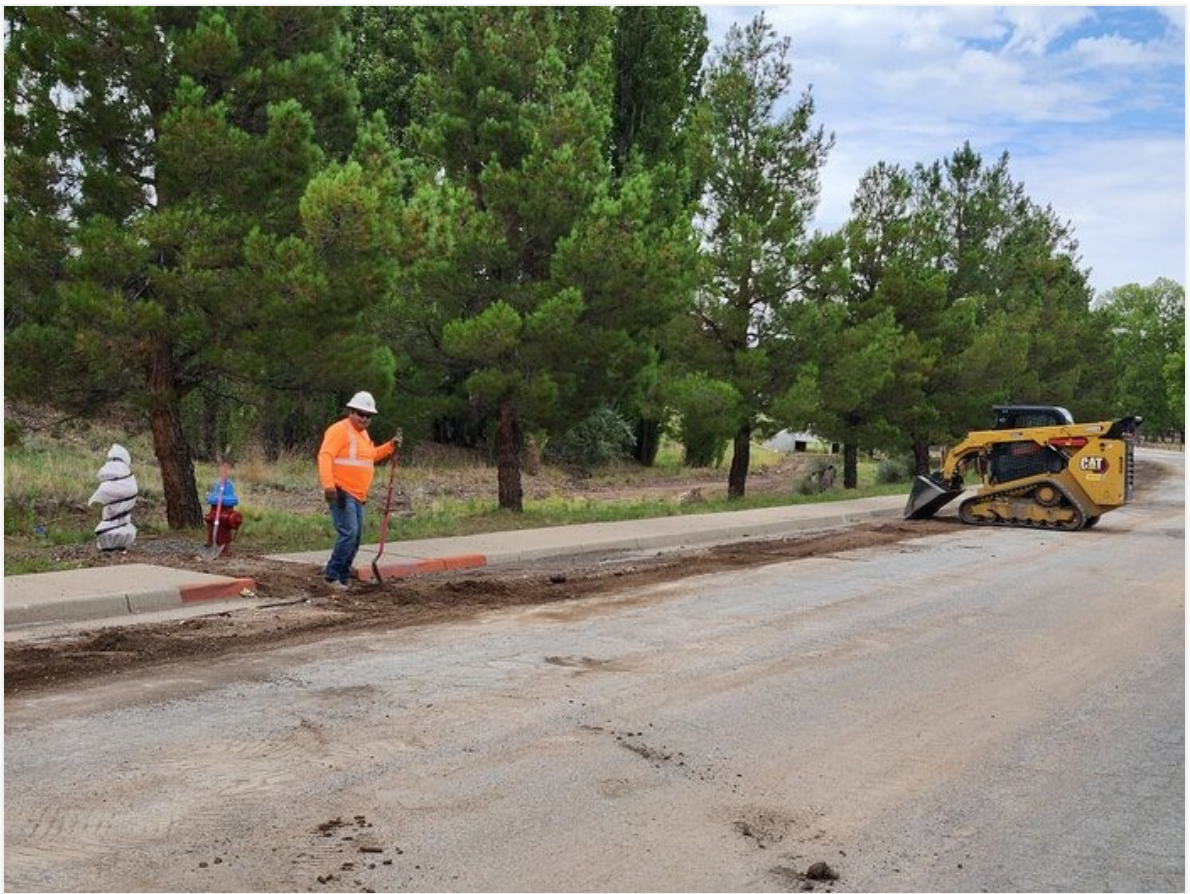
*Contractor maintaining shoulder damage caused by rains.*

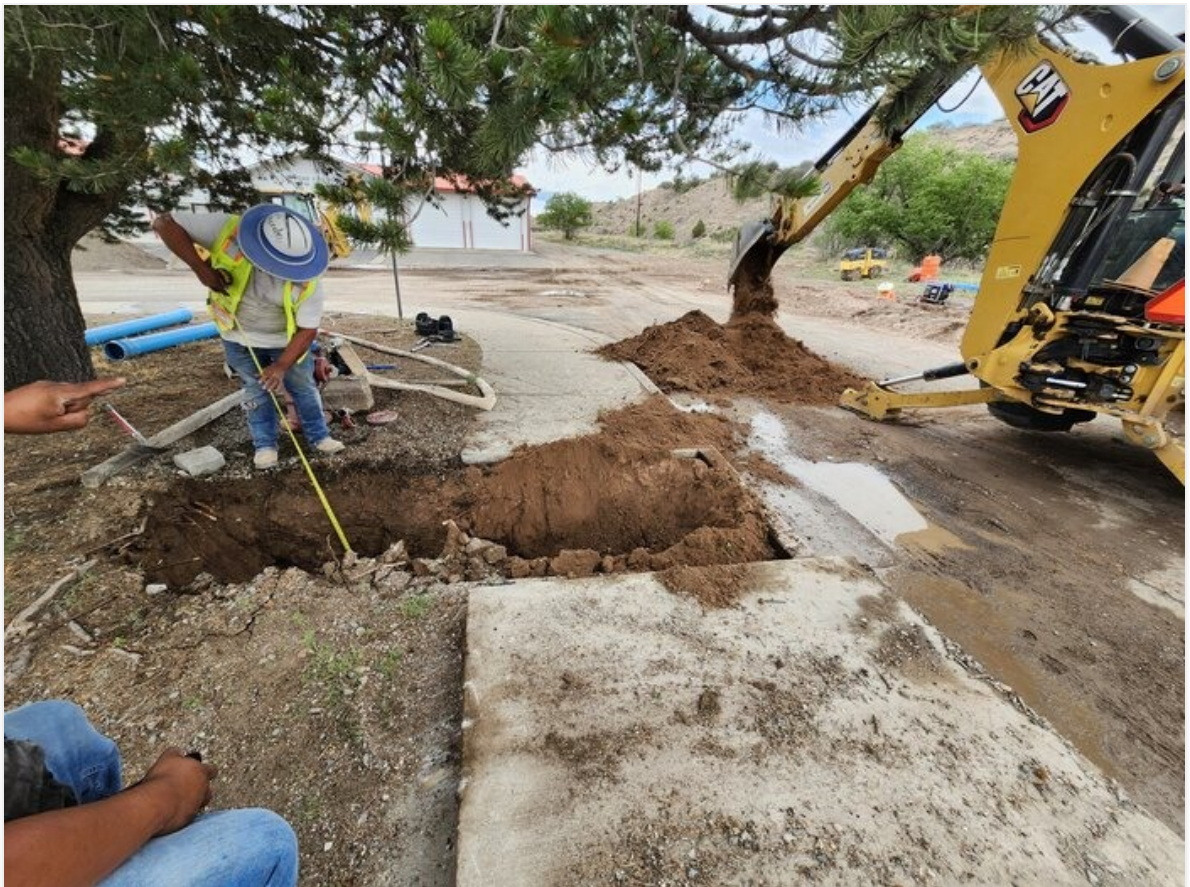
*Hydrant #1 excavation on Turquoise Dr.*

The contractor began placing 6" C-900 on Turquoise Dr as per plan. Smithco will be moving hydrant #1 at sta. 10+79, 3' east as per hydrant plan. Hydrant will be installed as per plan detail. The contractor will stop and cap the 6" C-900 5' past the hydrant as per field order #1.
