# **200KG Reservoir**

## **Tyrone Townsite**

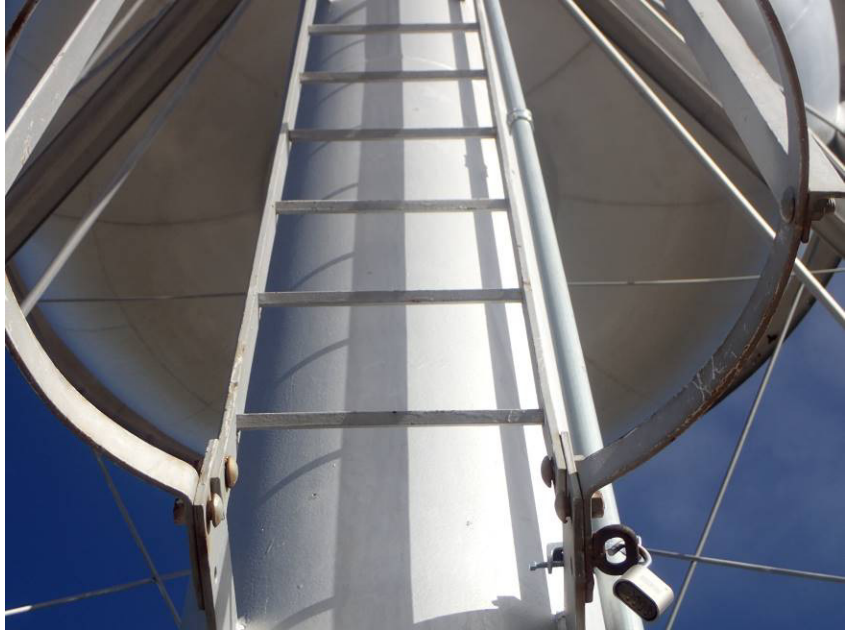
**Description:**  
Exterior Lower Ladder appeared to be in good condition with a minor amount of corrosion.

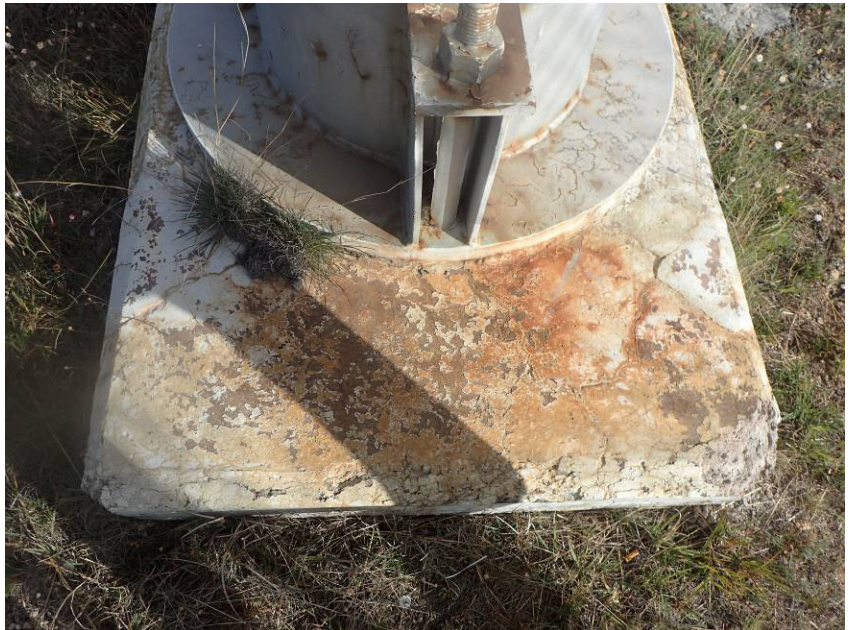
**Description:**  
32"x48" Support Column Base appeared to be in fair condition with a moderate amount of cracking.

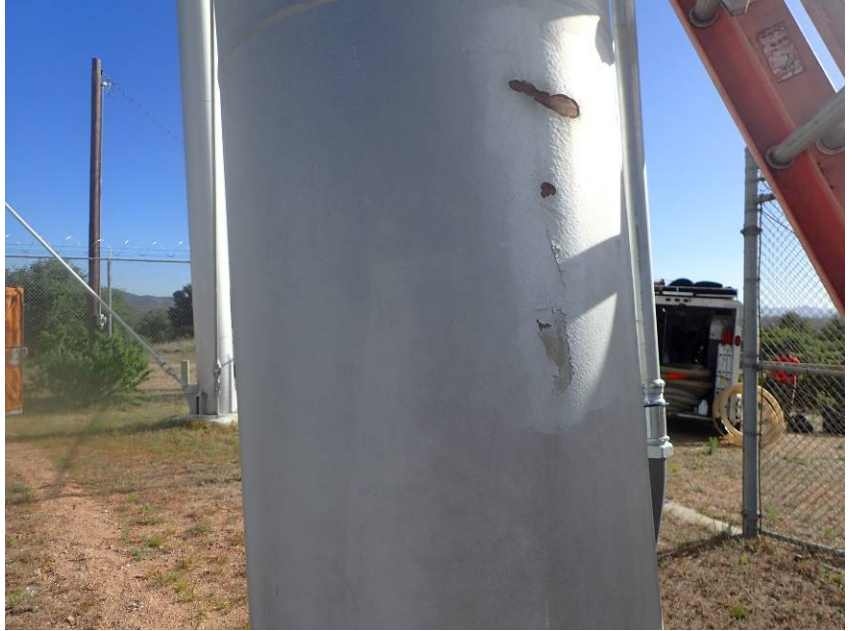
**Description:**  
24" Support Leg appeared to be in fair condition with a moderate amount of corrosion.

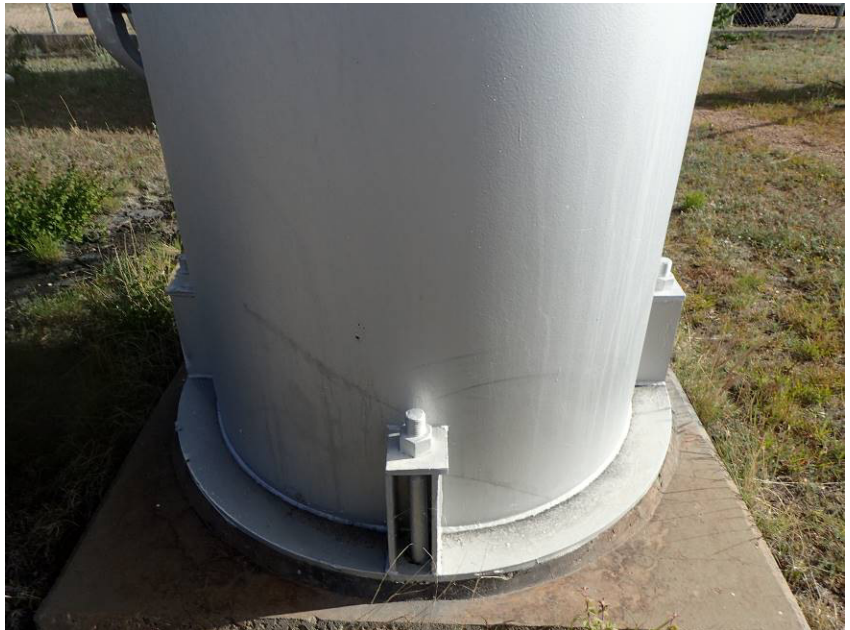
**Description:**  
48" Inlet / Outlet appeared to be in good condition with a minor amount of corrosion.

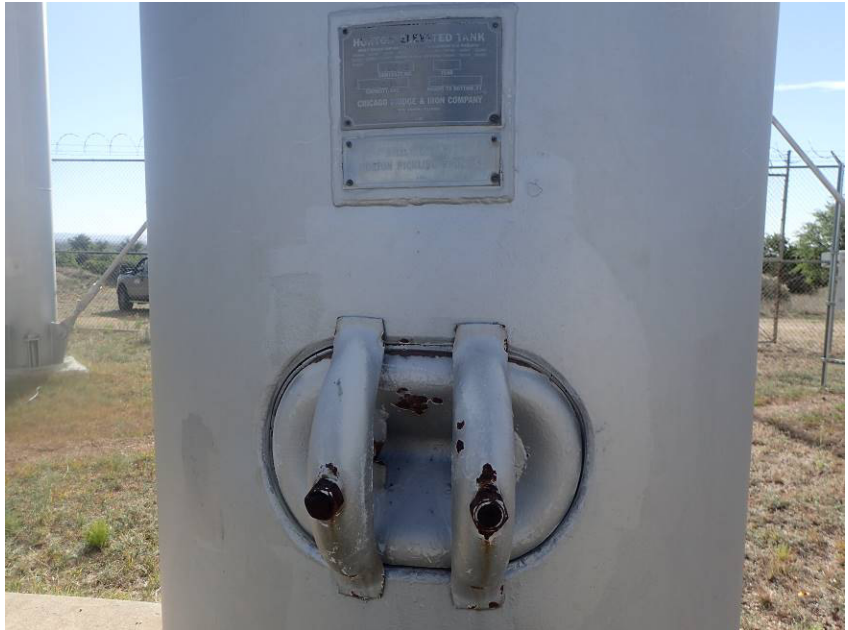
**Description:**  
18"x12" Man Way appeared to be in good condition with a minor amount of corrosion.

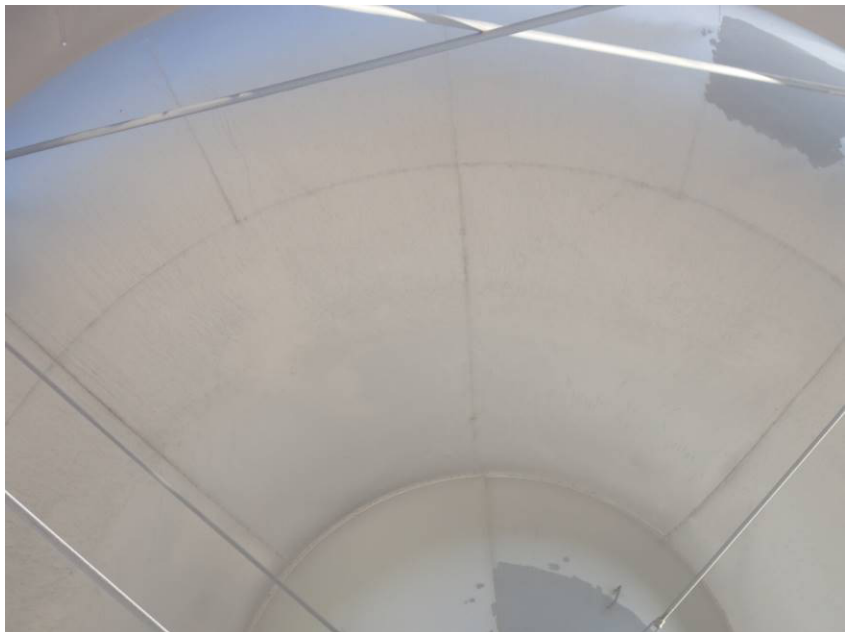
**Description:**  
Lower Wall appeared to be in good condition with a minor amount of corrosion.

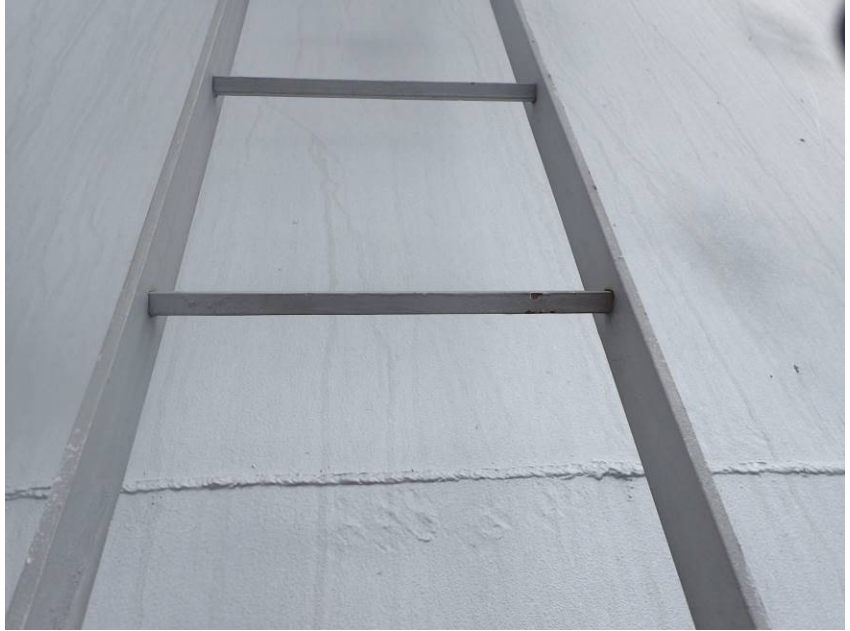
**Description:**  
Exterior Upper Ladder appeared to be in good condition with a minor amount of corrosion.

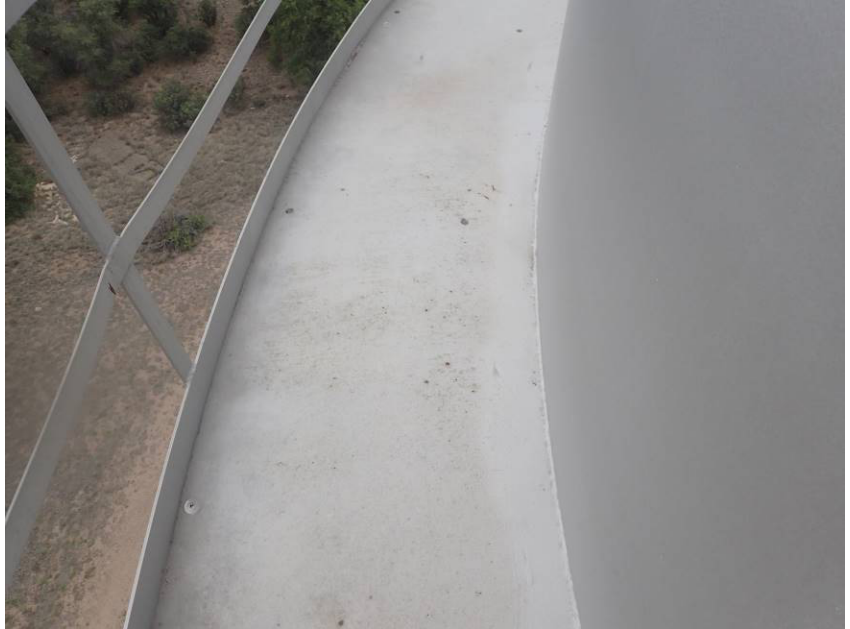
**Description:**  
Catwalk appeared to be in fair condition with a moderate amount of corrosion.

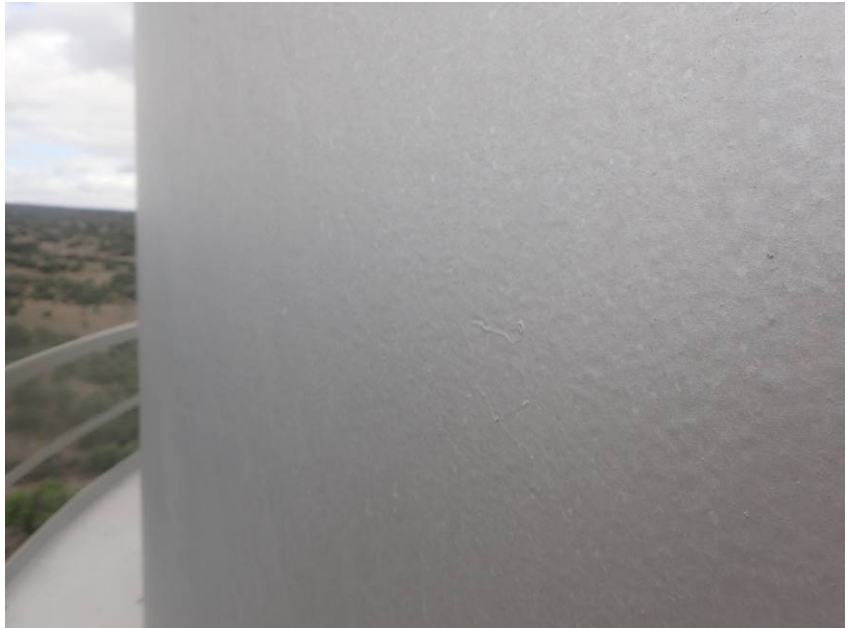
**Description:**  
Exterior Wall appeared to be in good condition with a minor amount of corrosion.

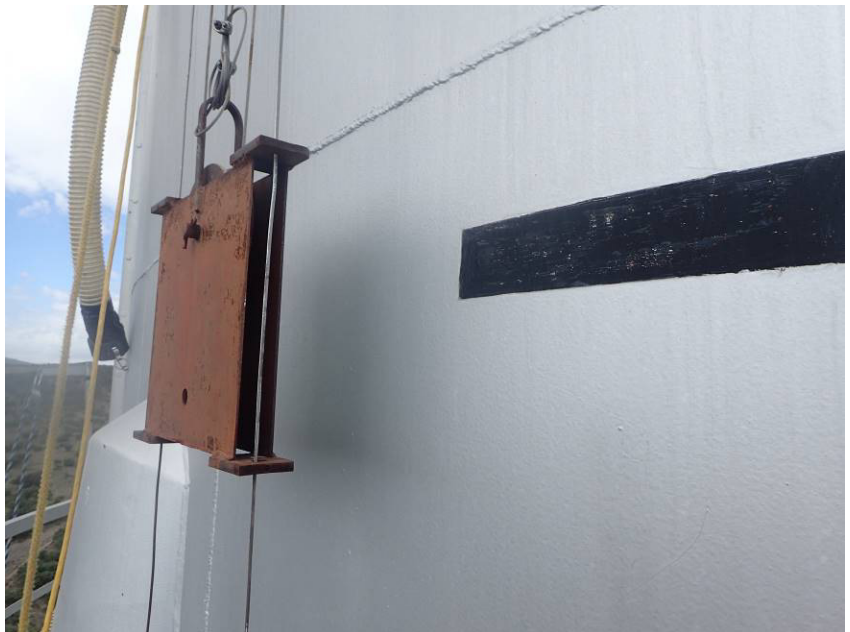
**Description:**  
Liquid Level Indicator Reader Board appeared to be in good condition with a minor amount of corrosion.

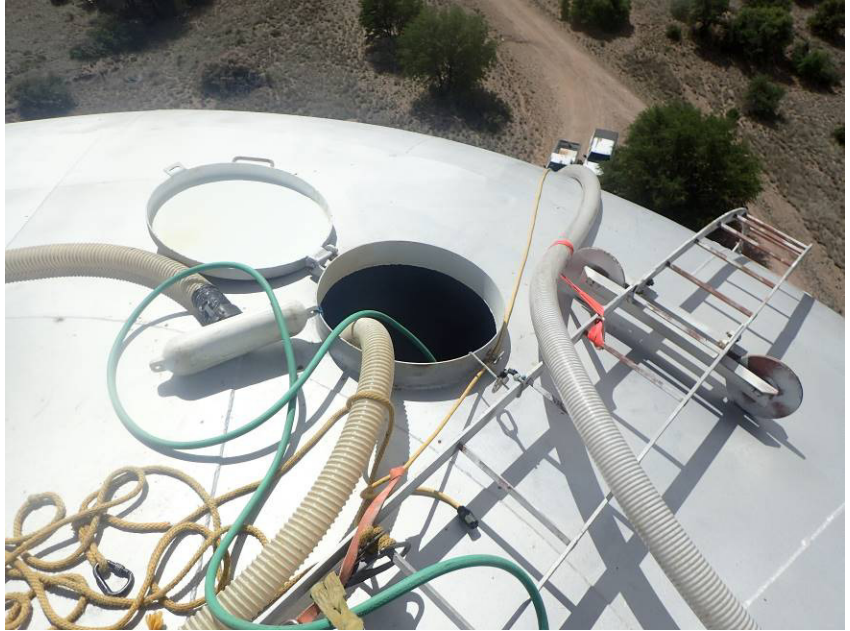
**Description:**  
28" Entry Hatch appeared to be in good condition with a minor amount of corrosion.

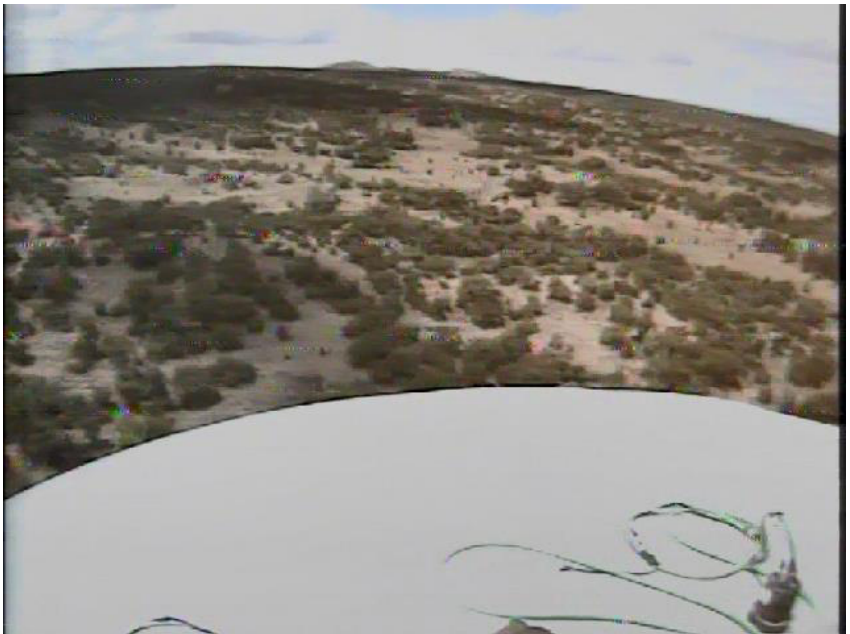
**Description:**  
Roof appeared to be in good condition with a minor amount of corrosion.

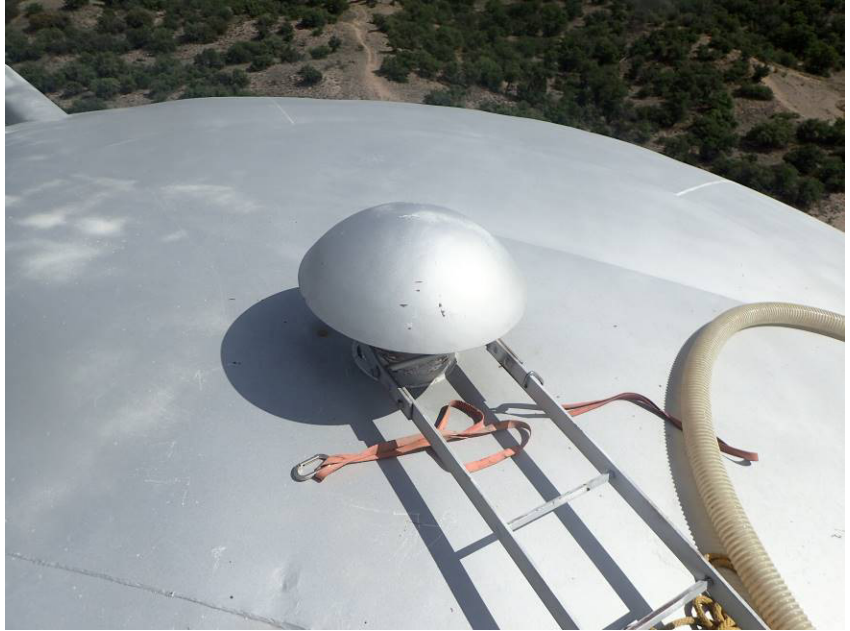
**Description:**  
12" Vent appeared to be in good condition with a minor amount of corrosion. No fine mesh screen was observed.

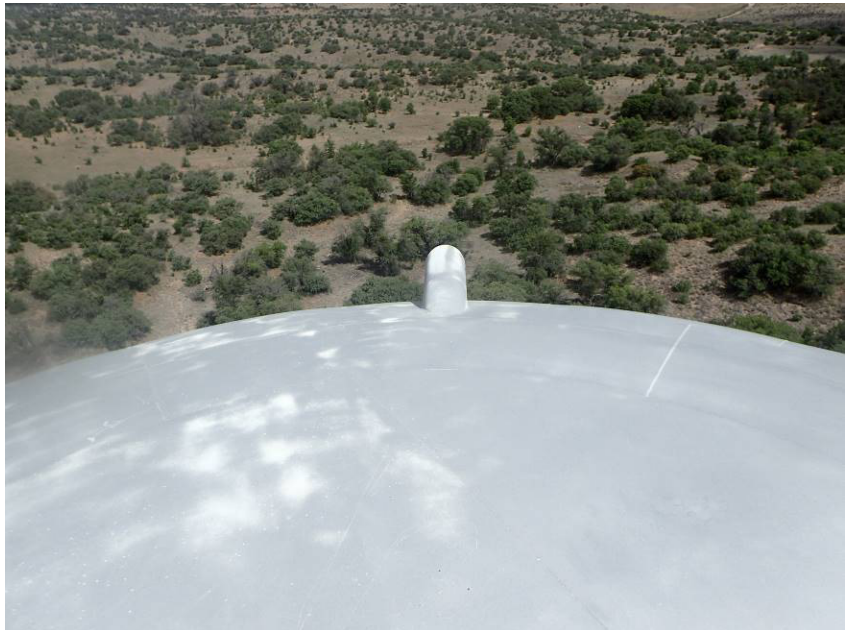
**Description:**  
12" Overflow appeared to be in good condition with a minor amount of corrosion.

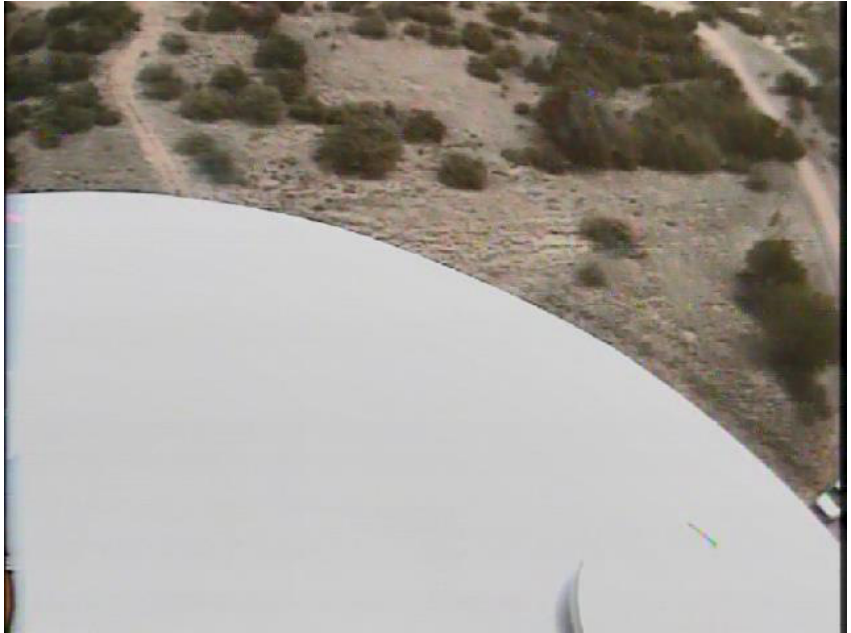
**Description:**  
Roof appeared to be in good condition with a minor amount of corrosion.

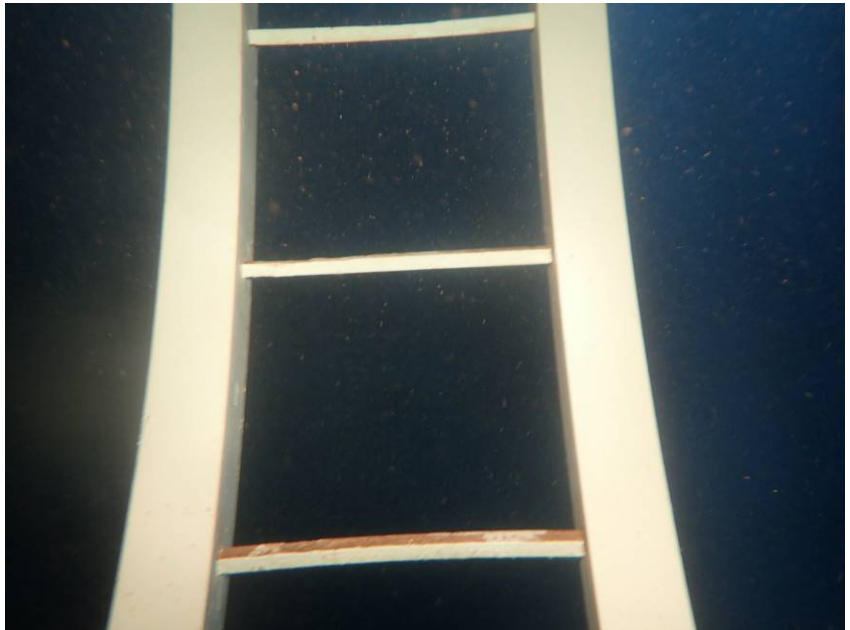
Interior Ladder appeared to be in good condition with a minor amount of corrosion.

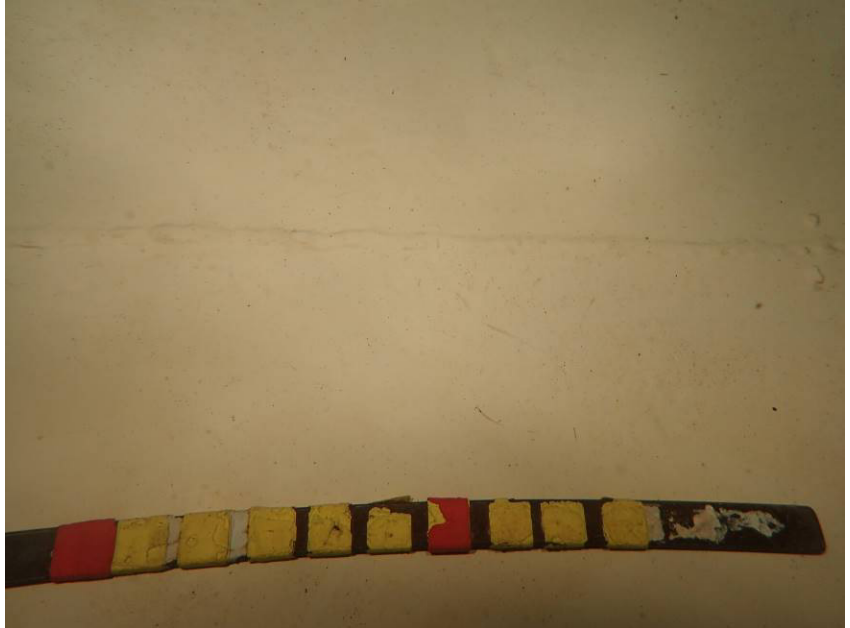
**Description:**  
Floor appeared to be in good condition with a minor amount of corrosion.

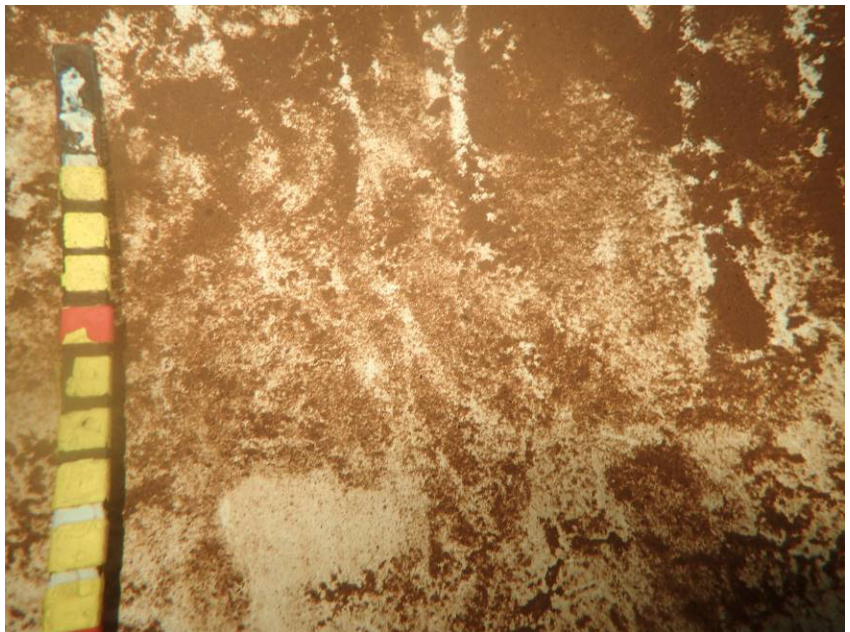
**Description:**  
Wall appeared to be in good condition with a minor amount of corrosion. Sediment was observed on wall.

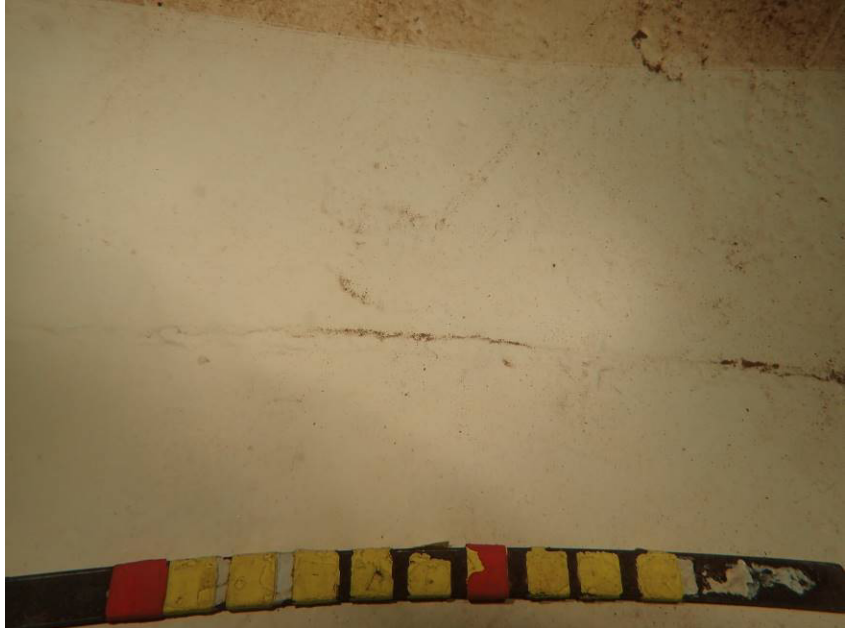
**Description:**  
Floor appeared to be in good condition with a minor amount of corrosion.

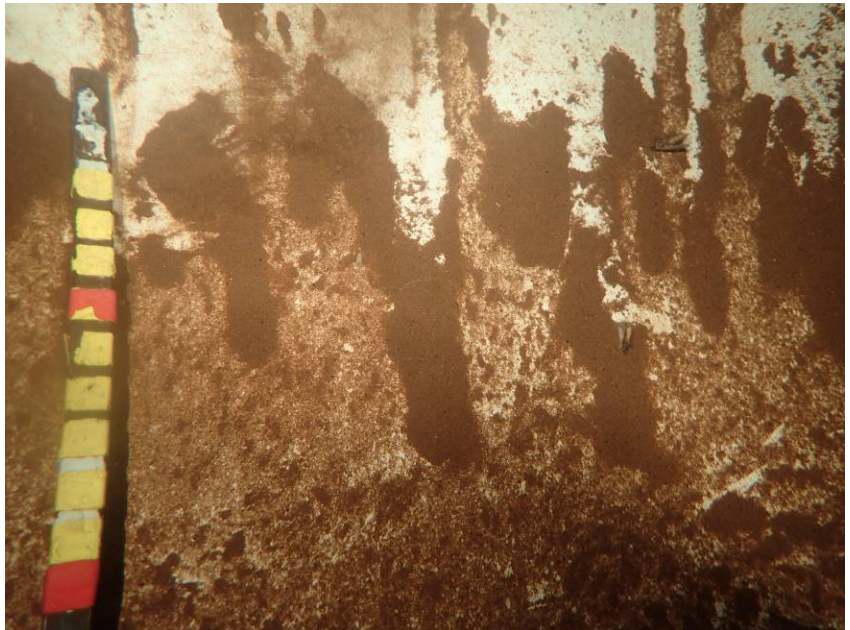
**Description:**  
Floor appeared to be in good condition with a minor amount of corrosion. Sediment was observed on wall.

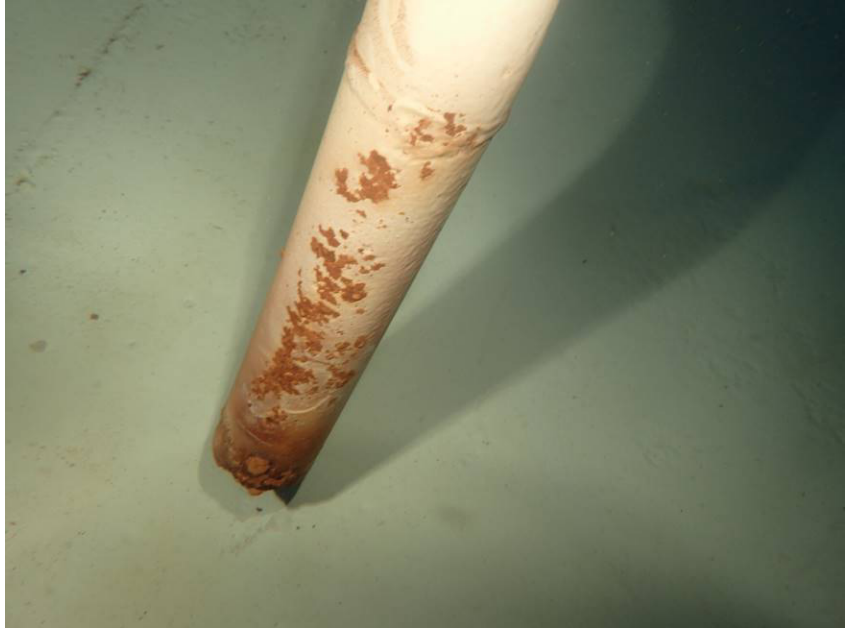
**Description:**  
3" Drain appeared to be in fair condition with a moderate amount of corrosion.

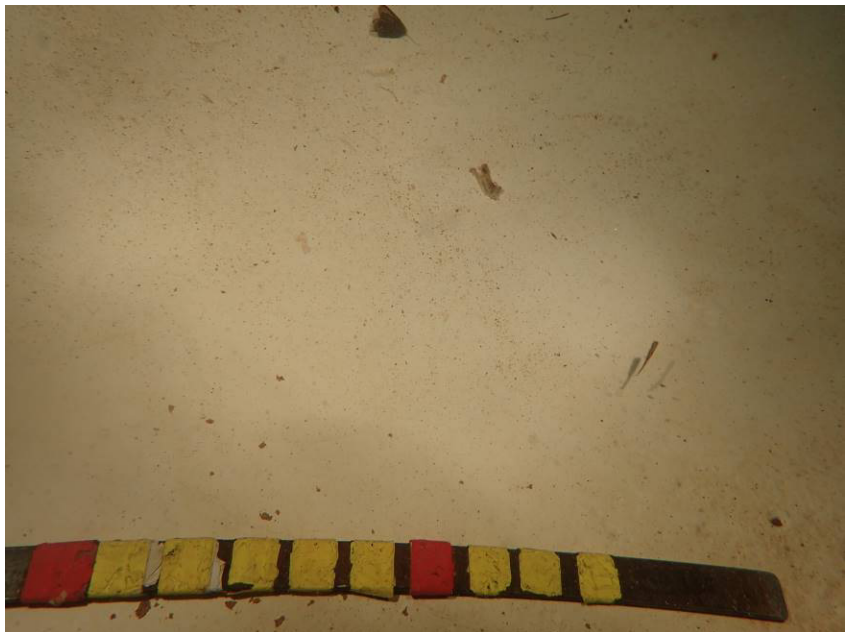
**Description:**  
Floor appeared to be in good condition with a minor amount of corrosion.

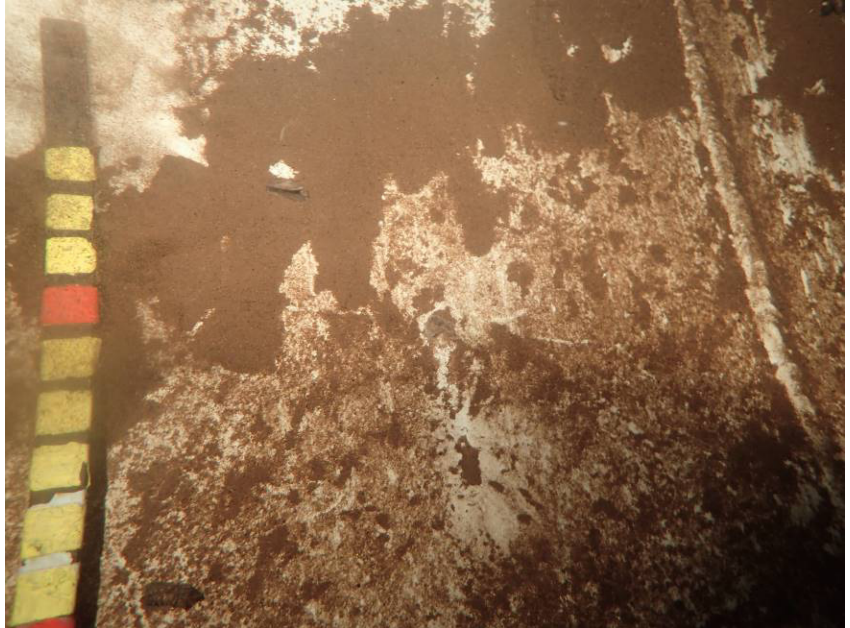
**Description:**  
Wall appeared to be in good condition with a minor amount of corrosion. Sediment was observed on wall.

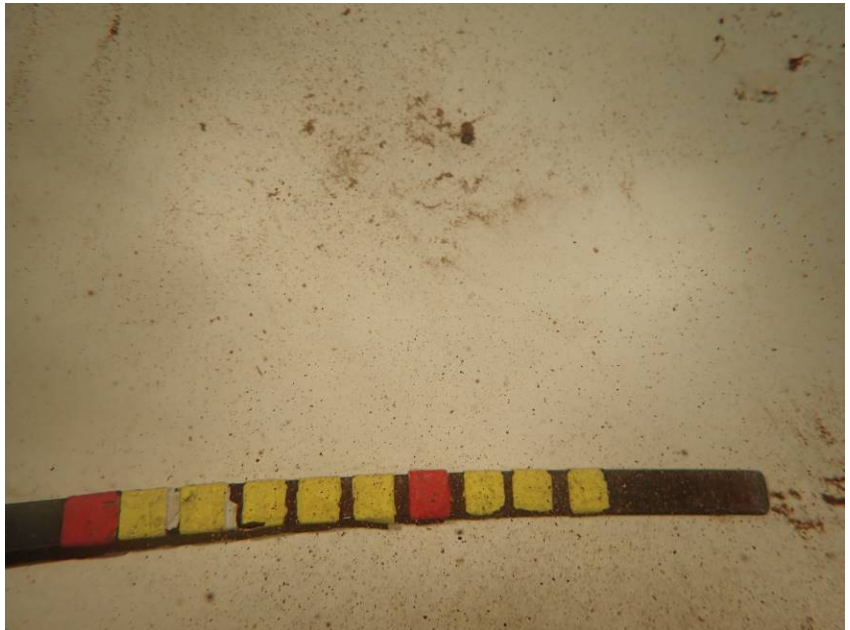
**Description:**  
Floor appeared to be in good condition with a minor amount of corrosion.

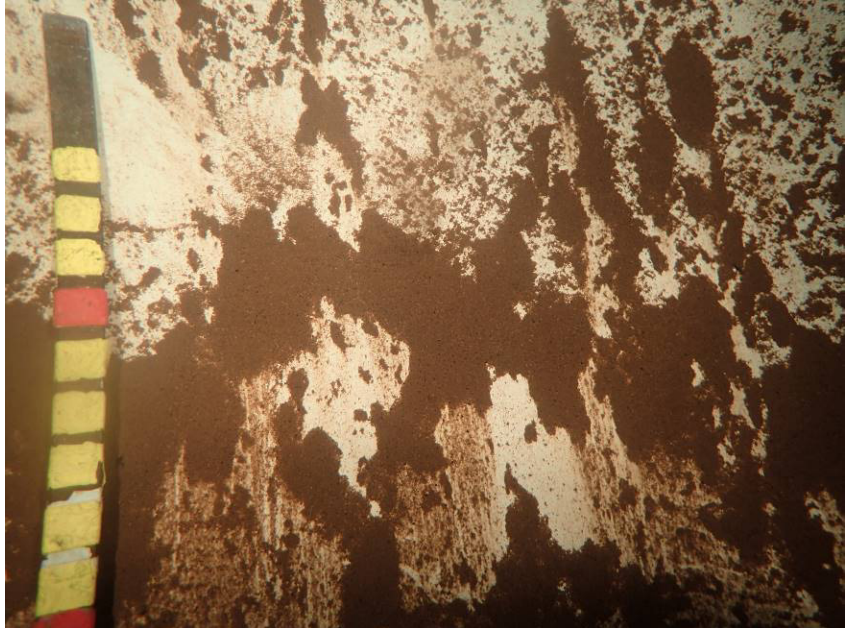
**Description:**  
Wall appeared to be in good condition with a minor amount of corrosion. Sediment was observed on wall.

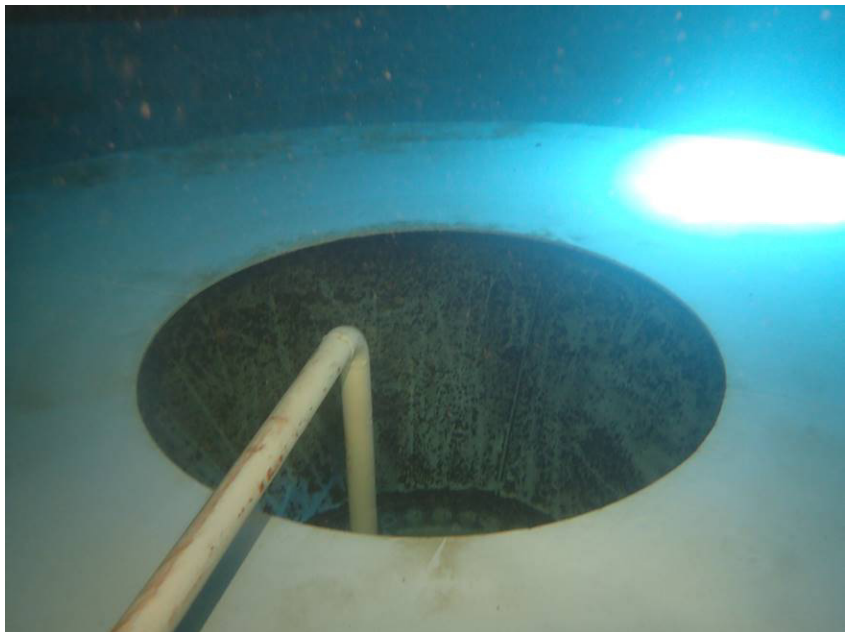
**Description:**  
Inlet / Outlet appeared to be in good condition with a minor amount of corrosion.

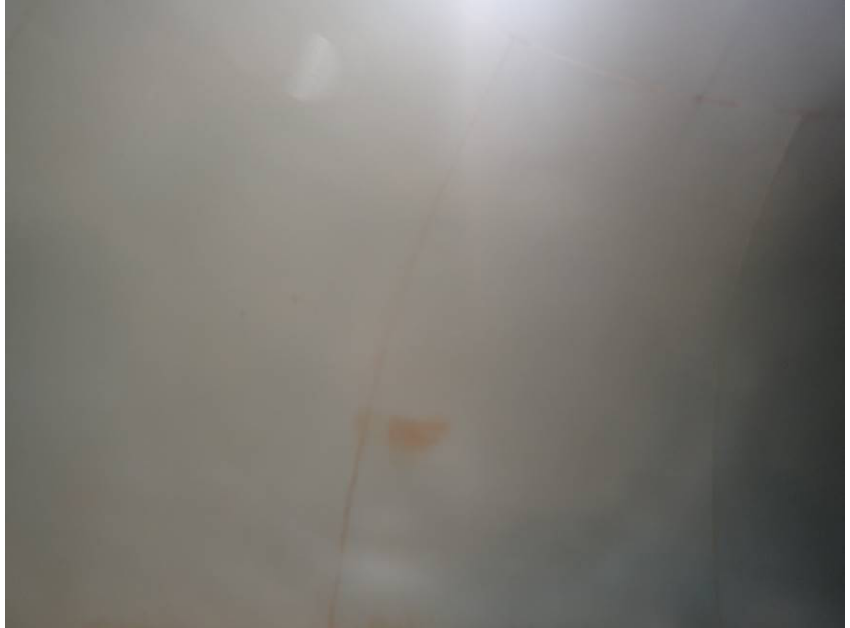
**Description:**  
Ceiling appeared to be in good condition with a minor amount of corrosion.

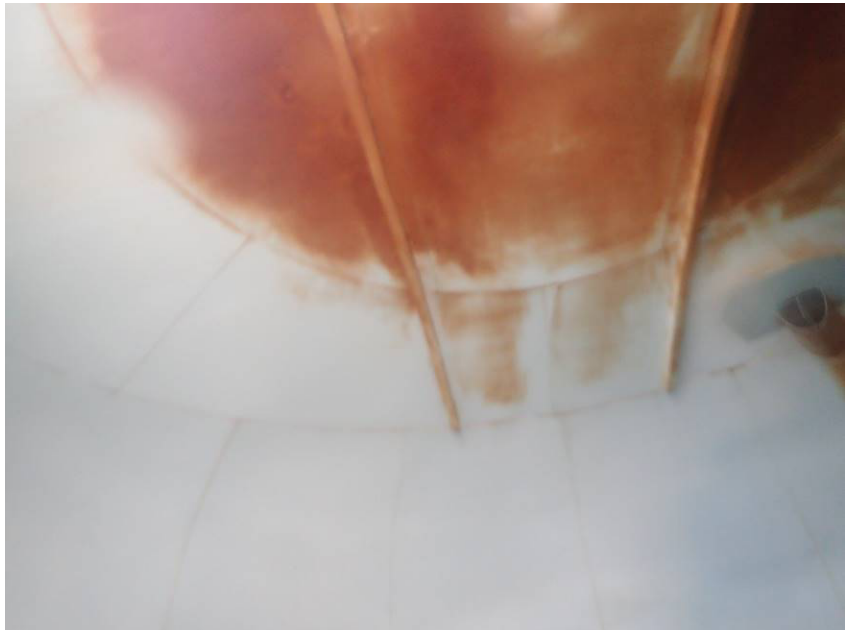
**Description:**  
Ceiling appeared to be in fair condition with a moderate amount of corrosion.

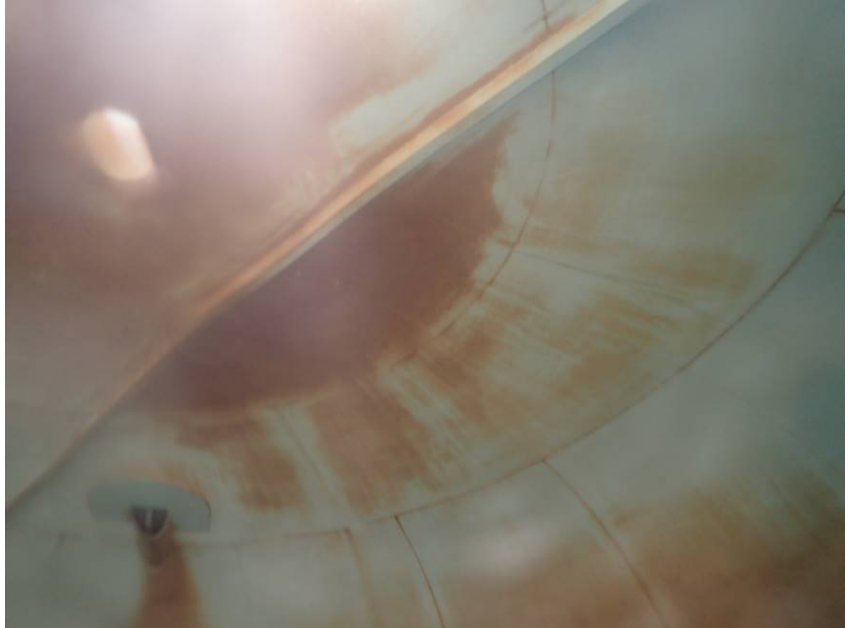
**Description:**  
Ceiling appeared to be in fair condition with a moderate amount of corrosion.

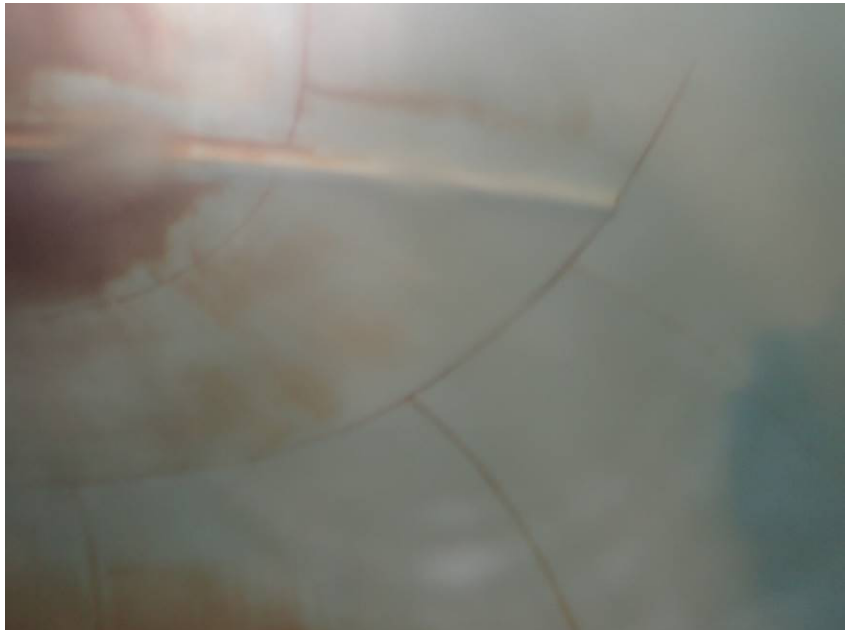
**Description:**  
Ceiling appeared to be in fair condition with a moderate amount of corrosion.

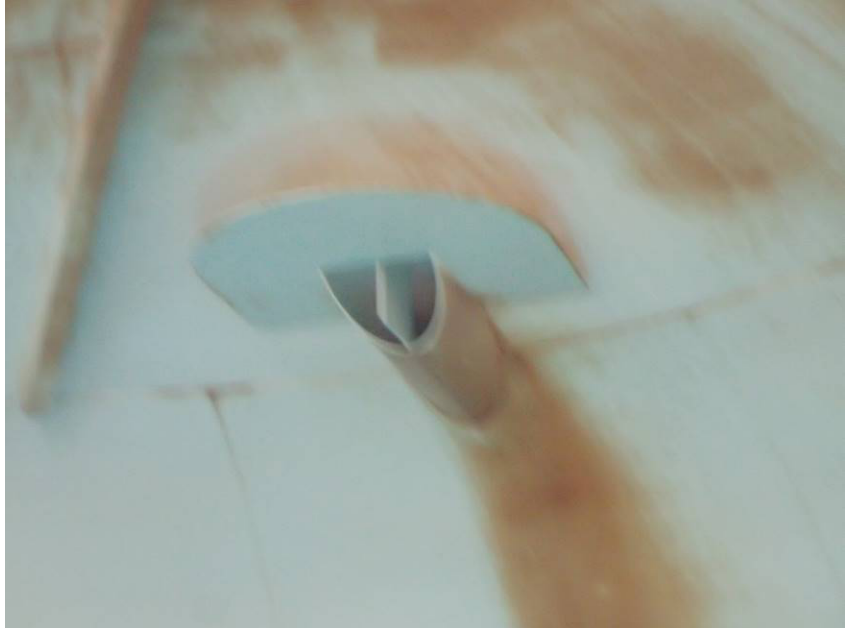
**Description:**  
Overflow appeared to be in fair condition with a moderate amount of corrosion.

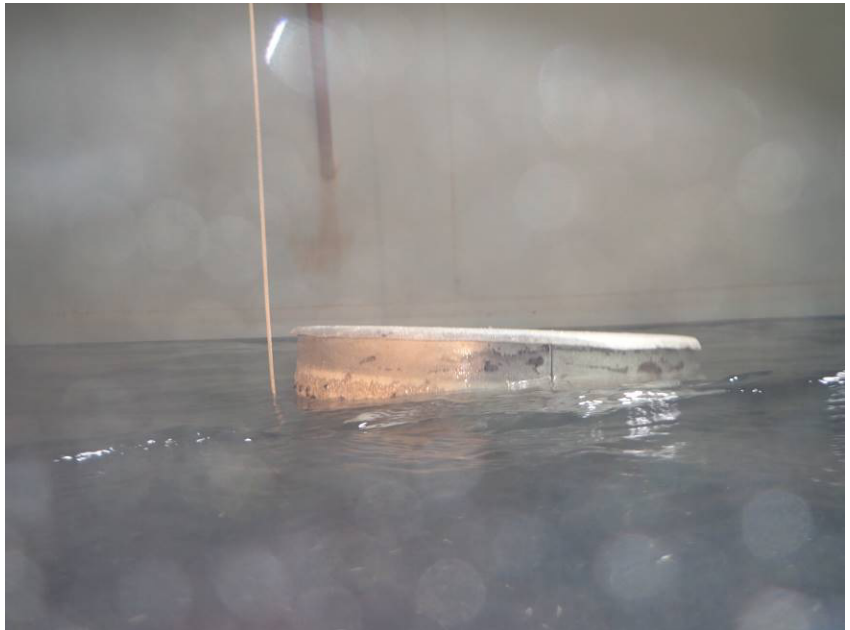
**Description:**  
Liquid Level Indicator Float appeared to be in good condition with a minor amount of corrosion.
