| <b>REPORT NUMBER:</b> | 16 |
| <b>PROJECT NUMBER:</b> | 20260236 |
| <b>PROJECT:</b> | Tyrone Water System Improvements<br>Construction |

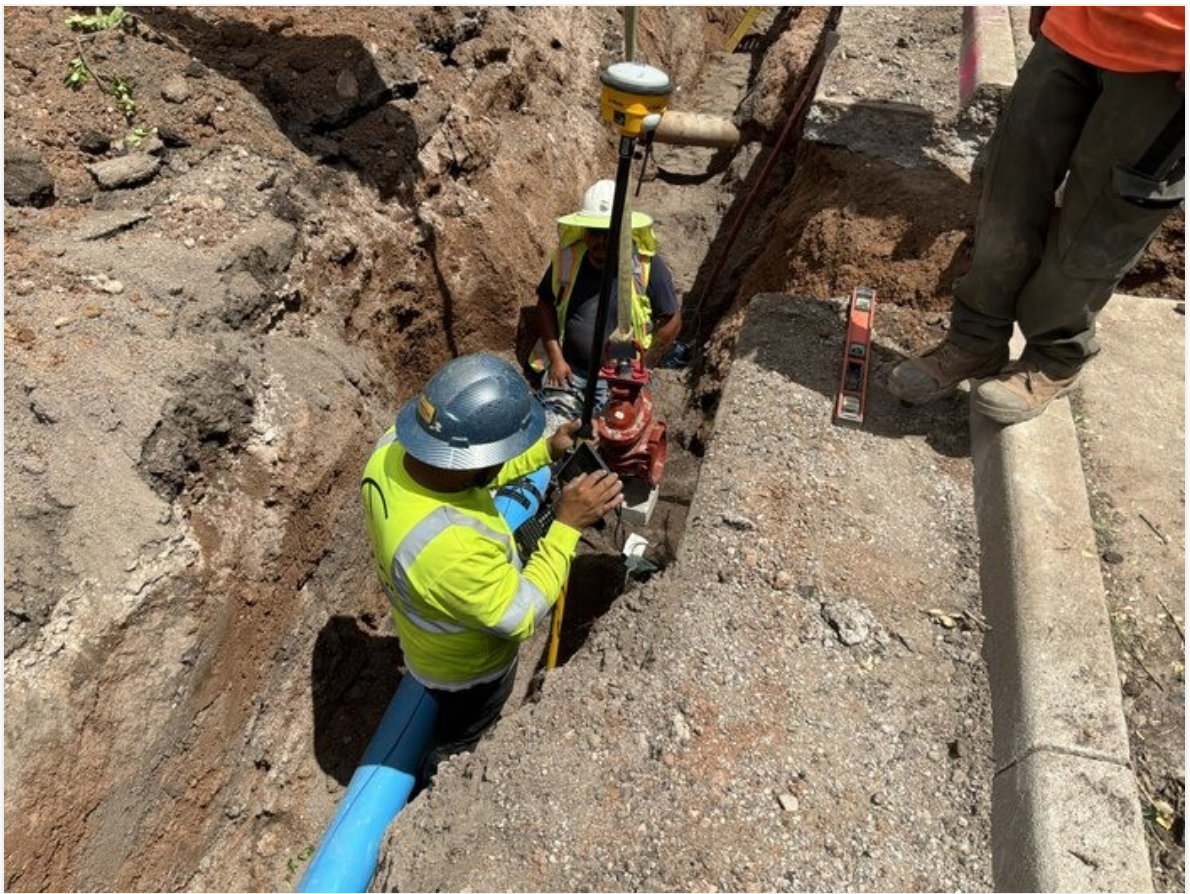
*Survey as-built shots being taken on installed fittings on Bornite St.*

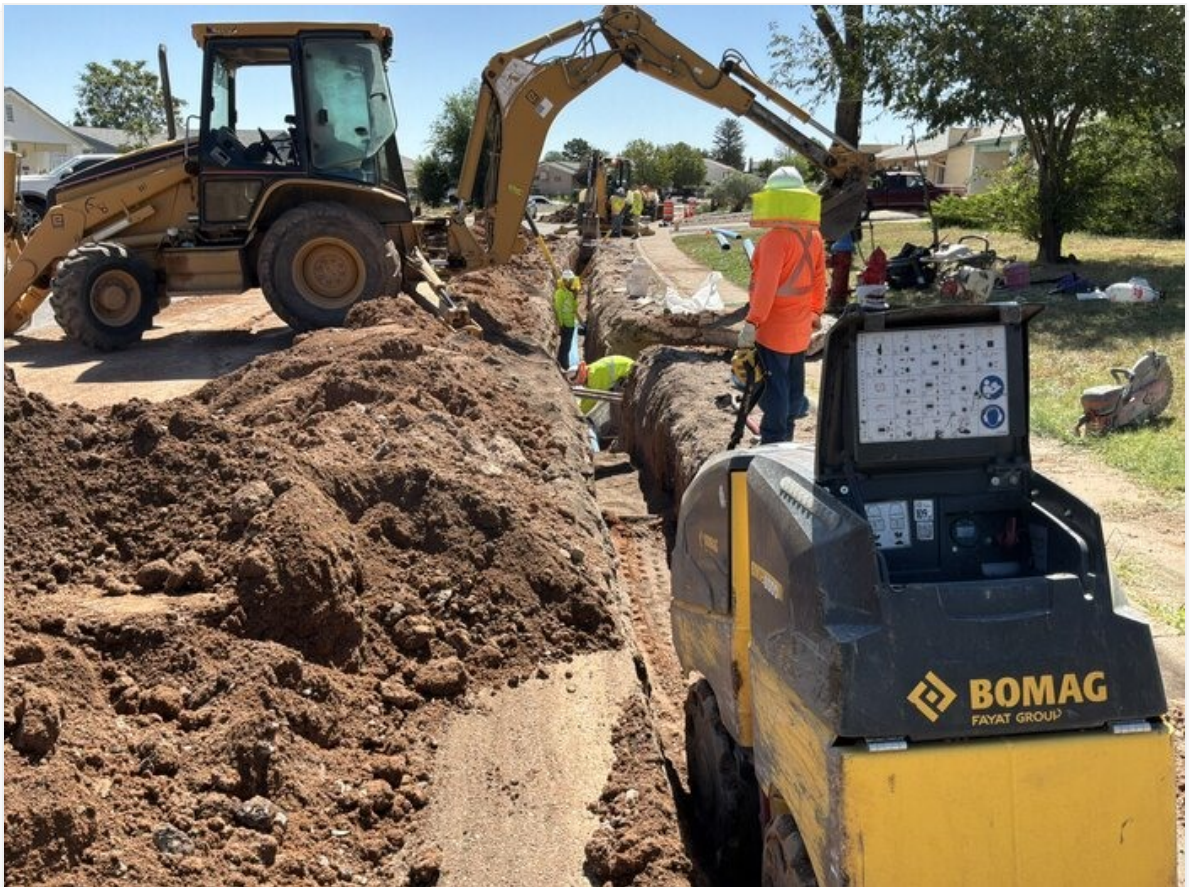
*Compaction and hydrant placement on Bornite St.*

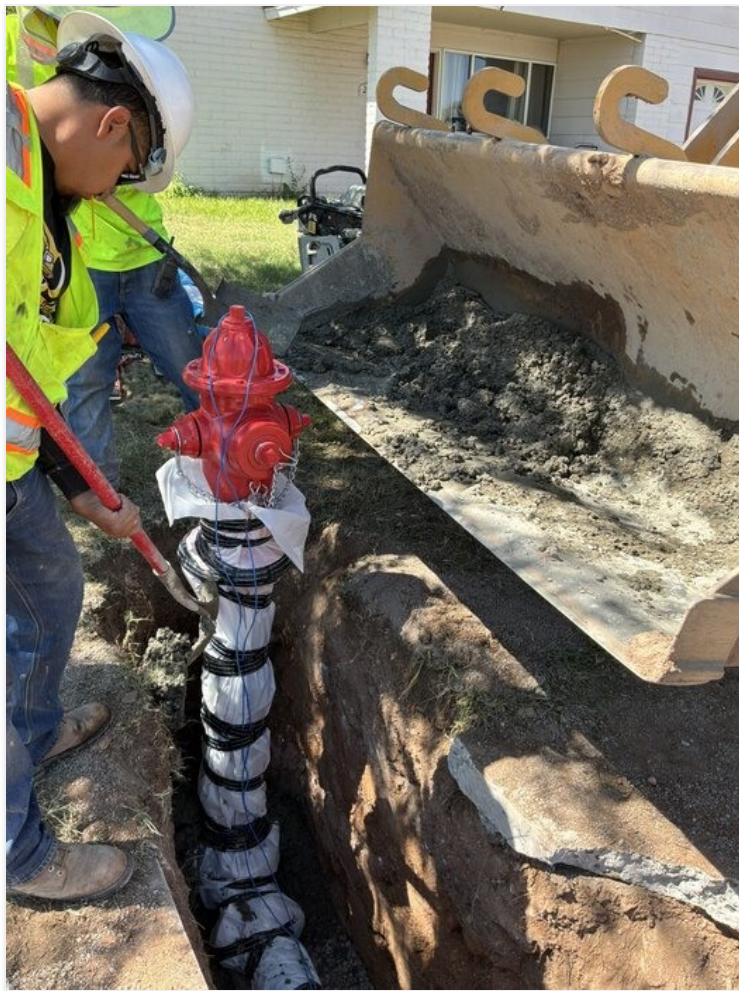
*Placing fresh concrete for hydrant thrust block.*

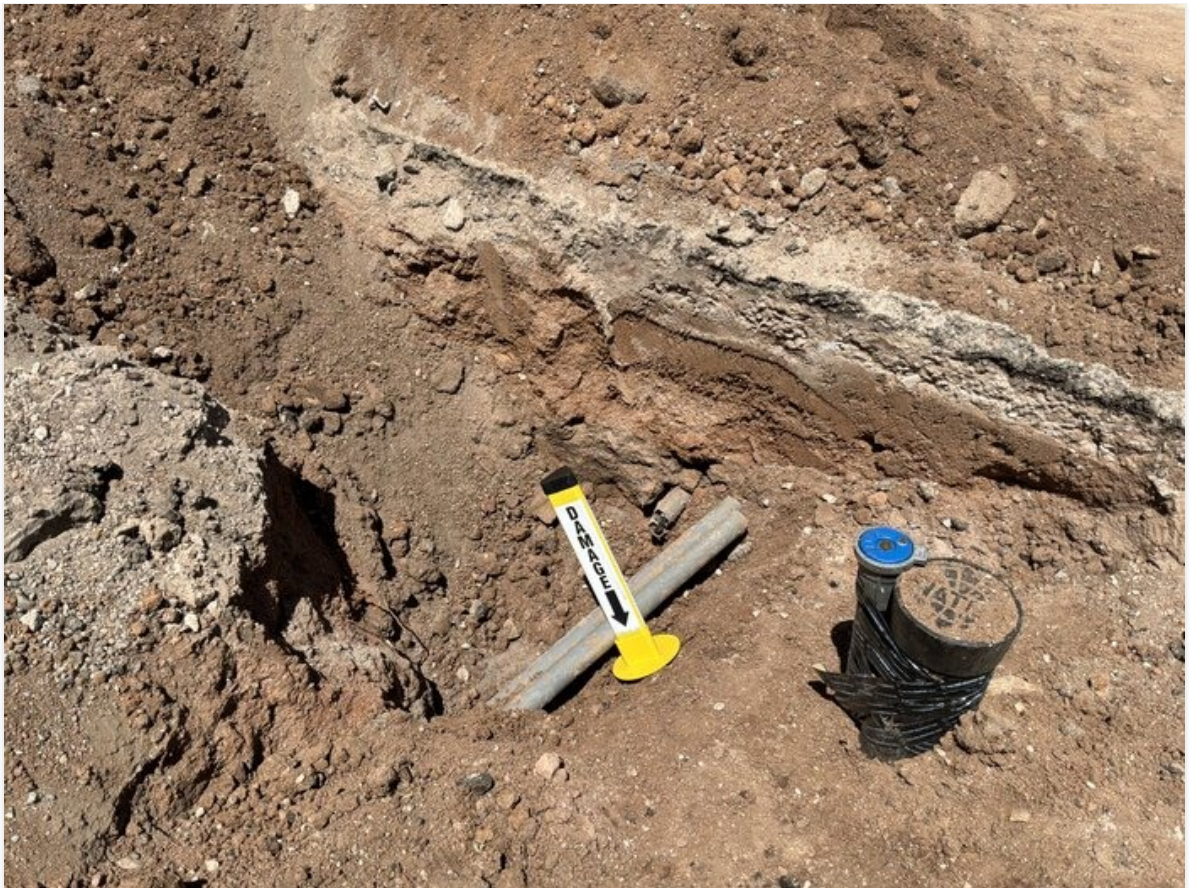
The contractor continued to place 6” C-900 on Bornite St. and install new fire hydrants as per plan and per hydrant plan set detail. During excavation of the 6” water line. the contractor hit an unmarked communications line on Bornite, at approx. sta. 23+65. The proper owner was notified and scheduled as repair late in the afternoon. Summit testing was called onsite to take backfill densities. All tests taken passed.

*Damaged unmarked communications line on Bornite St. sta. 23+65*

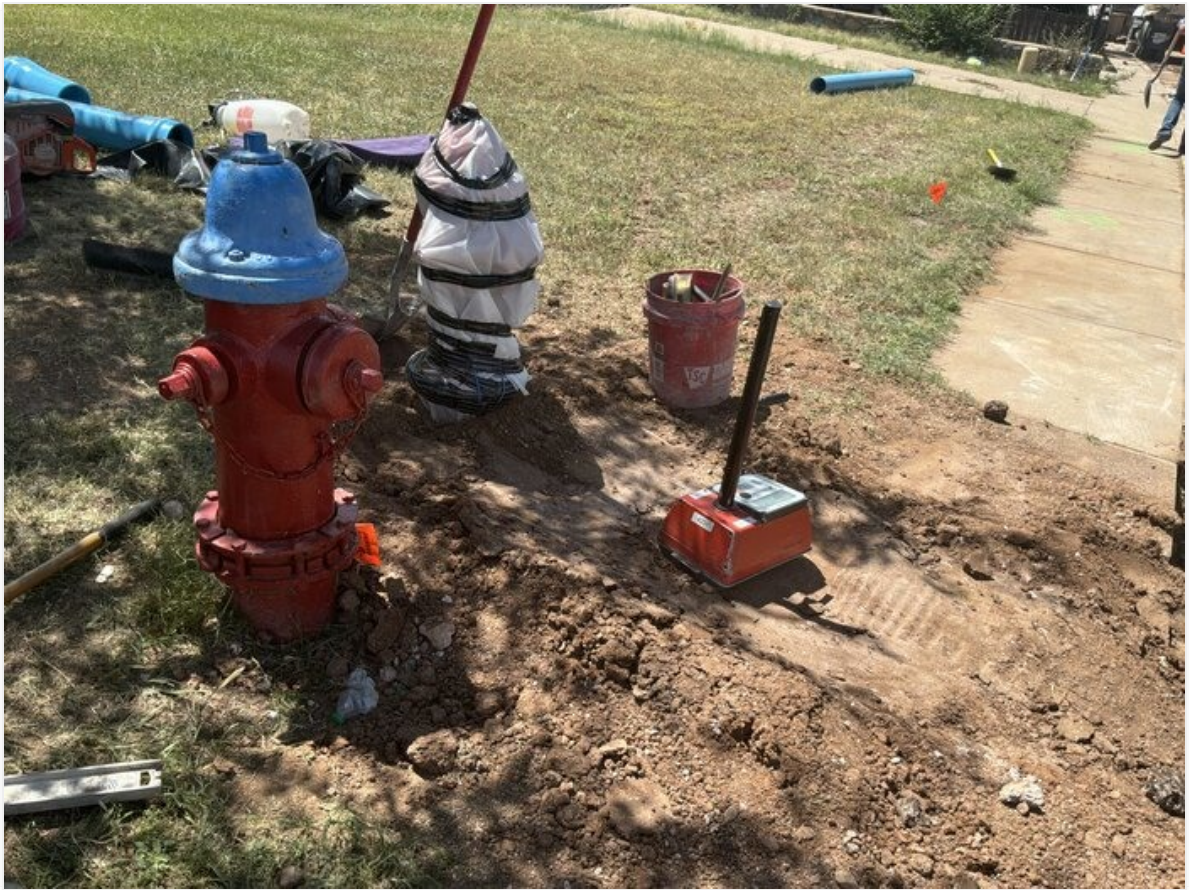
*Fire line backfill density on Bornite St.*

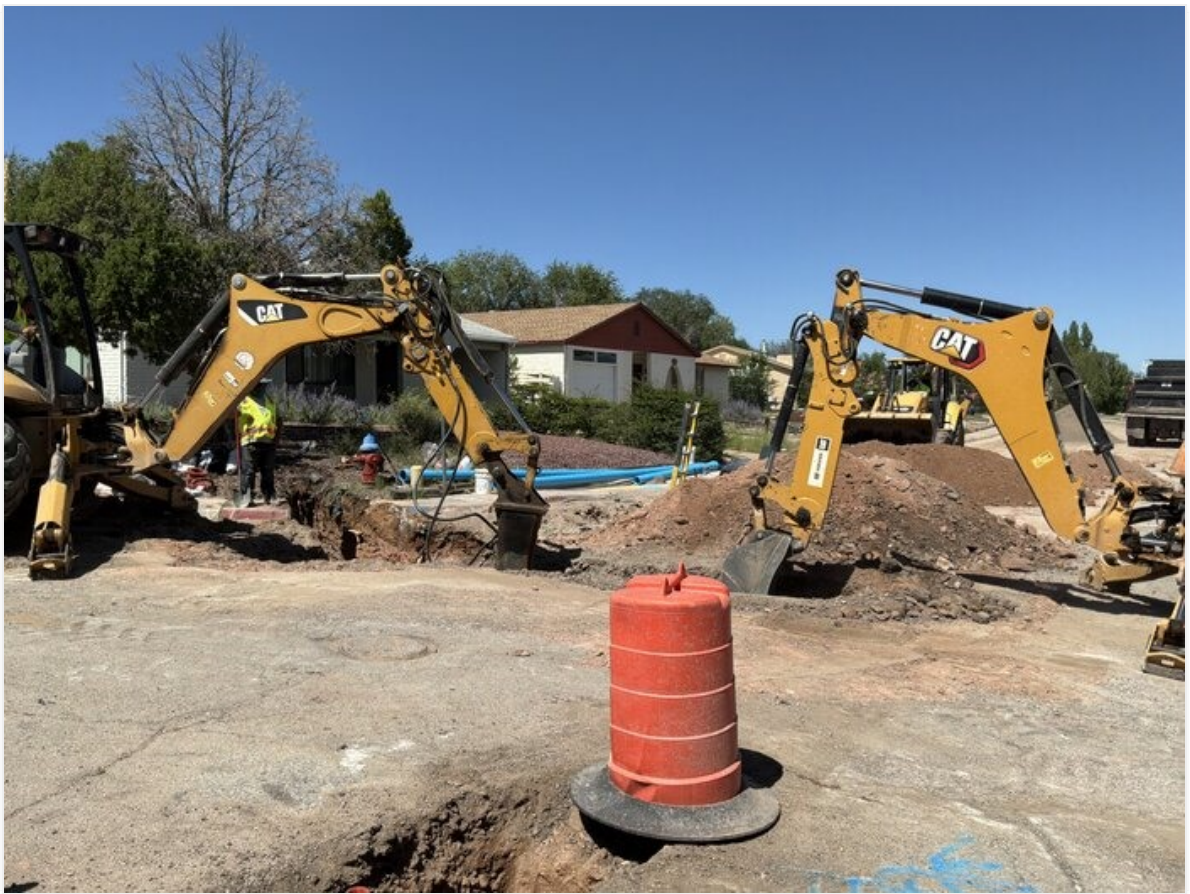
*Hammer attachment and backhoe needed to excavate hard soil.*

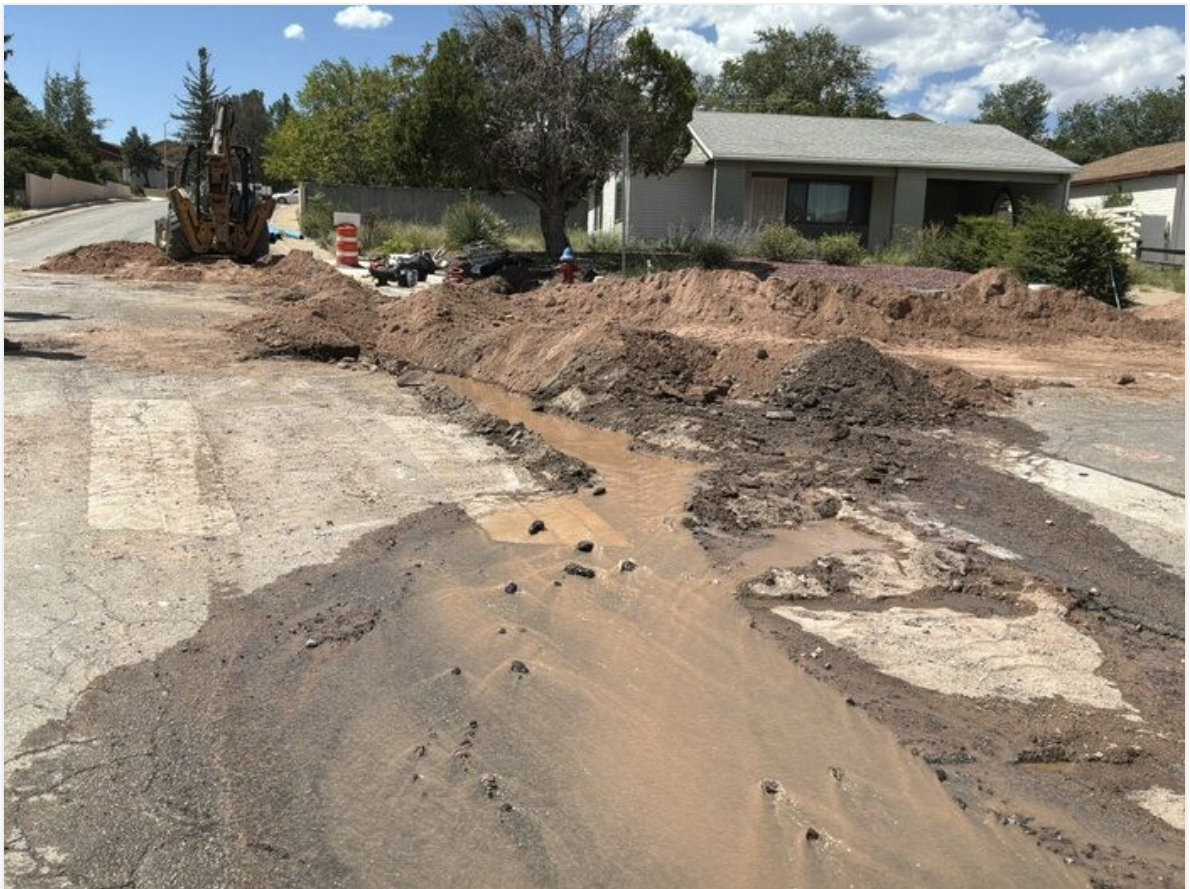
The contractor continued to place 6” C-900 and place new fire hydrants on Bornite St. as per plan. During excavation for the new water line. The contractor hit the existing AC water line on Bornite St. at approx. sta. 26+80. Alan and Eddie (Tyrone) were notified and the water was shut off so Smithco can repair the damaged AC line. The contractor was able to place a repair wrap around the damaged AC line and stop the leak. The line was hit at 11:54AM and fixed at 2:30PM.

*Damaged water line on Bornite St. sta. 26+80*

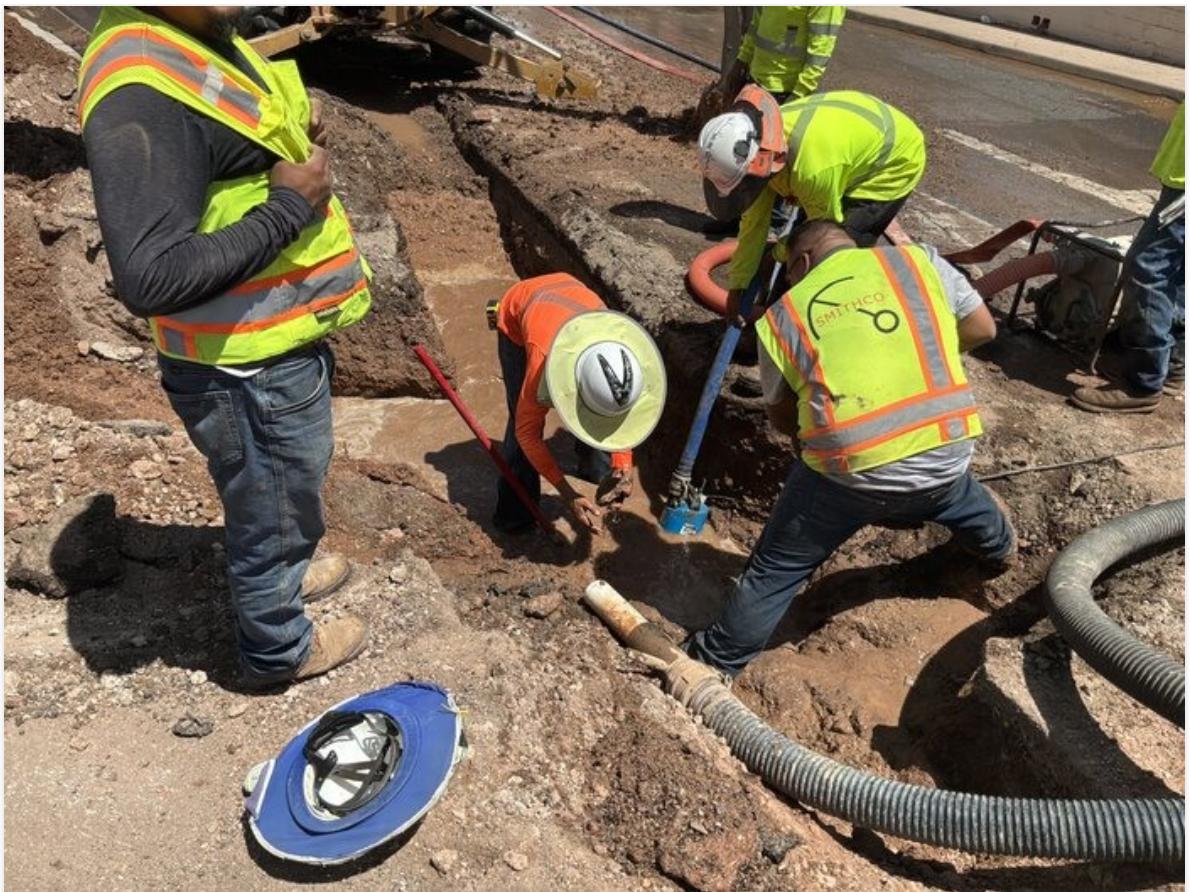
*Vac truck and pumps to remove water for pipe repair on Bornite St.*

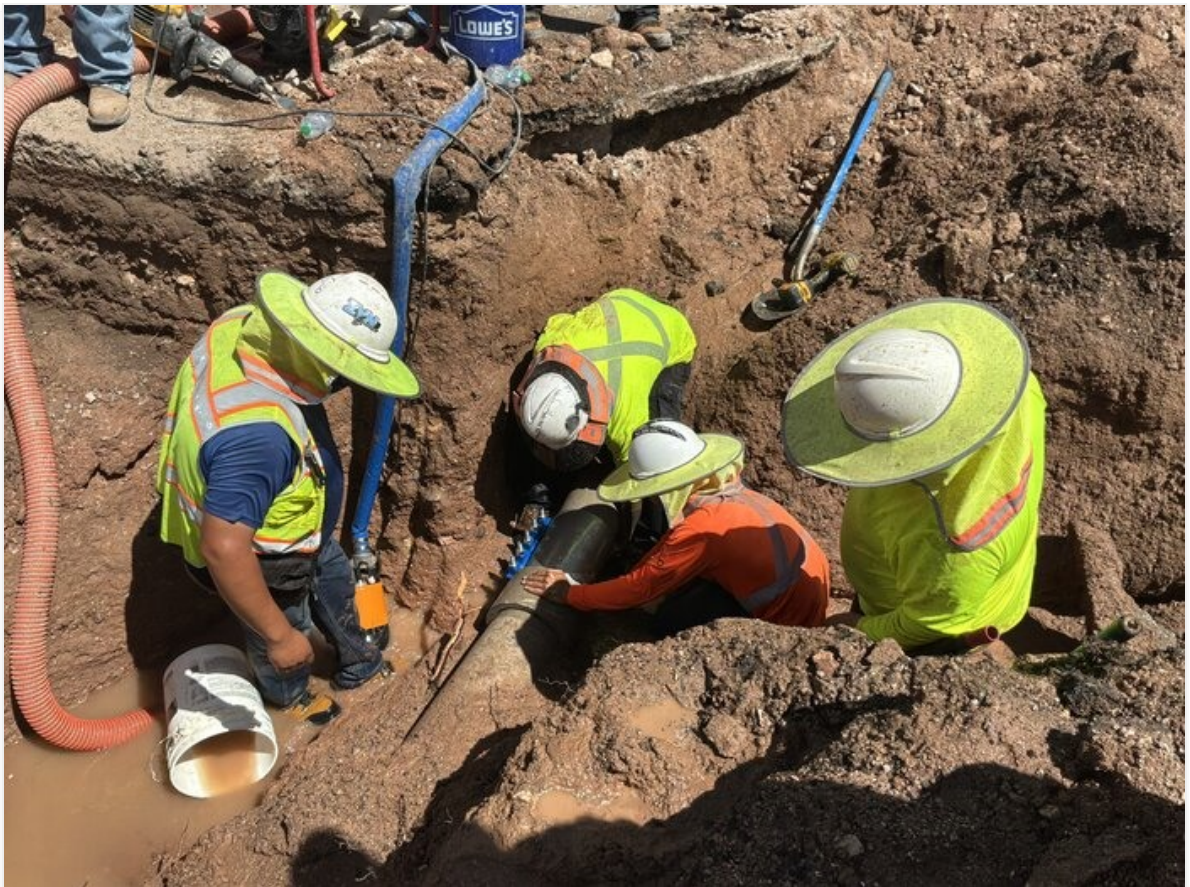
*Installing repair coupling over 8" water line.*

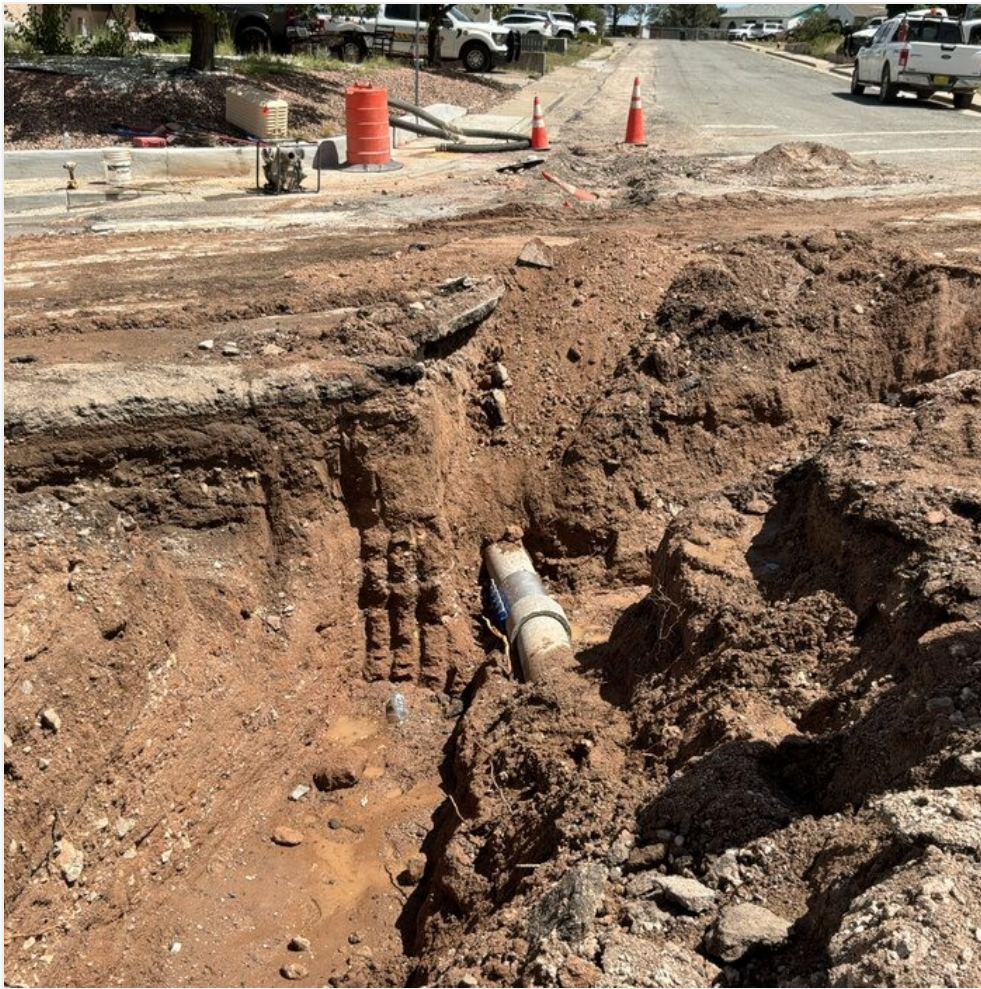
*repair coupling on existing 8" AC line on Bornite st.*

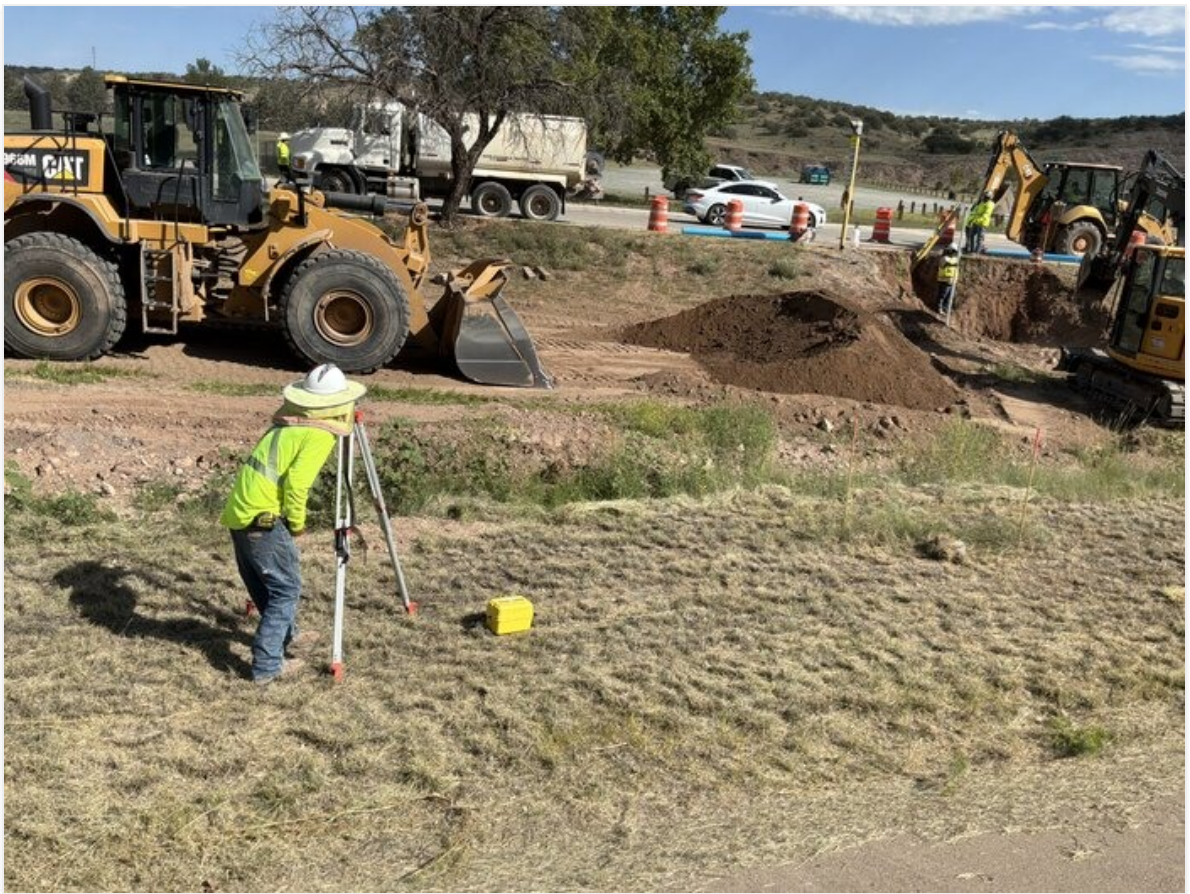
*Taking elevation shots foe steel casing.*

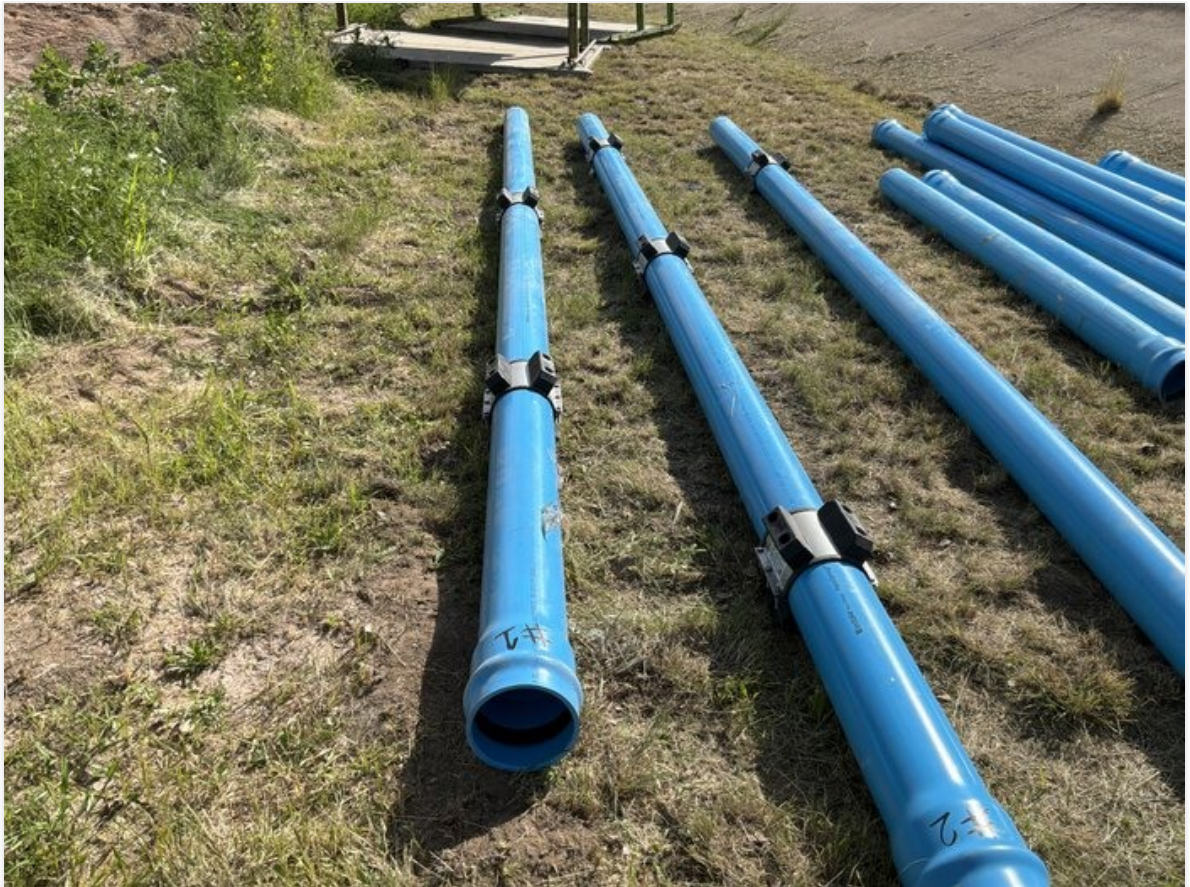
*6" C-900 with pipe spacers as per pipe recommendation*

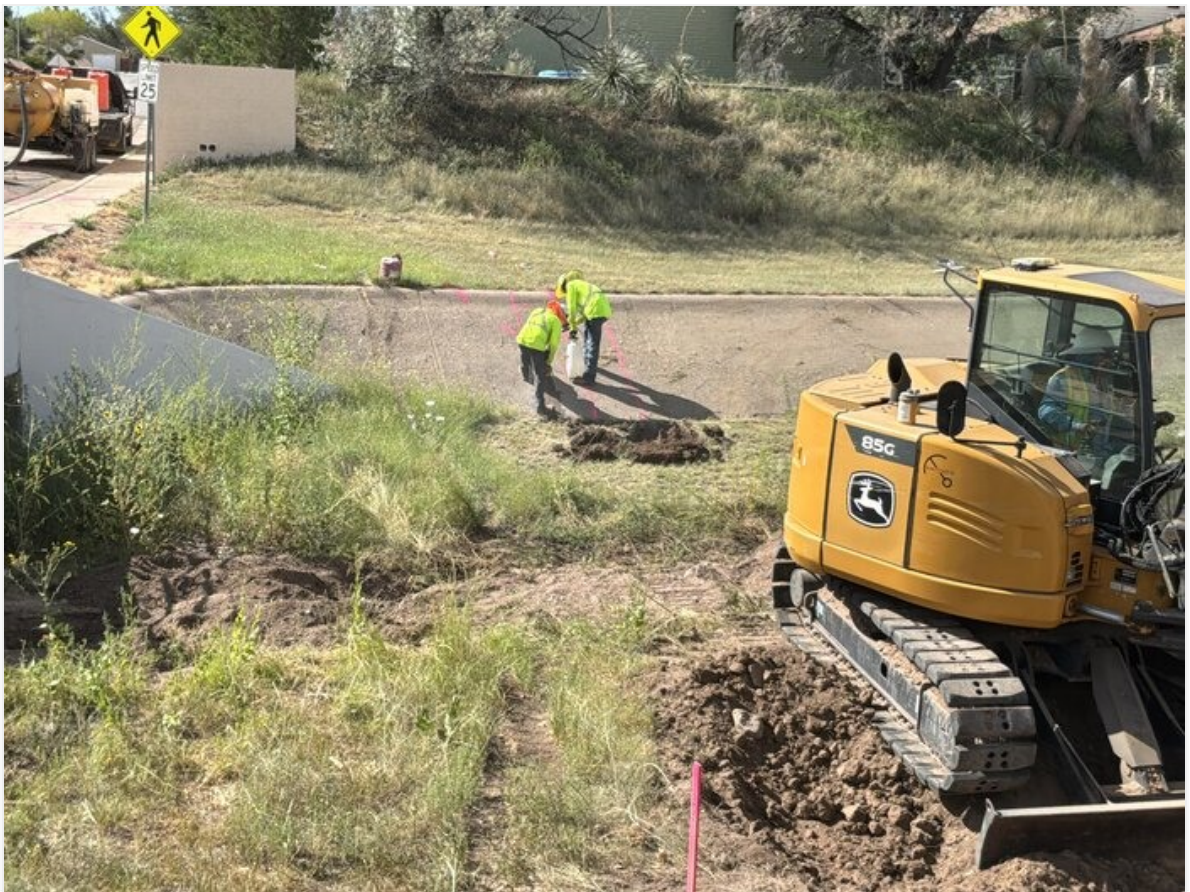
*Saw cutting sloped concrete blanket at sta. 11+48*

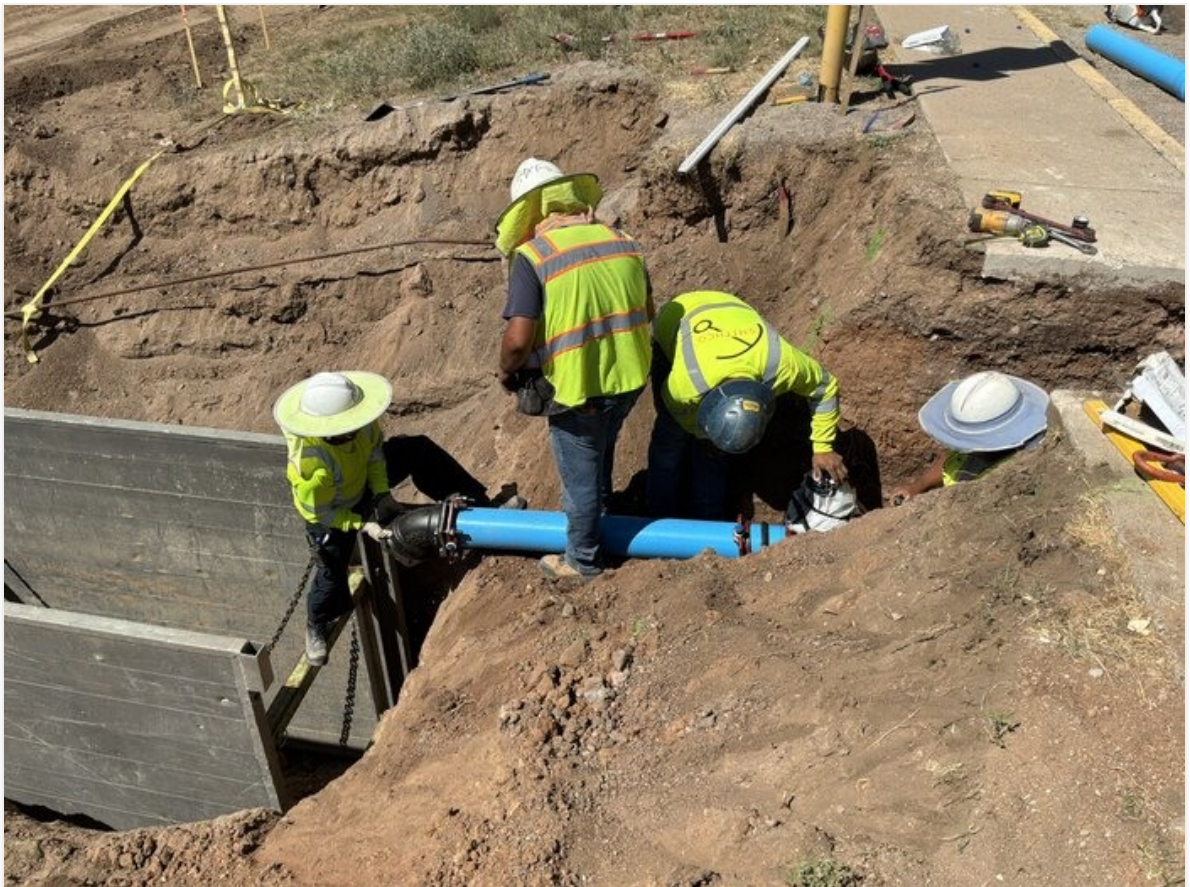
*DI 45 fittings and GV at sta. 10+88*

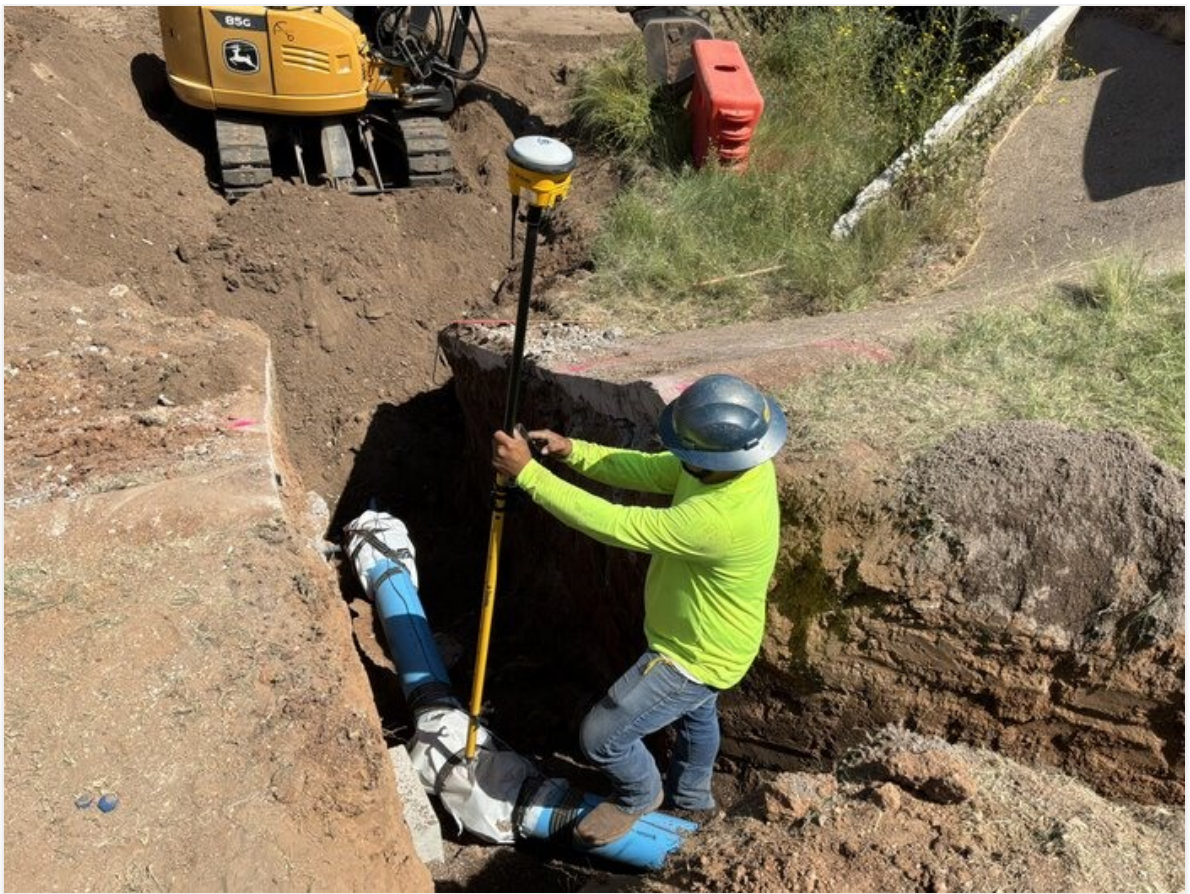
*As-built survey shots on DI 45 fittings.*

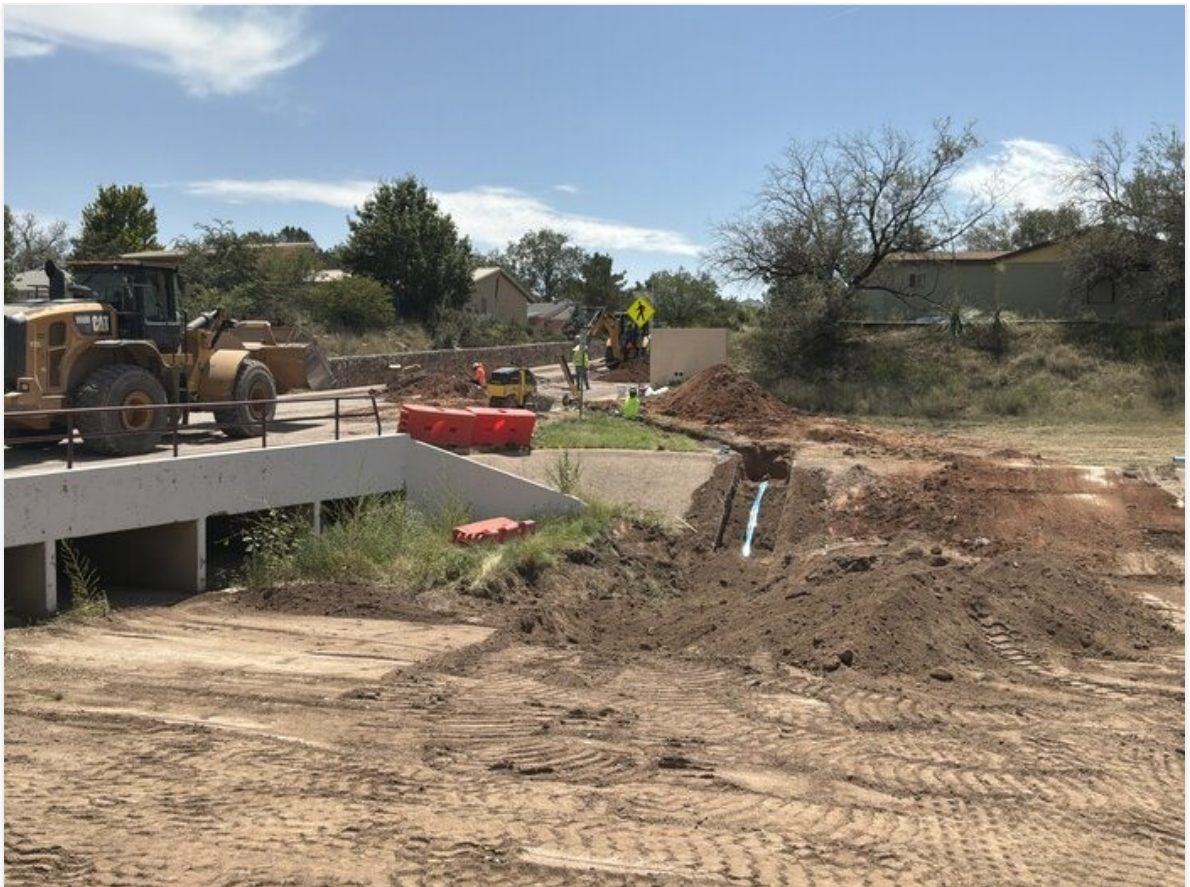
*Caution tape at removed concrete sloped blanket.*

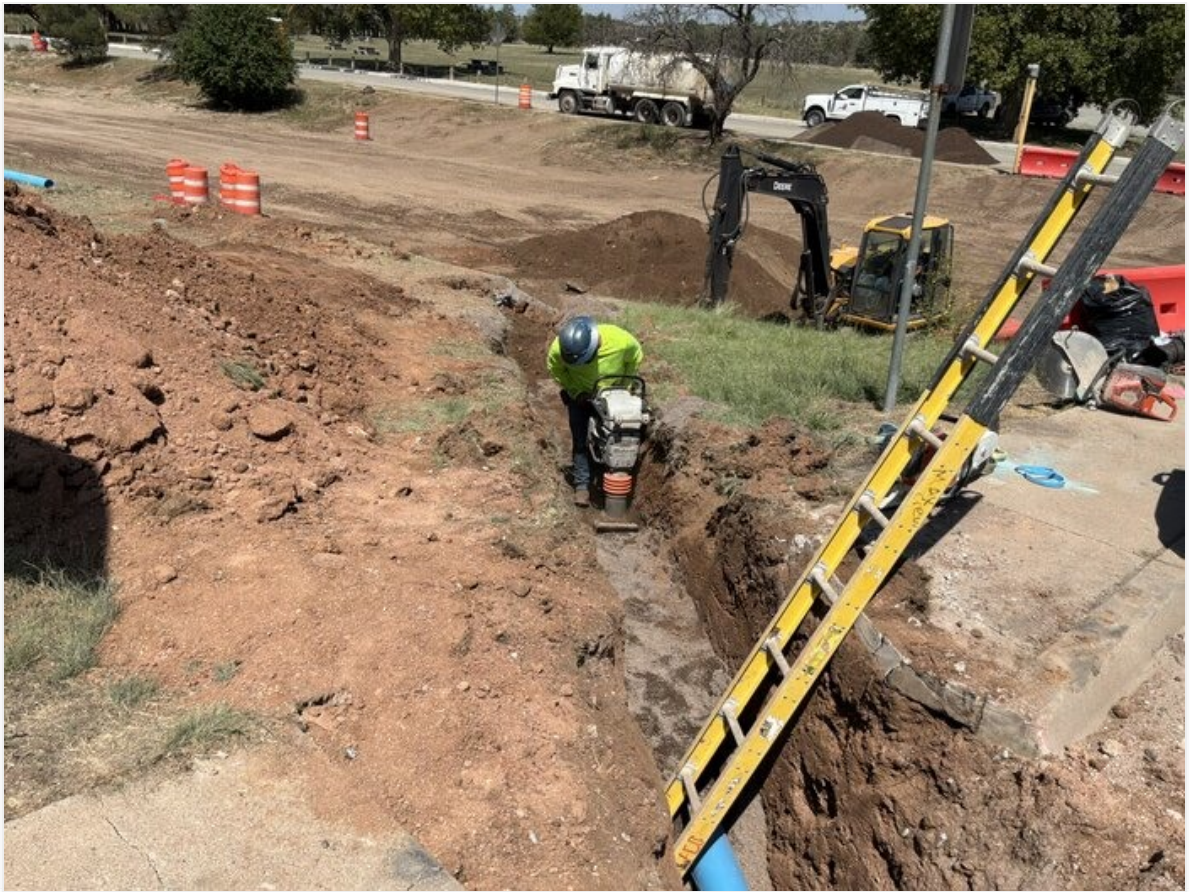
*Compaction over 6" c-900, first lift.*

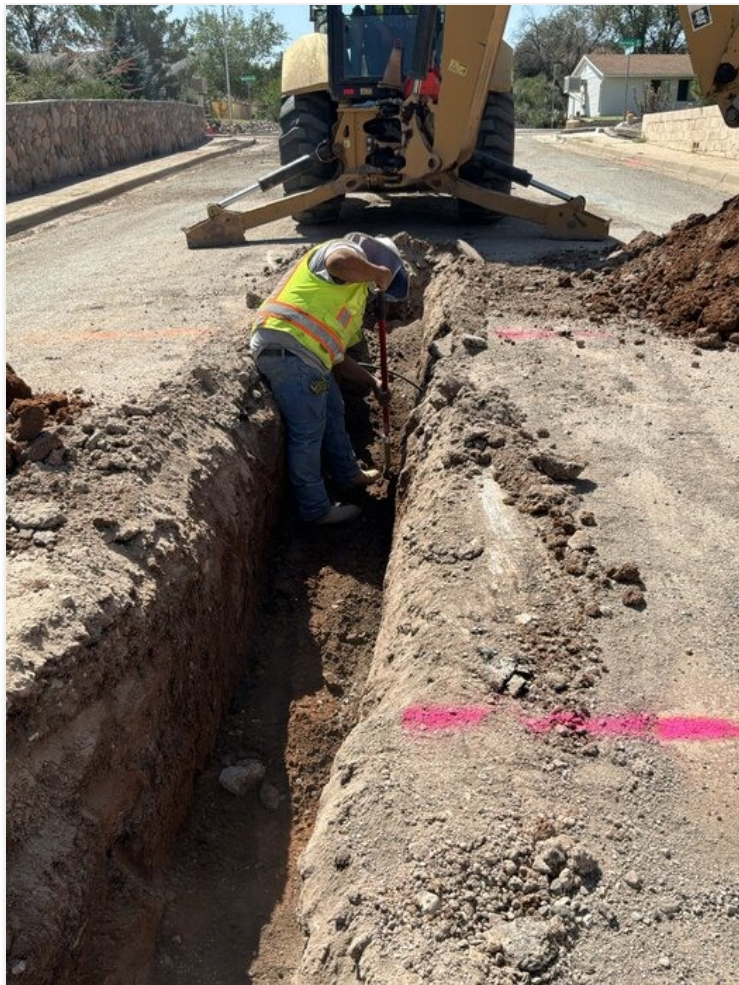
*Hand digging to verify existing water service on Chrysocolla Ave.*

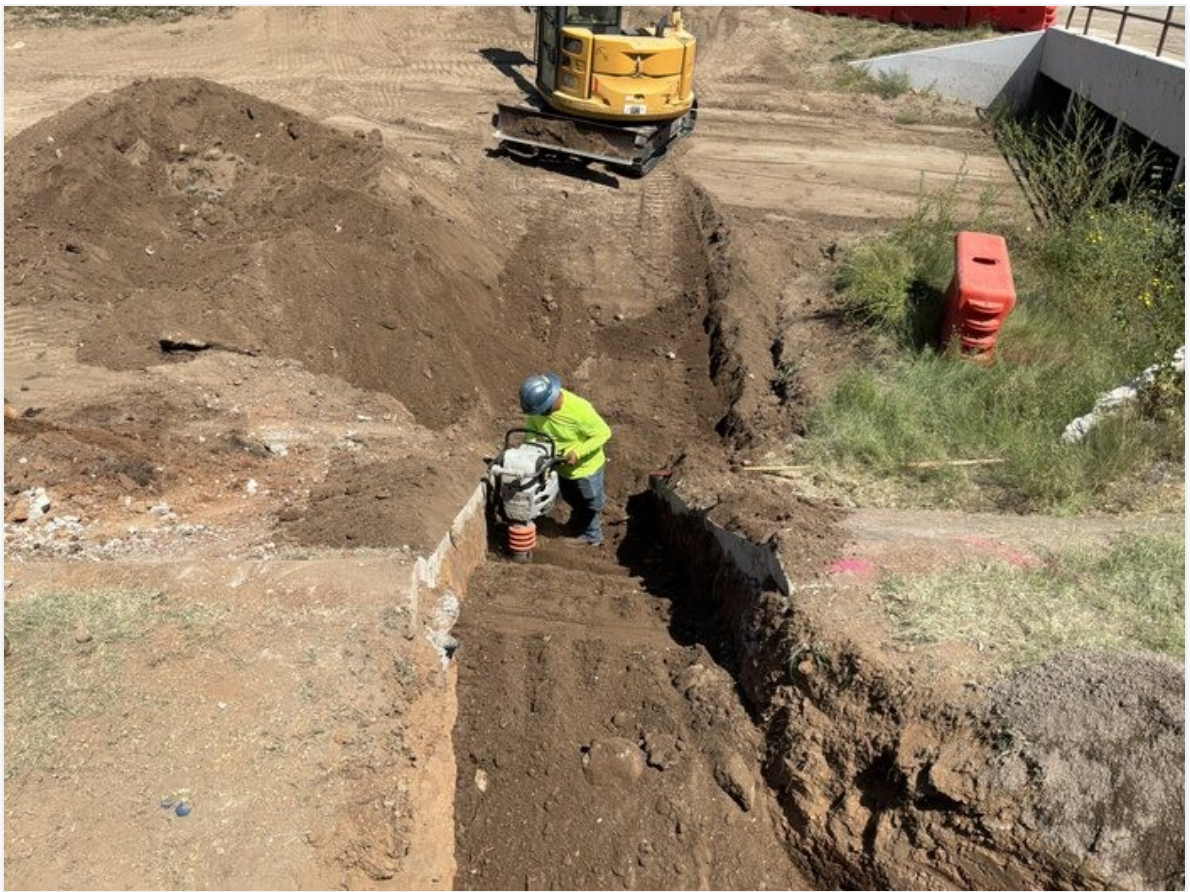
*Compaction at removed sloped blanket at arroyo.*

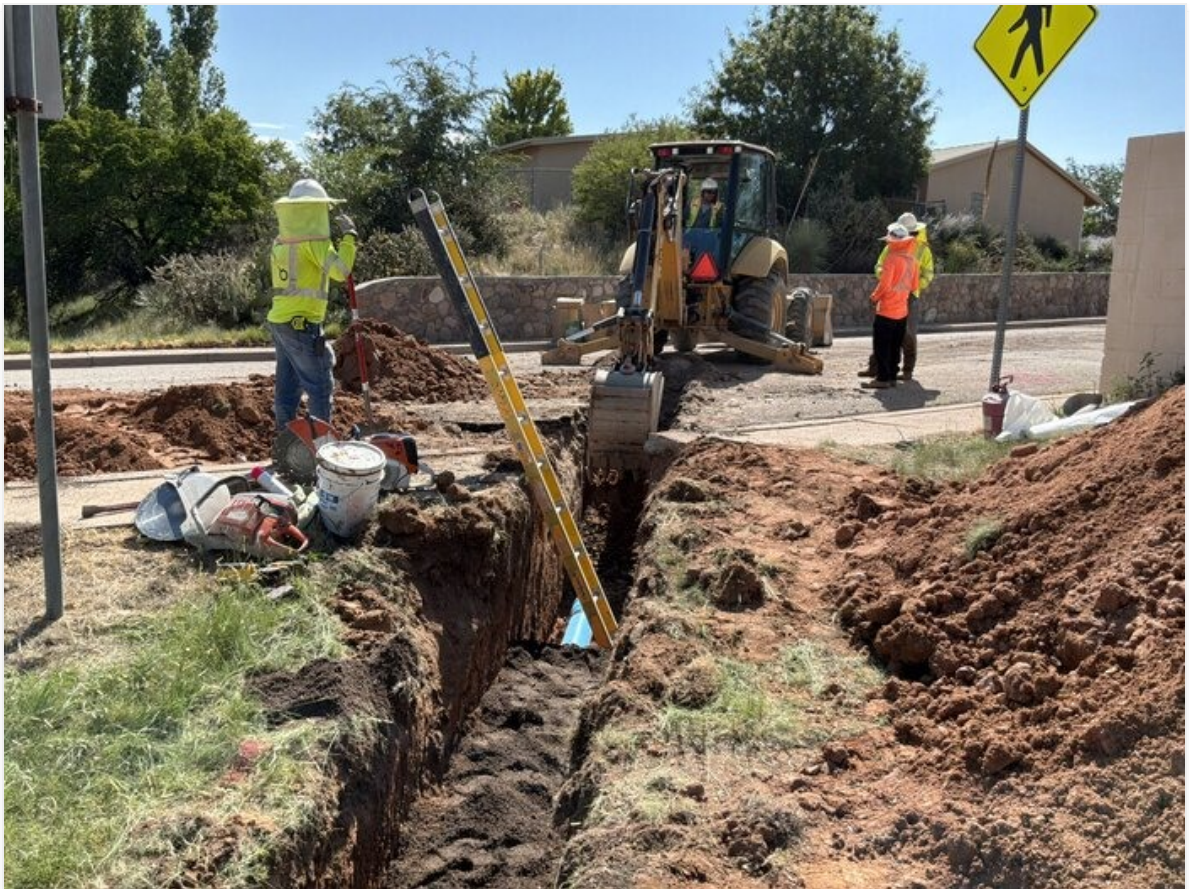
*Excavating for 6" C-900 on Chrysocolla Ave.*
