| <b>DATE:</b> | 8/10/2026 - 8/13/2026 |
| <b>REPORT NUMBER:</b> | 14 |
| <b>PROJECT NUMBER:</b> | 20260236 |
| <b>PROJECT:</b> | Tyrone Water System Improvements Construction |

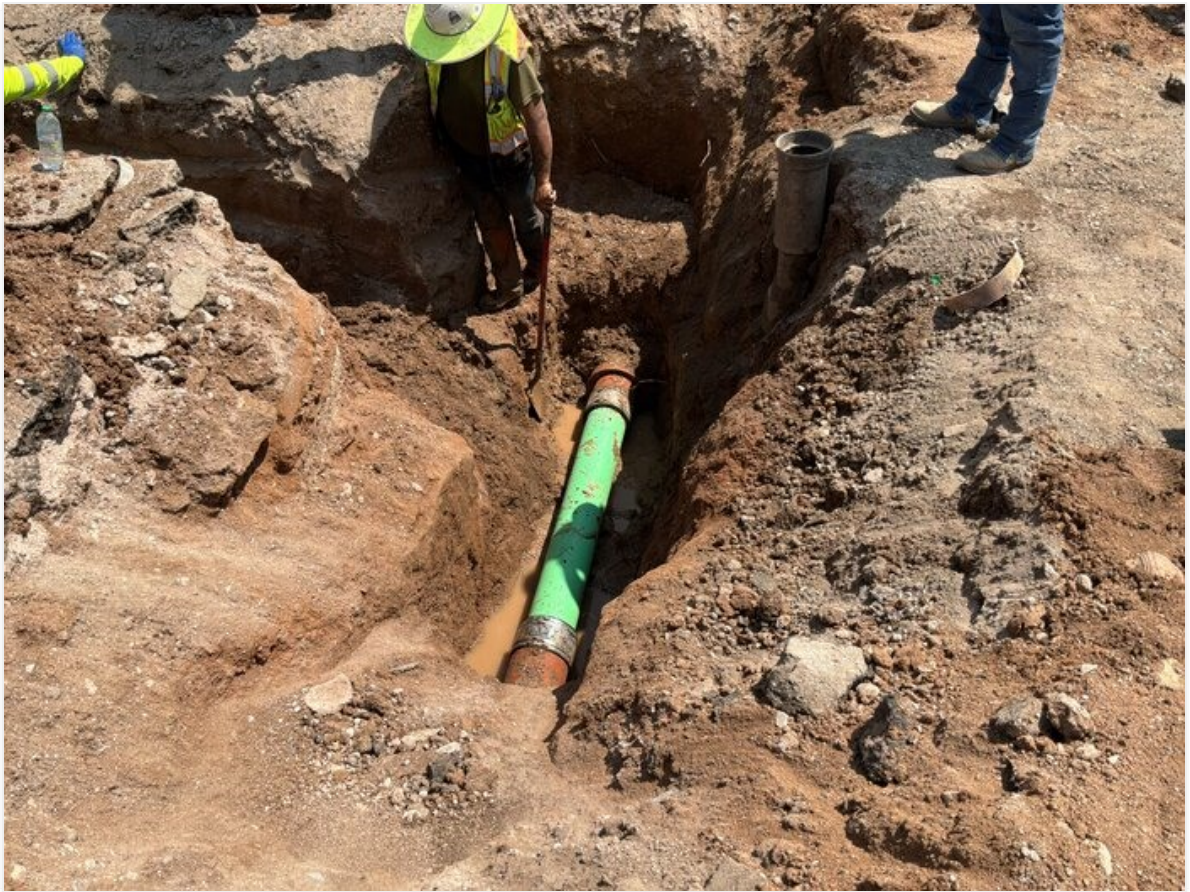
**Crew #1**– The contractor continued to place new fire hydrants as per hydrant plan and as per plan detail on Cuprite St. During excavation for the 6” fire line, the excavator snagged the existing sewer line at approx sta. 29+17. Smithco vacuumed out sewer water, saw cut both ends of existing line and replaced with 4’ of 8” SDR11 pipe with two repair couplings. The new fire line was placed and hydrant installed. Backfill and compaction followed.

The existing sewer line was marked but the mark was off about 2’. The plans did show it at the hit location.

*Repaired sewer line at approx. sta 29+17*

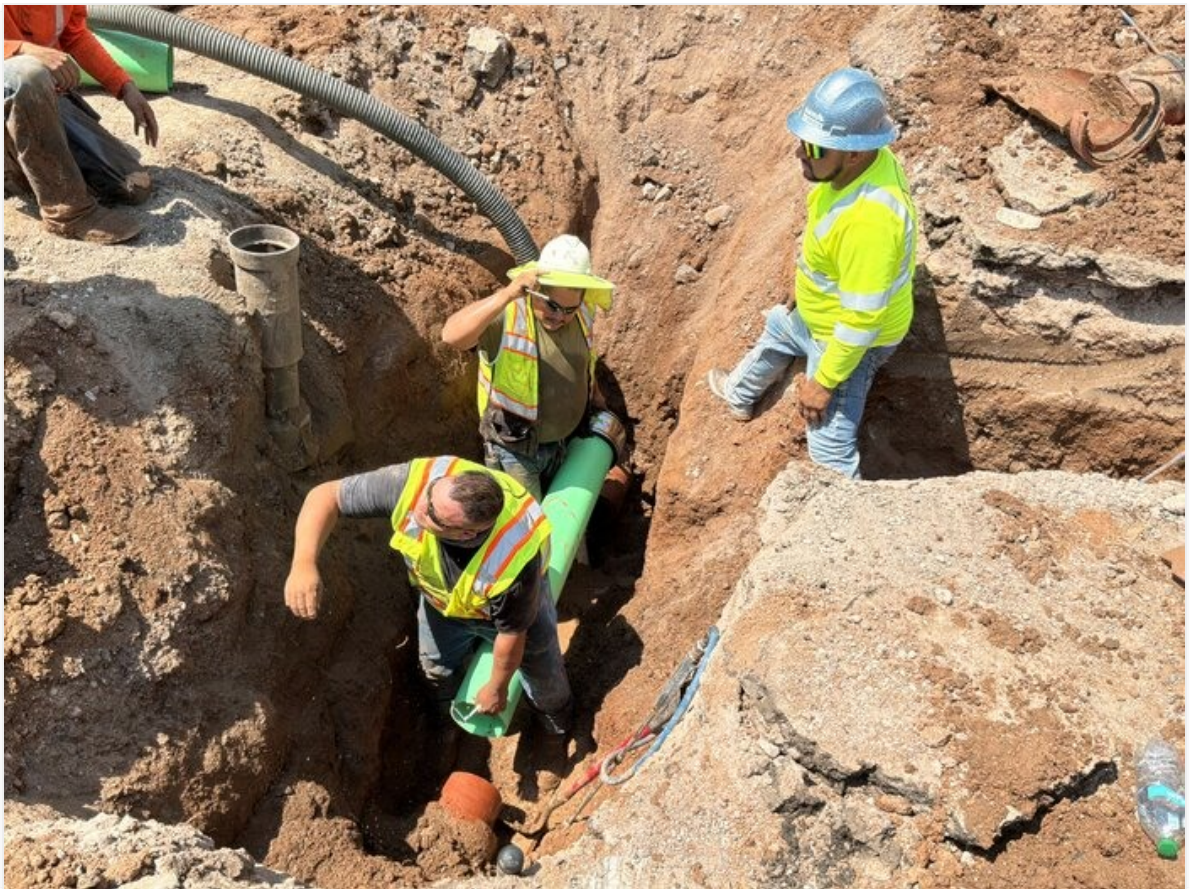
*Repair for sewer at approx sta 29+17 Cuprite St.*

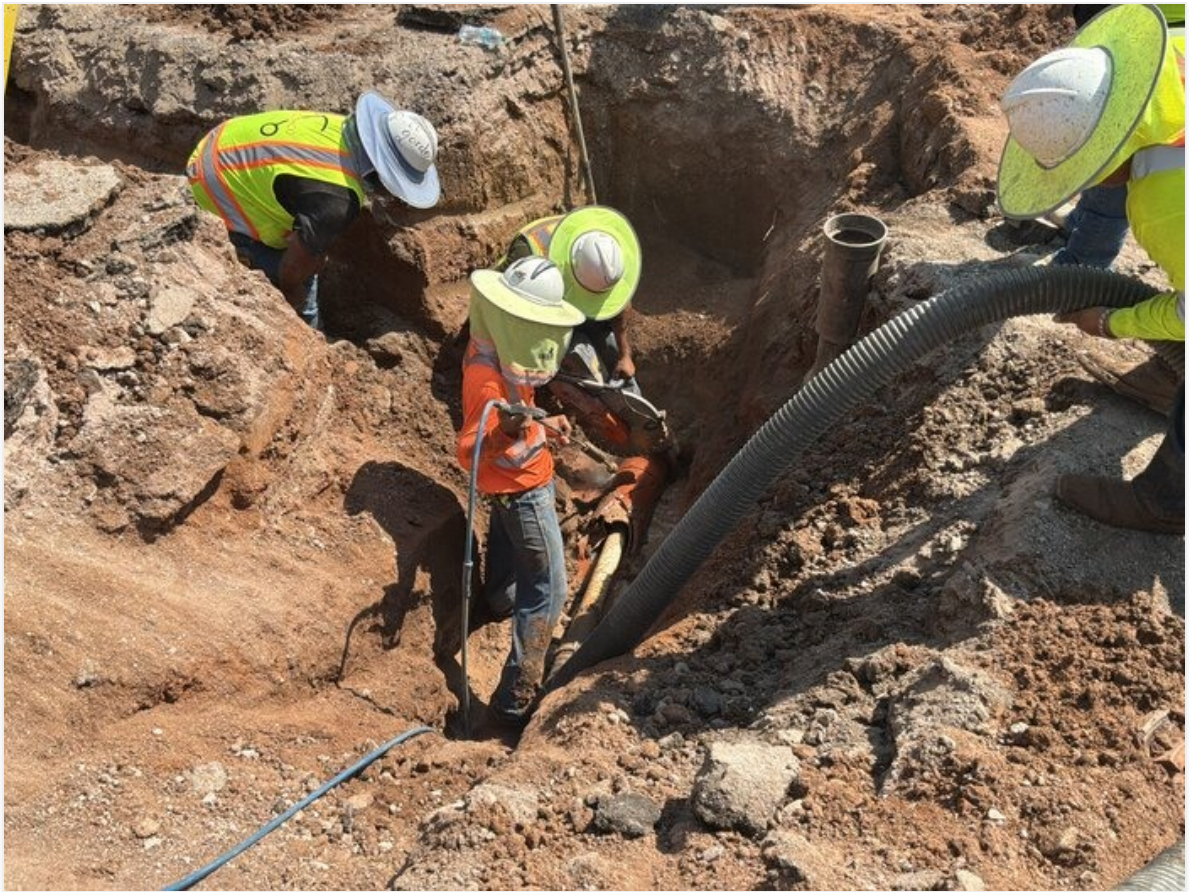
*Vacuum the sewer sludge on cuprite St. at sta 29+17*

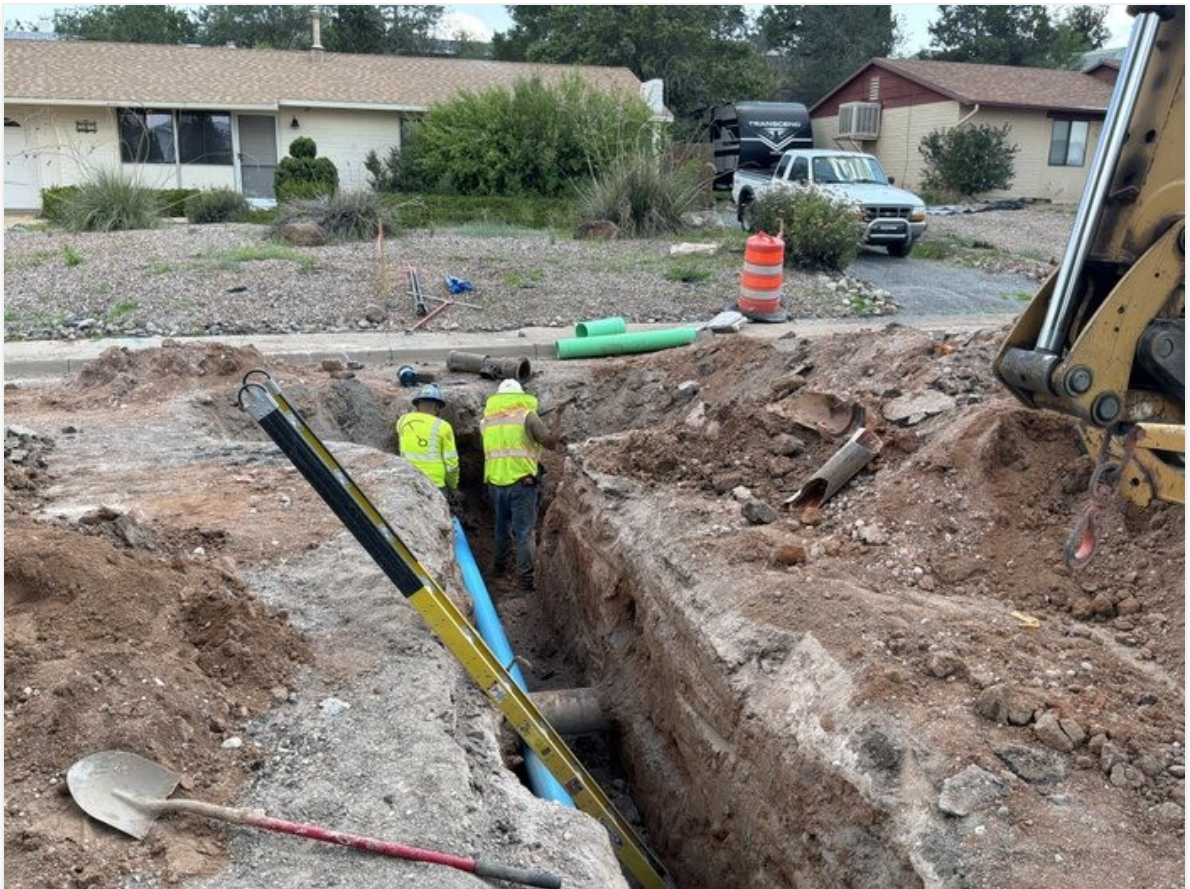
*Fire line on Cuprite St. at approx. sta. 29+17*

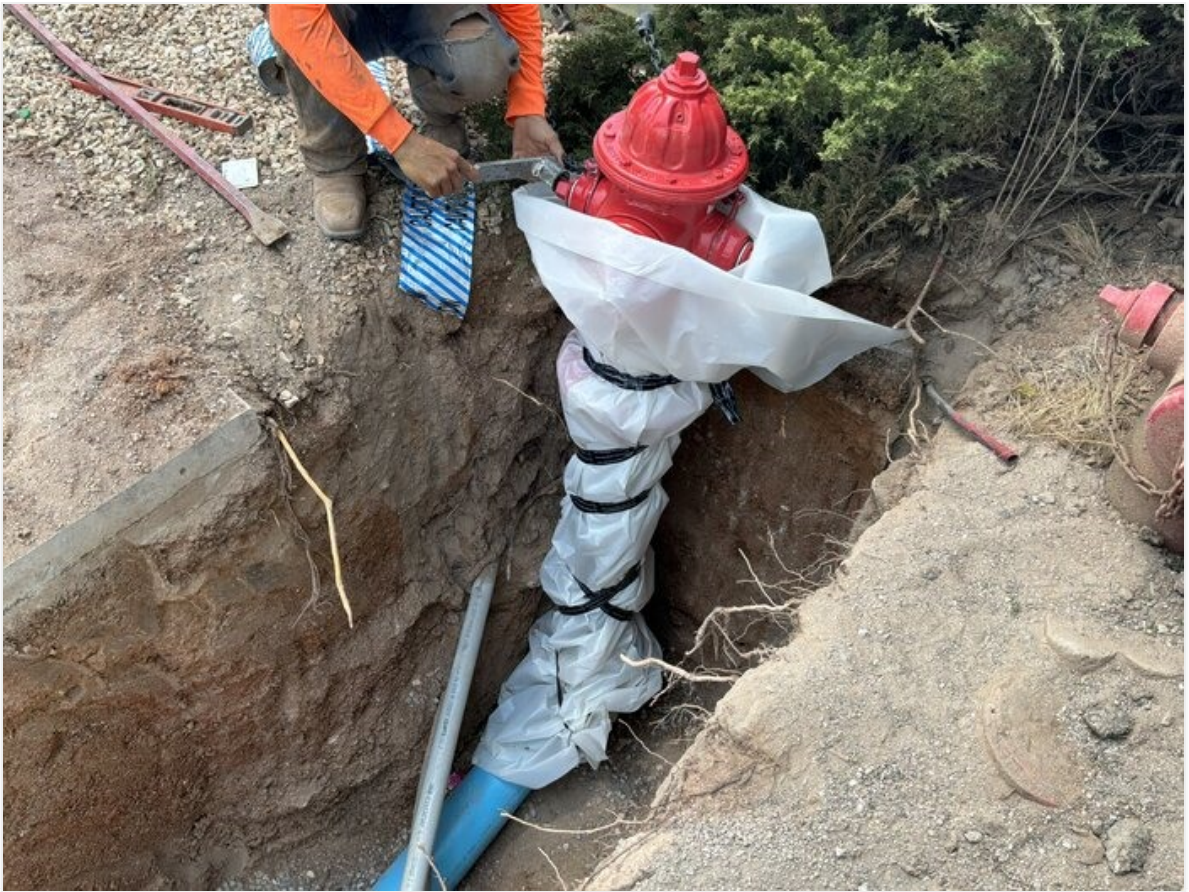
*Installed hydrant #32. A riser will be needed to raise to grade.*

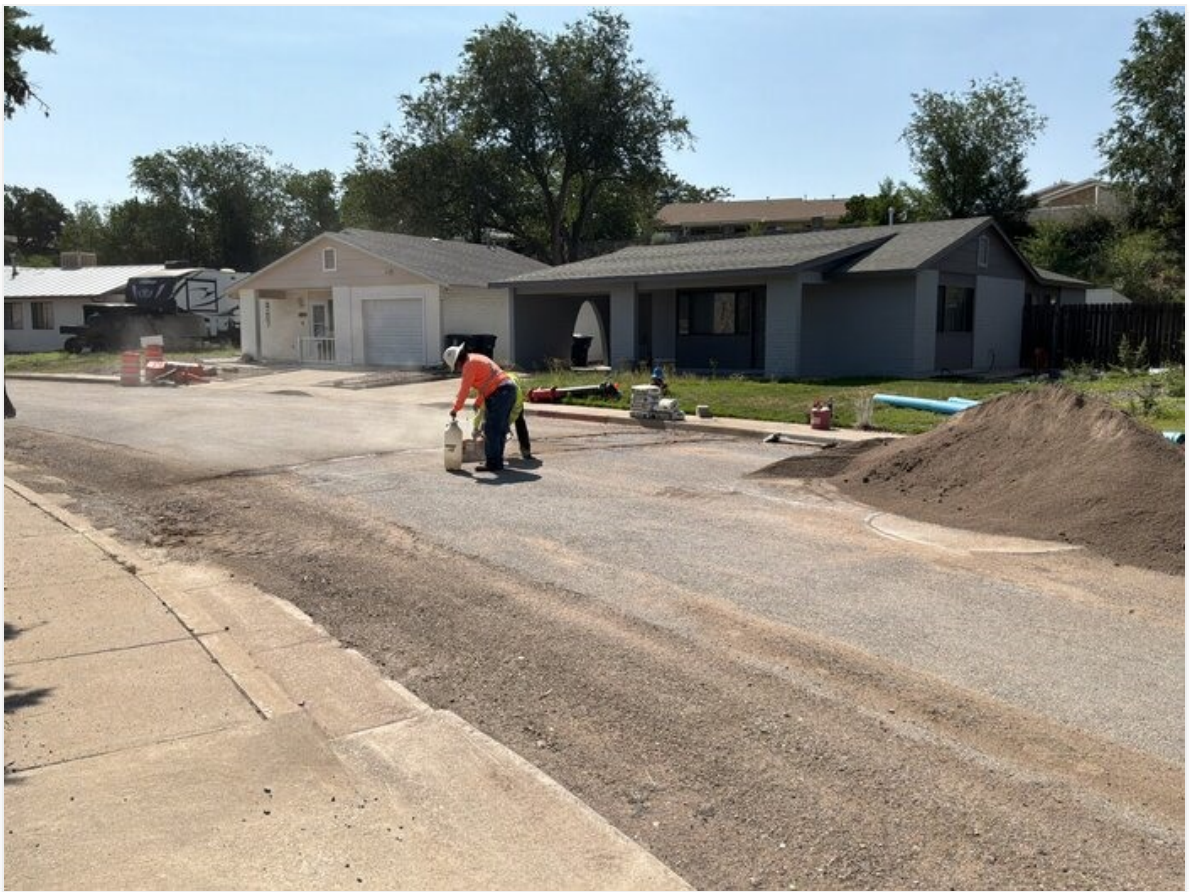
*Saw cutting roadway for fire line on Chalcocite St. hydrant #43*

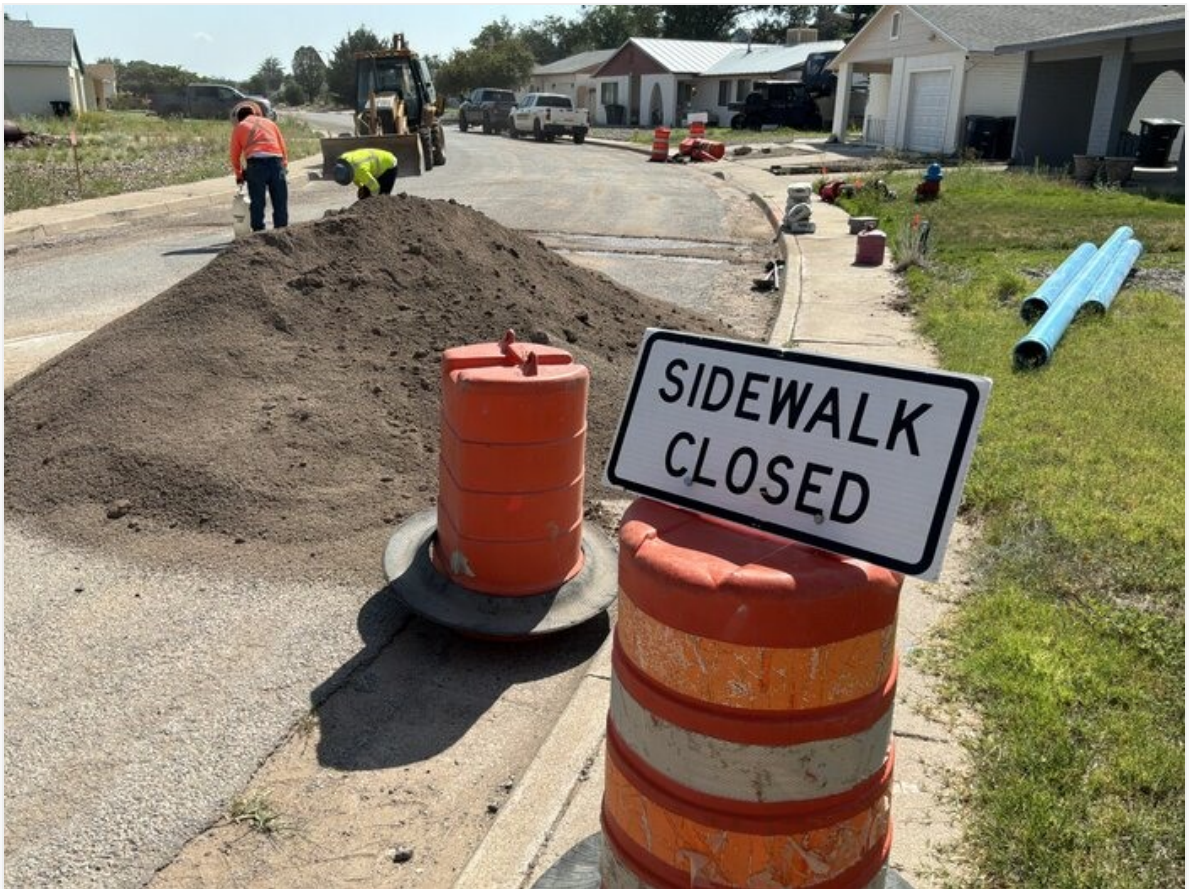
*Sidewalk closed sign for pedestrian safety.*

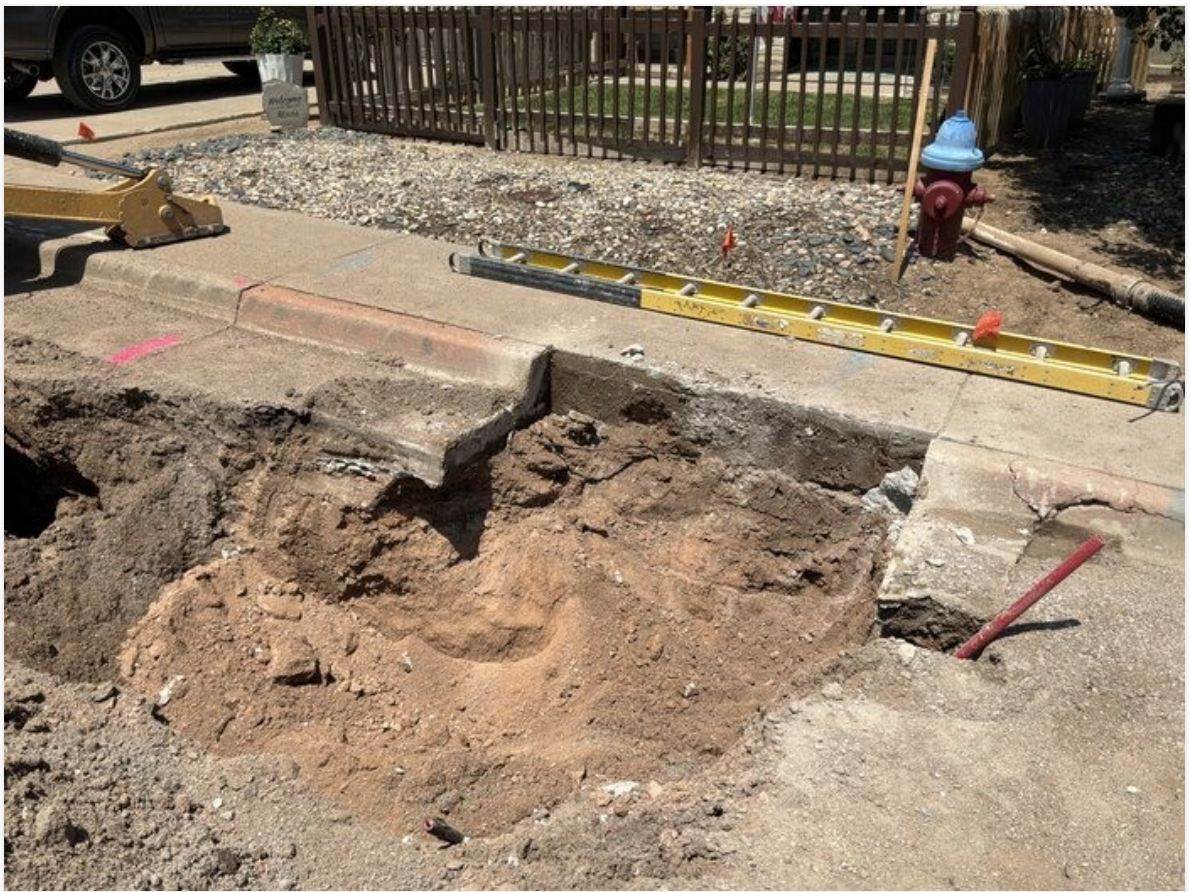
*Excavation for GV on Cooper Dr. sta 25+55*

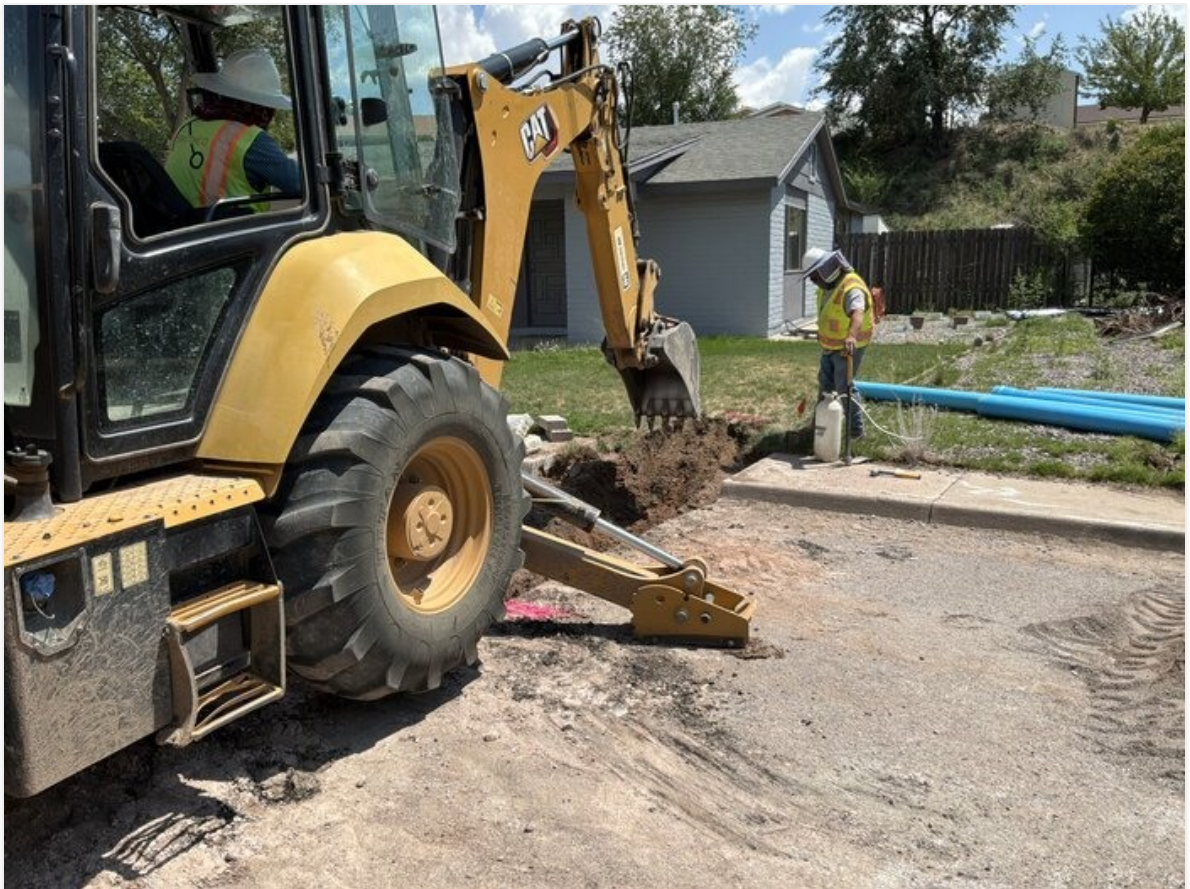
*Excavation for hydrant #43 on Chalcocite St.*

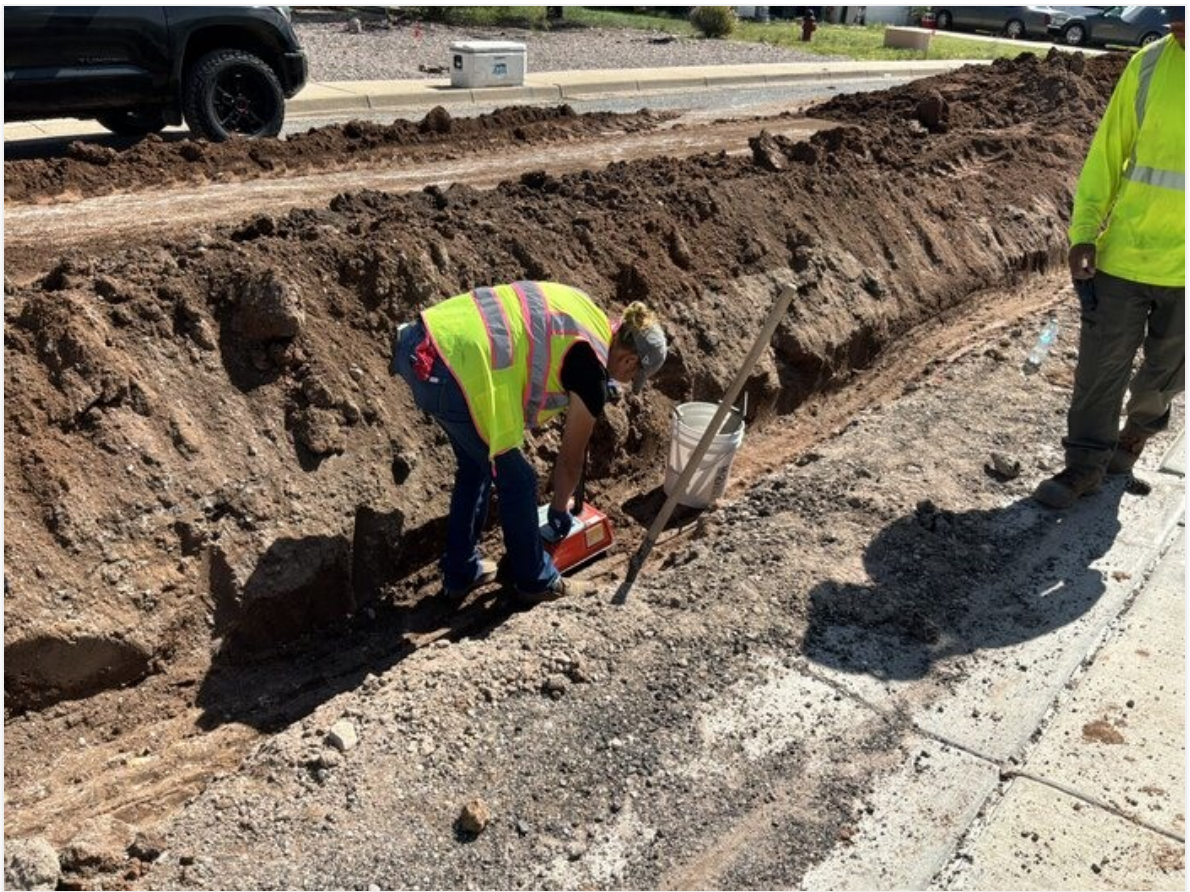
Summit Lab was onsite to take backfill densities. All tests taken passed.

*Summit Lab taking backfill densities.*

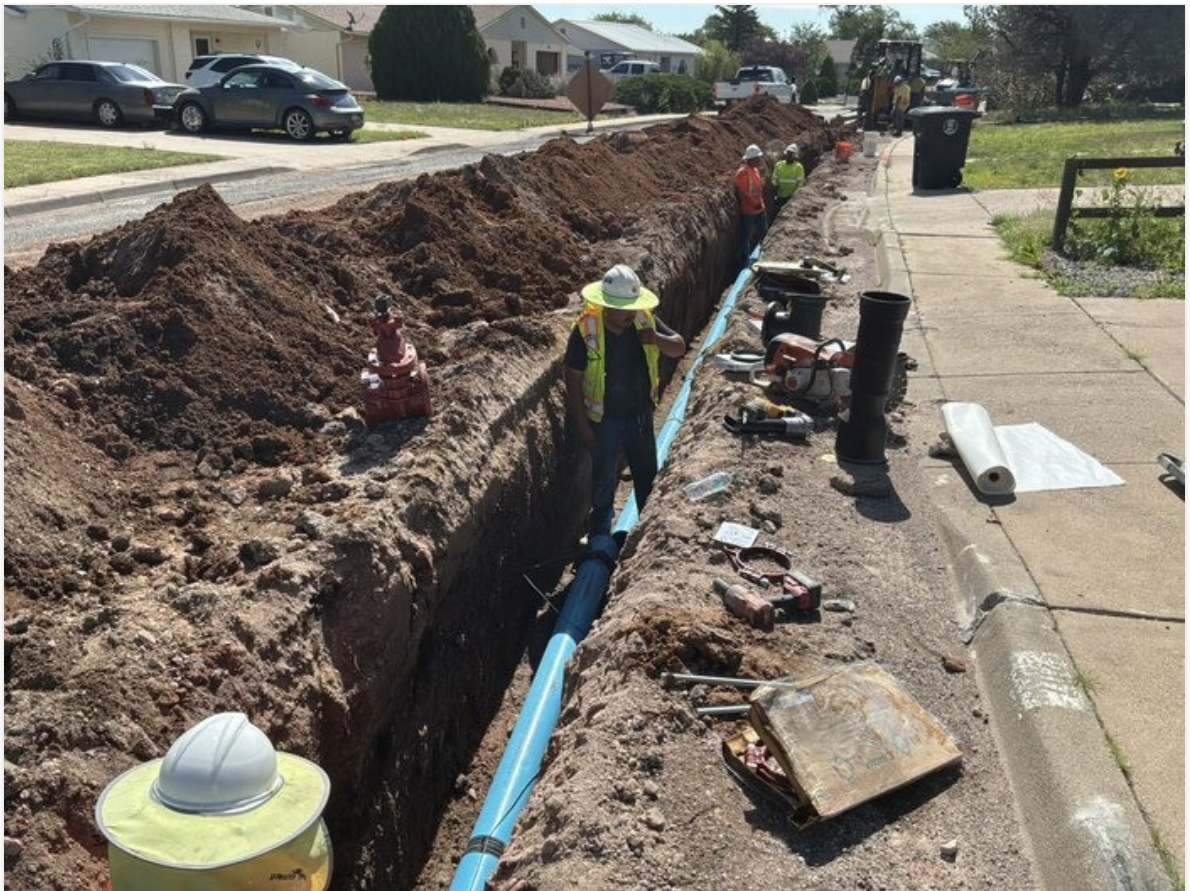
*6" C-900 pipe laying operations on Chalcocite St.*

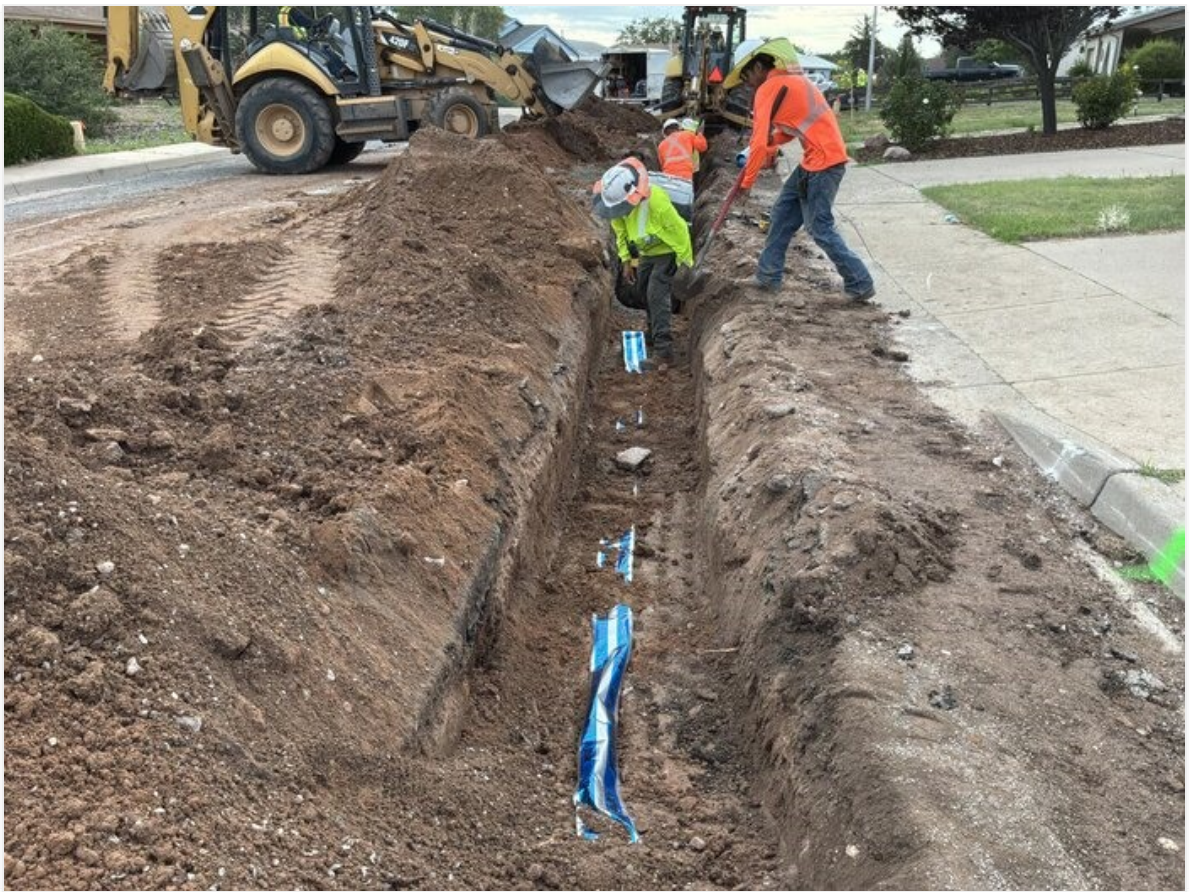
*Caution tape being placed as per plan detail.*

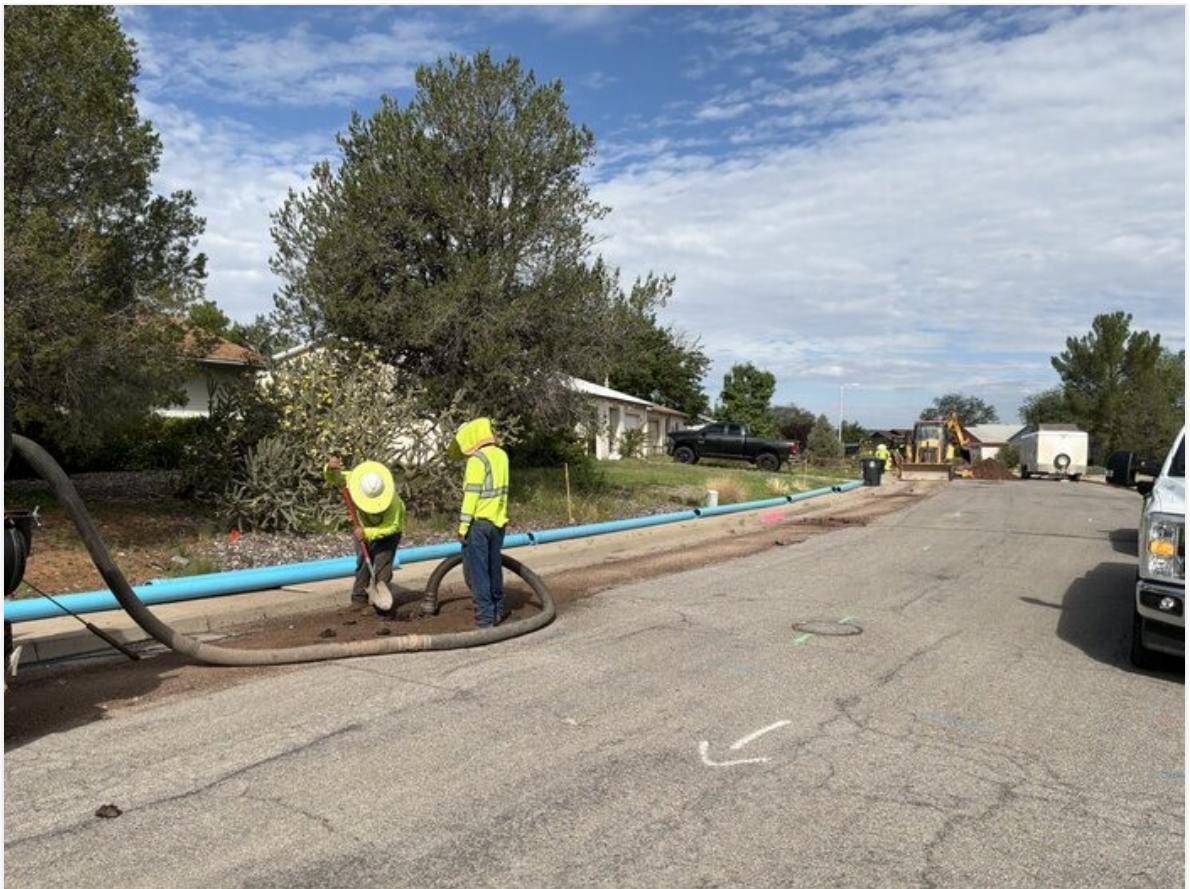
*Potholing for existing utilities ahead of excavation on Chalcocite St.*

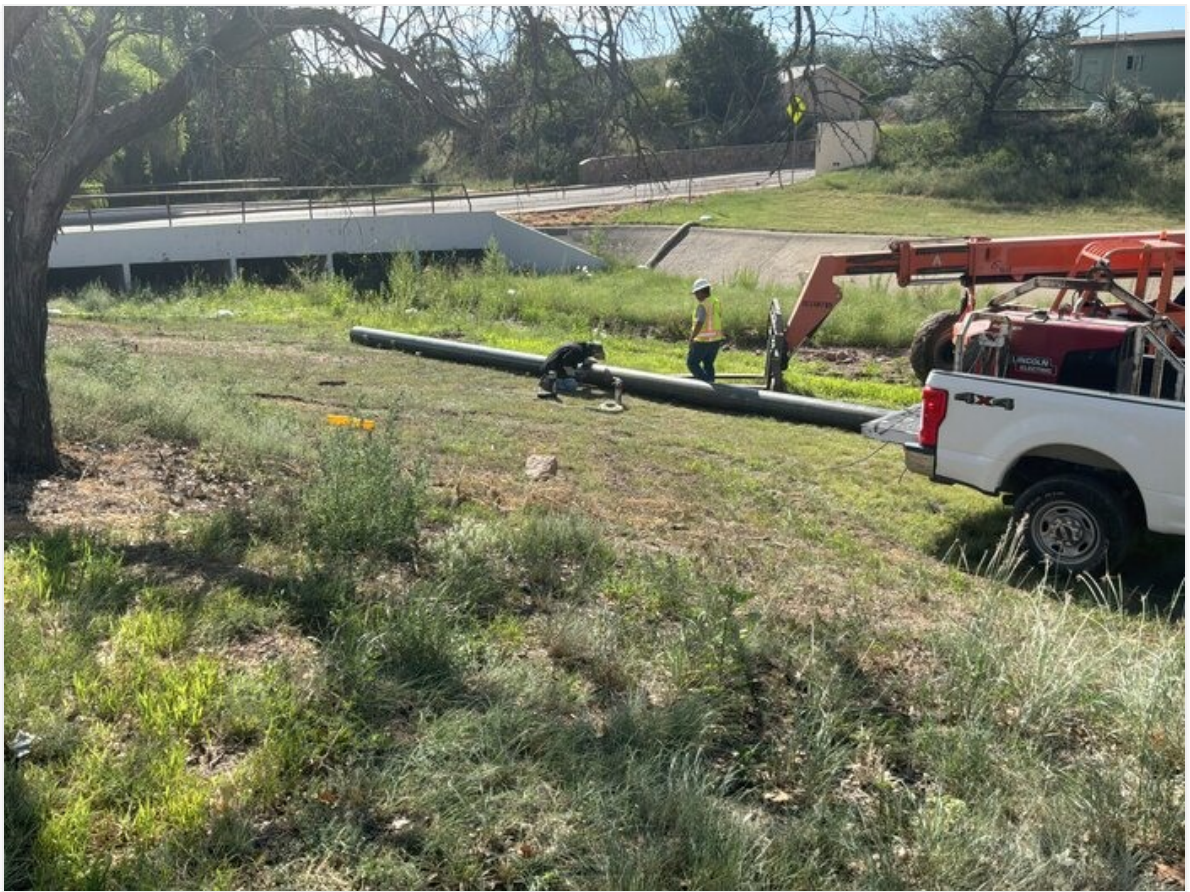
*Welding of the 12" steel casing for arroyo crossing.*

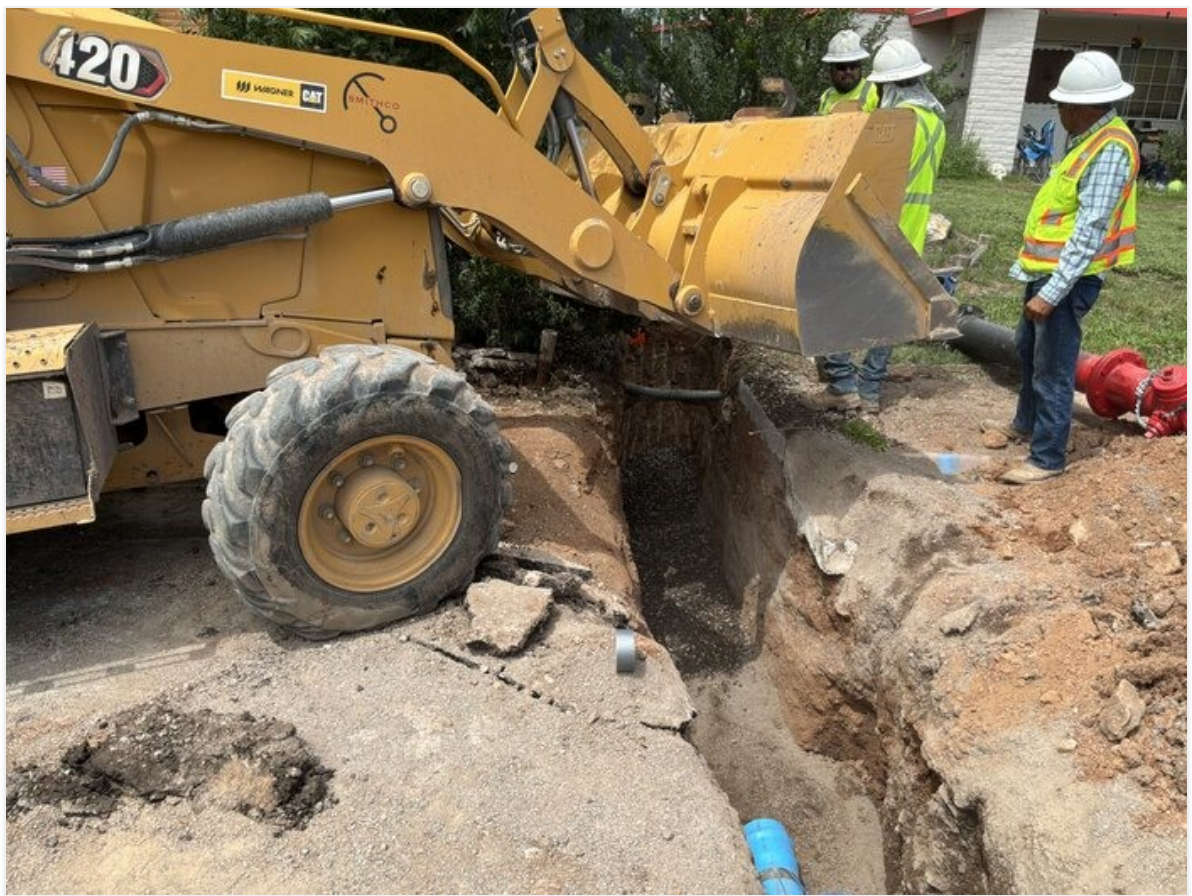
*Placing gravel for hydrant weep hole.*

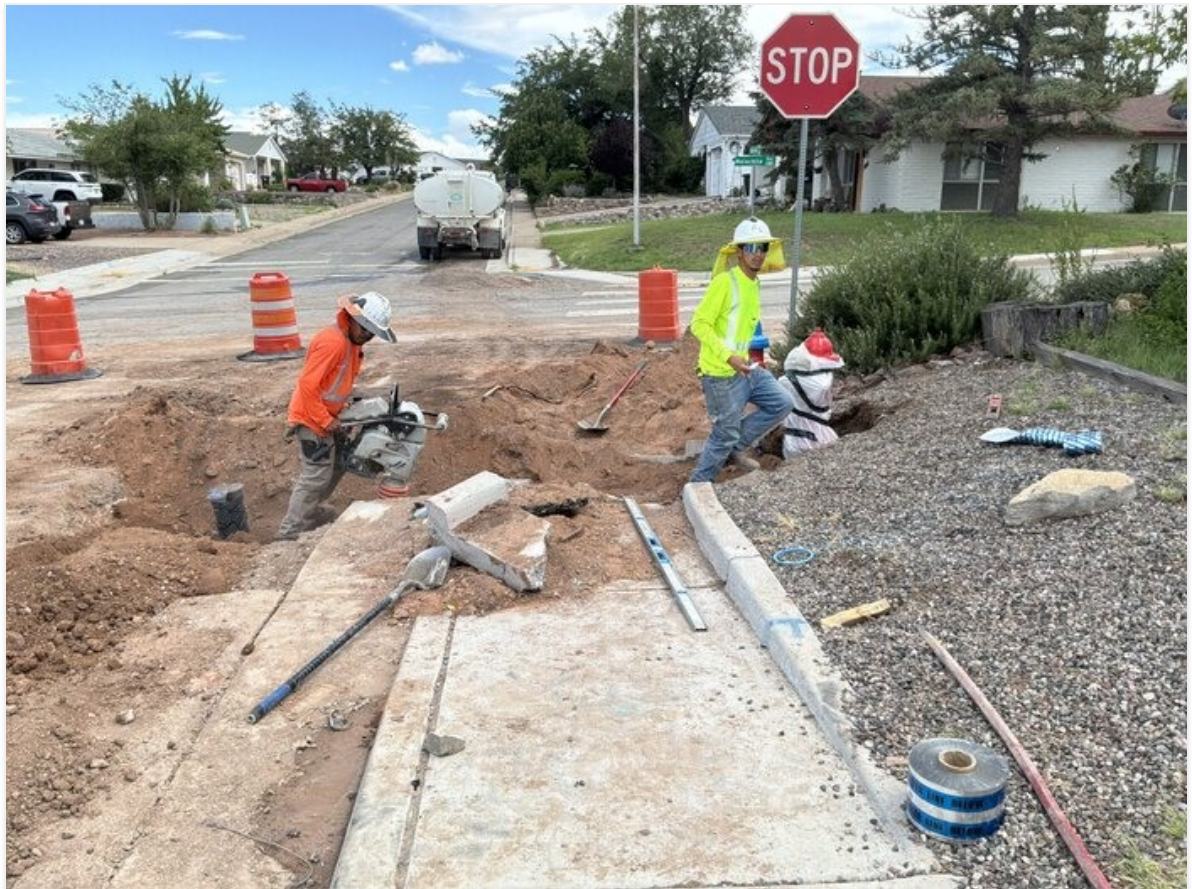
*Compaction of hydrant fire line on Chalcocite St.*

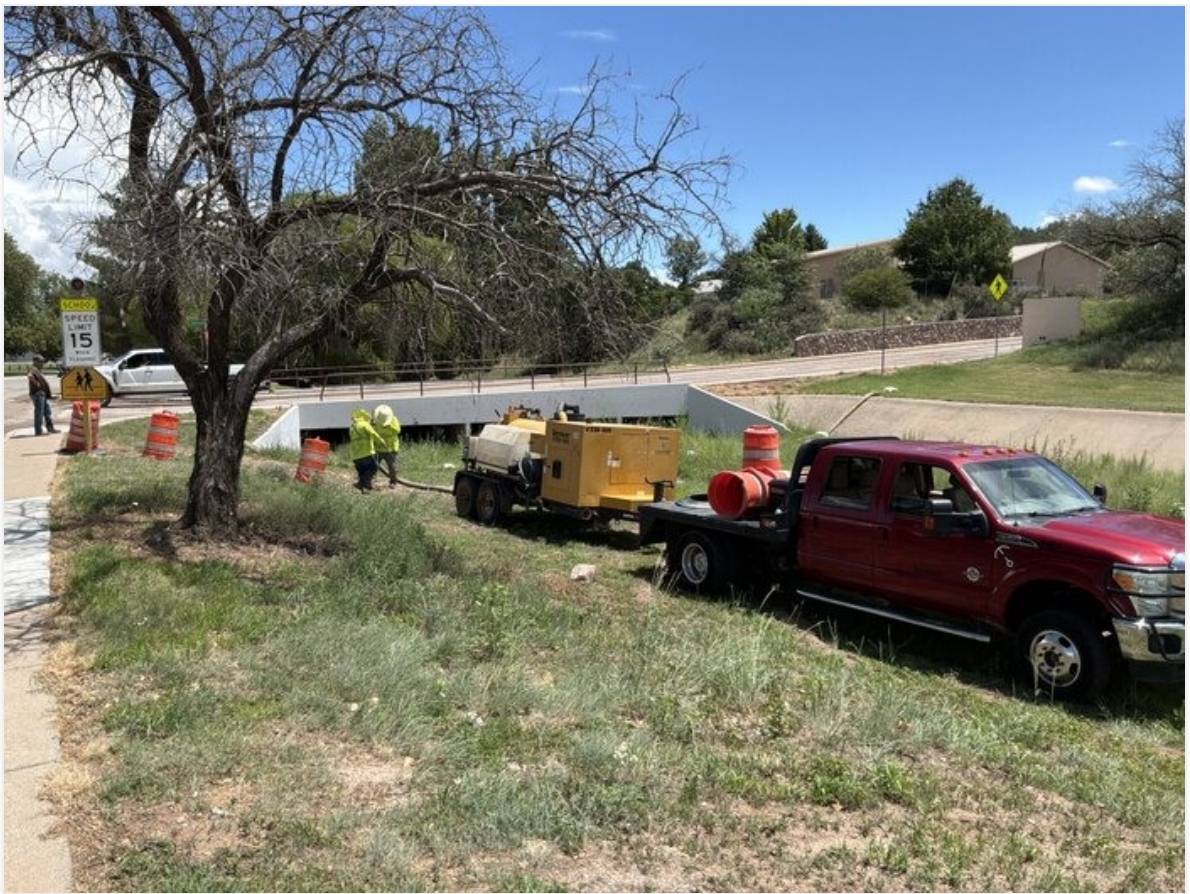
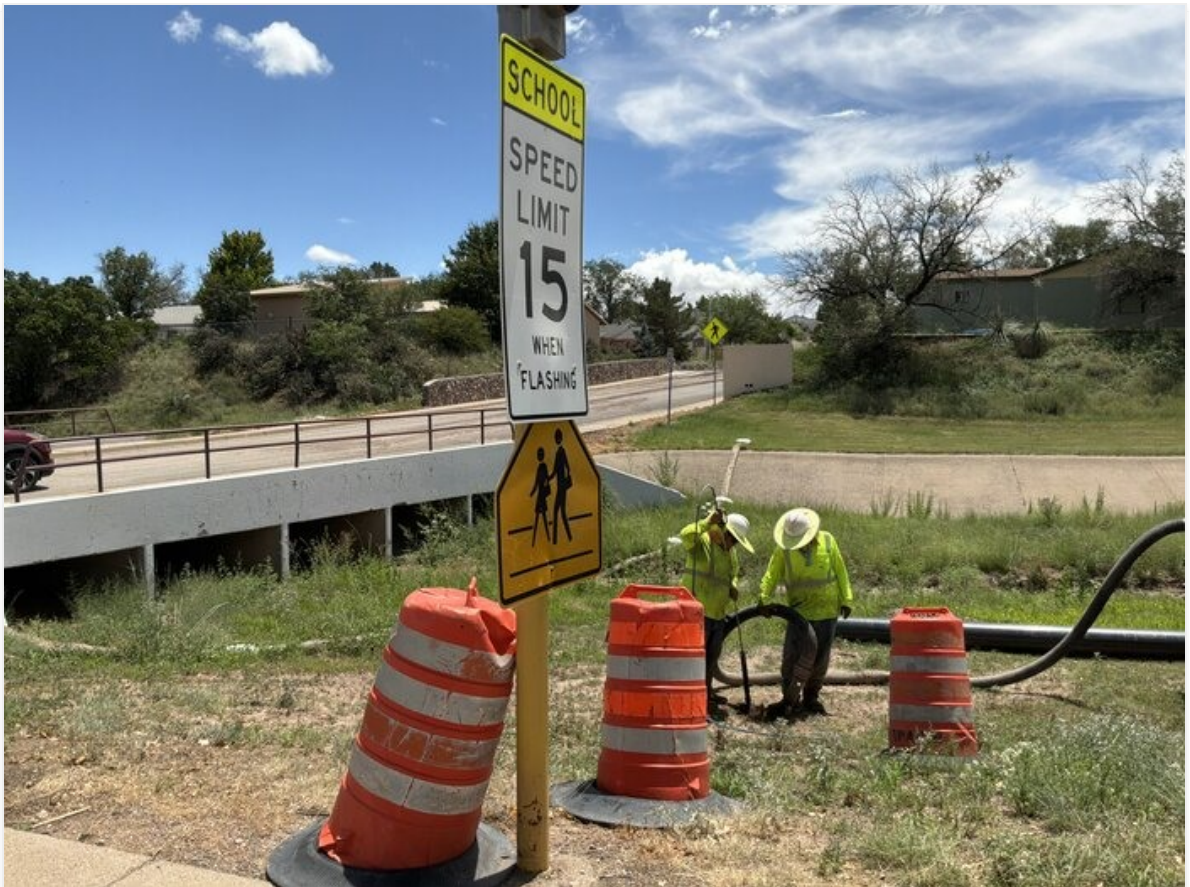
**\*\* Utility Exploration\*\*** The contractor used one hour of utility exploration time to pothole an existing underground power source that feeds the lighted crosswalk sign on Cooper Dr. This could potentially be in the way of the 12” steel casing in the arroyo off of Cooper Dr.

*Potholing for power line in arroyo.*

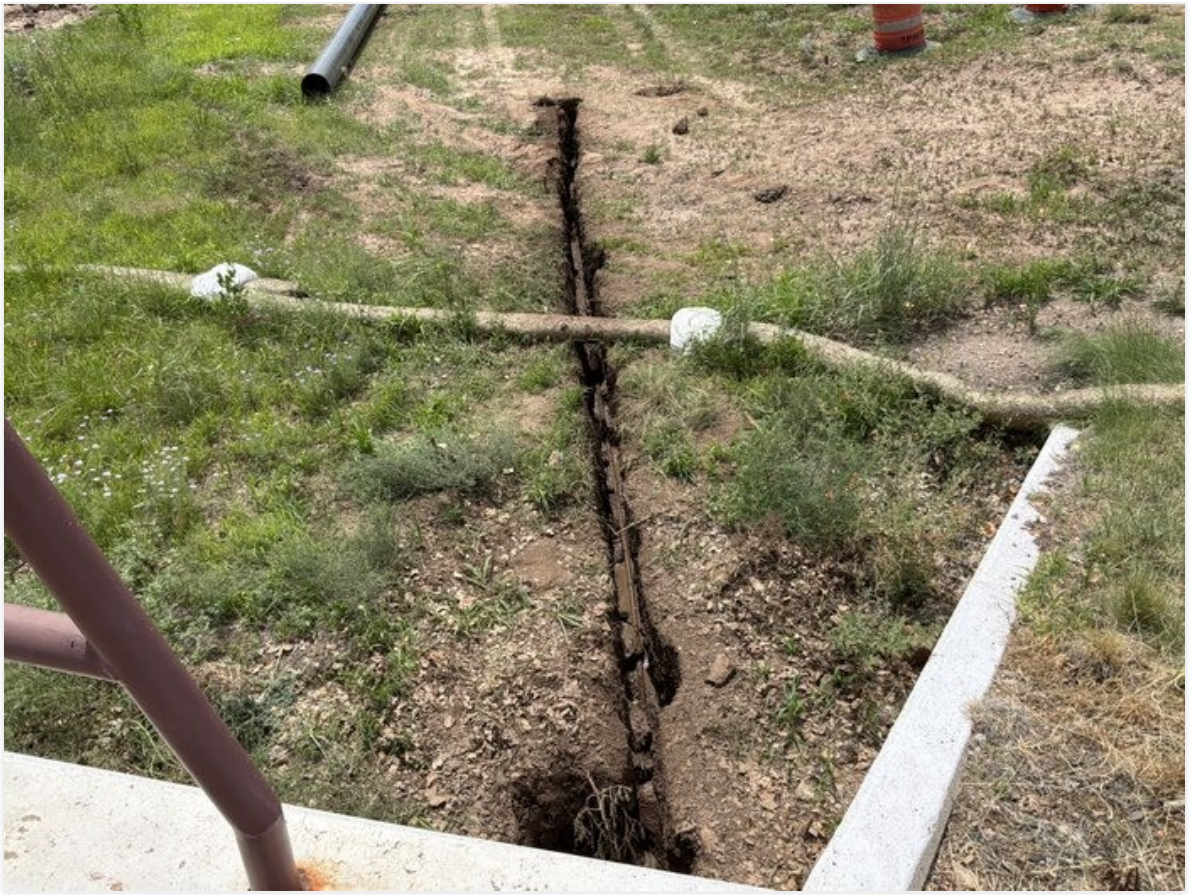
*Located power line in arroyo.*

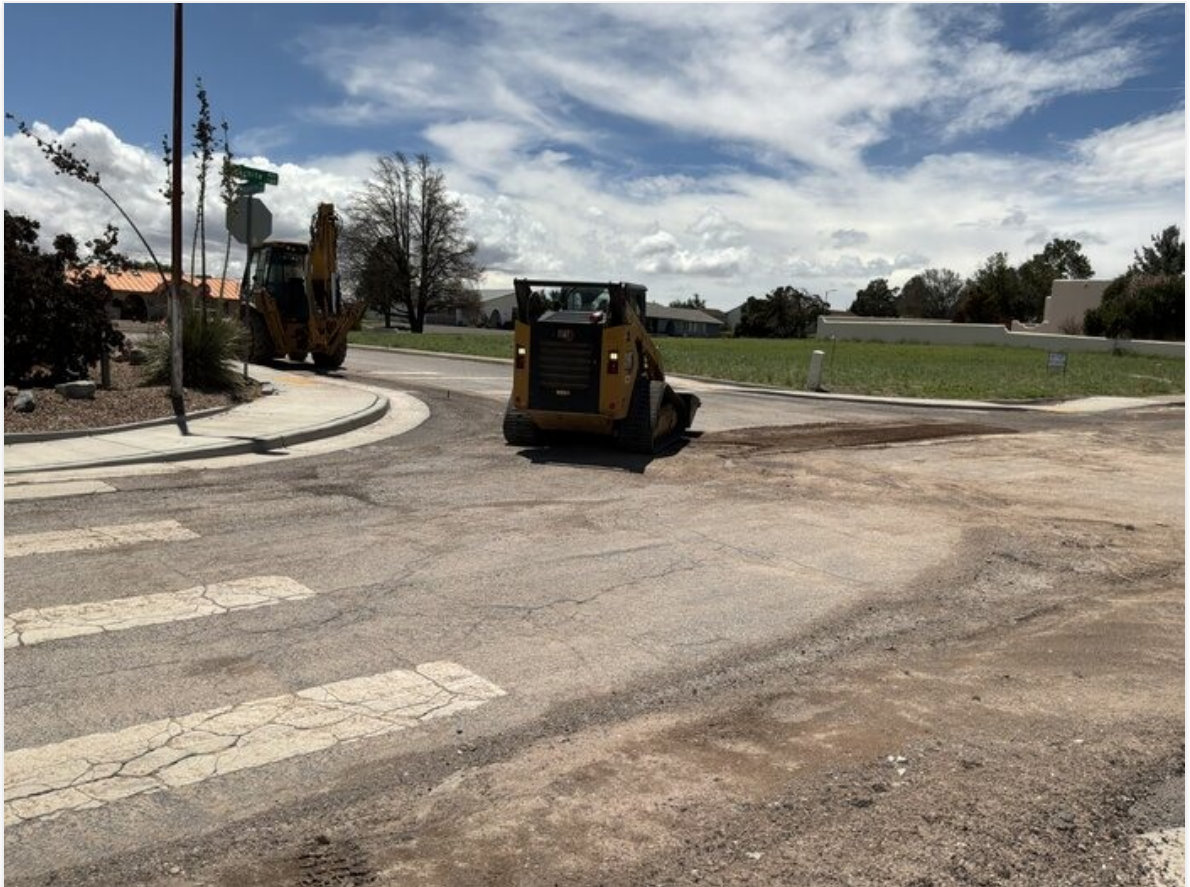
*Maintaining intersections due to rain.*
